Main decommissioning work and steps

Fuel removal from the spent fuel pool was completed in December 2014 at Unit 4 and on February 28, 2021 at Unit 3.
 Work continues sequentially toward the start of fuel removal from Units 1 and 2 and debris (Note 1) retrieval from Units 1-3.
 (Note 1) Fuel assemblies having melted through in the accident.

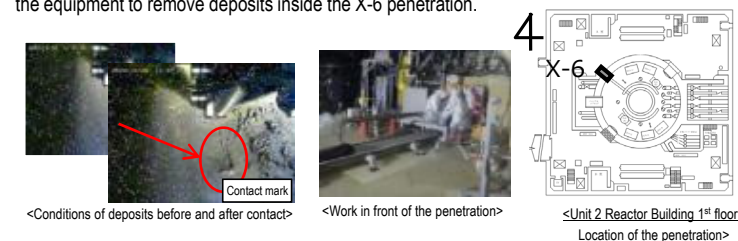
- In October 2020, as part of work to prepare for the PCV internal investigation and trial retrieval, a contact investigation to study deposits inside the penetration (X-6 penetration) was conducted, which involved inserting a guide pipe incorporating an investigative unit into the penetration. This confirmed that deposits inside the penetration had not deformed and come unstuck. The investigative information obtained will be utilized in the mockup test of the equipment to remove deposits inside the X-6 penetration.

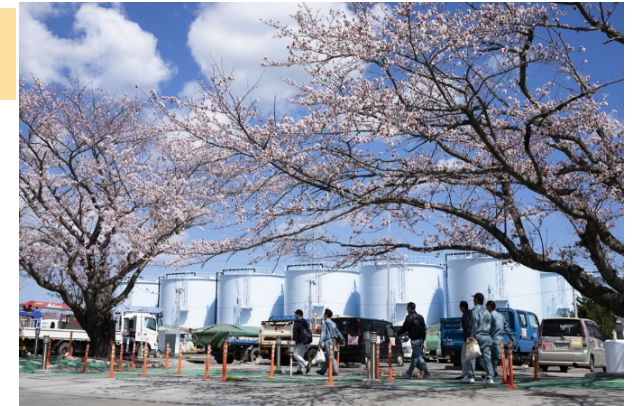
Regarding the site-wide reduction in the radiation dose and prevention of contamination spreading, the radiation dose on site was reduced by removal of rubble, topsoil and facing. Moreover, the operation was improved to use environmentally-improved areas as a Green Zone, within which workers are allowed to wear general work clothes and disposable dust-protective masks which are less of a physical burden.

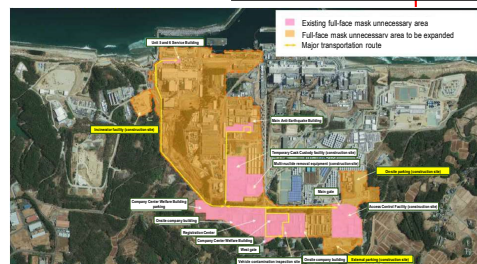
In August 2021, operation started while eliminating the need for the DS2 mask during light work in G-zone outside the protection area around Unit 1-4 (except for inside Units 5 and 6).

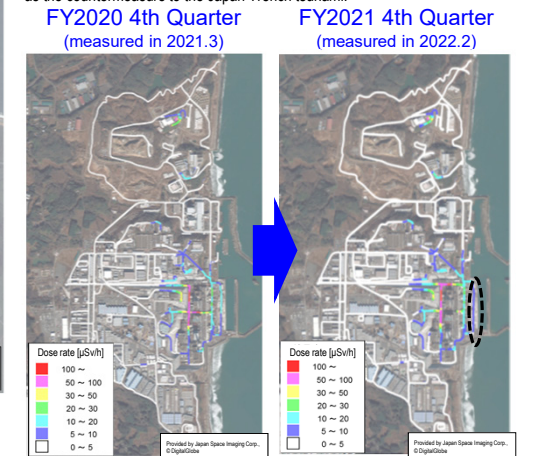
<Travel survey results of major roads within the site>
The dose rate has been declining every year. In particular, in the area on the east side of the Turbine Building shown a black dotted line, the dose rate declined by facing related to installation of the seawall as the countermeasure to the Japan Trench tsunami.
