## Main decommissioning work and steps

## Progress status

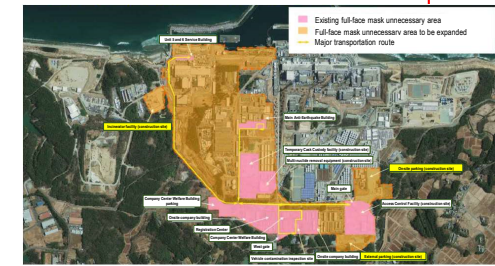
In May 2013, areas excluding those around Unit 1-4, tank areas and rubble storage areas were set to full-face mask unnecessary areas.

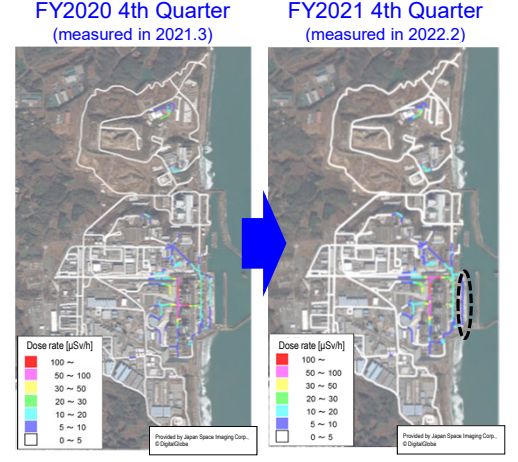
<Travel survey results of major roads within the site>  
 The dose rate has been declining every year. In particular, in the area on the east side of the Turbine Building shown a black dotted line, the dose rate declined by facing related to installation of the seawall as the countermeasure to the Japan Trench tsunami.
