Main decommissioning work and steps

Unit 1 Status of the Primary Containment Vessel (PCV) internal investigation (the latter half)

Unit 2 Status of preliminary work for the PCV internal investigation and trial retrieval

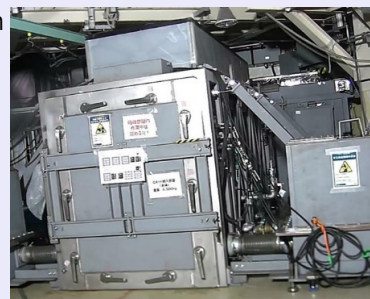
< Status of the isolation room installation >

In preparation for the investigation inside Unit 2's Primary Containment Vessel (PCV) and the trial retrieval, an isolation room was installed on-site and completed on April 14.

The new isolation room will serve as a boundary to contain gas inside the PCV when opening the hatch for the X-6 penetration, which will be the entry point for the robot arm.

While the hatch is open, measures will be taken to prevent the spread of contamination, such as increasing the pressure inside the isolation room to prevent gas leakage from the PCV and installing filtered local exhaust fans. Moreover, dust concentration will be monitored during the work to ensure that safety remains a top priority.

- As preliminary work of the Unit 2 site, work to install the isolation room toward opening the X-6 penetration hatch commenced from November 2021. In response to the damage to the rubber box in the isolation room, bending of the guide roller (earthquake response), misalignment of the shield door, damage to the pressing mechanism part and others having occurred during the work, countermeasures were implemented, and the installation of the isolation room was completed in April 2023. Subsequently, removal of deposits inside X-6 penetration and other work are scheduled. Work will proceed safely and carefully.

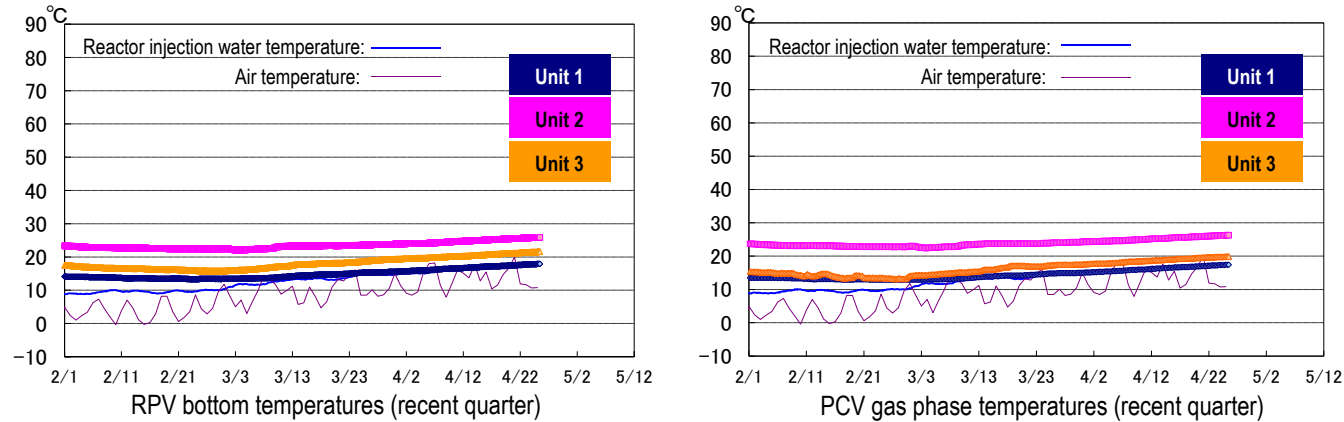
Through continuous reactor cooling by water injection, the temperatures of the Reactor Pressure Vessel (RPV) bottom and the Primary Containment Vessel (PCV) gas phase were maintained within the range of approx. 15 to 25°C for the past month, though it varied depending on the unit and location of the thermometer.

*1 The trend graphs show part of the temperature data measured at multiple points.
*2 A part of data could not be measured due to maintenance and inspection of the facility and other work.

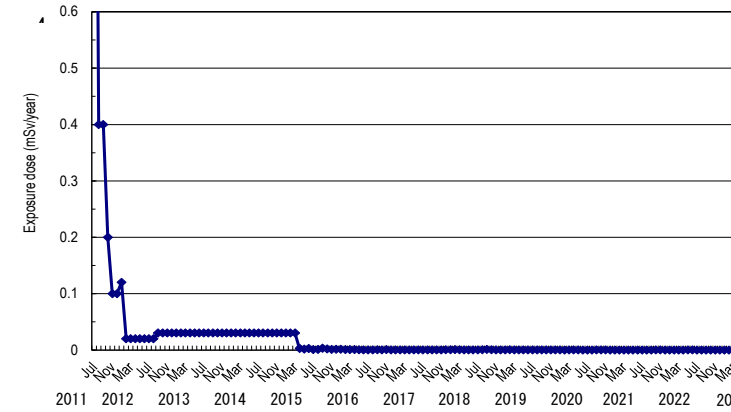
Annual radiation dose at site boundaries by radioactive materials (cesium) released from Reactor Building Units 1-

As of March 2023, the concentration of radioactive materials newly released from Reactor Building Units 1-4 into the air and measured at the site boundary was evaluated at approx. 2.2×10^{-12} Bq/cm³ and 1.5×10^{-12} Bq/cm³ for Cs-134 and -137 respectively, while the radiation exposure dose due to the release of radioactive materials there was less than 0.00004 mSv/year.

* The concentration limit of radioactive materials in the air outside the surrounding monitoring area:
[Cs-134]: 2×10^{-5} Bq/cm³
[Cs-137]: 3×10^{-5} Bq/cm³
* Data of Monitoring Posts (MP1-MP8).
Data of Monitoring Posts (MPs) measuring the air dose rate around the site boundary showed 0.315- 1.066 μSv/h (March 29 - April 25, 2023).
To measure the variation in the air dose rate of MP2-MP8 more accurately, work to improve the environment (trimming trees, removing surface soil and shielding around the MPs) was completed.

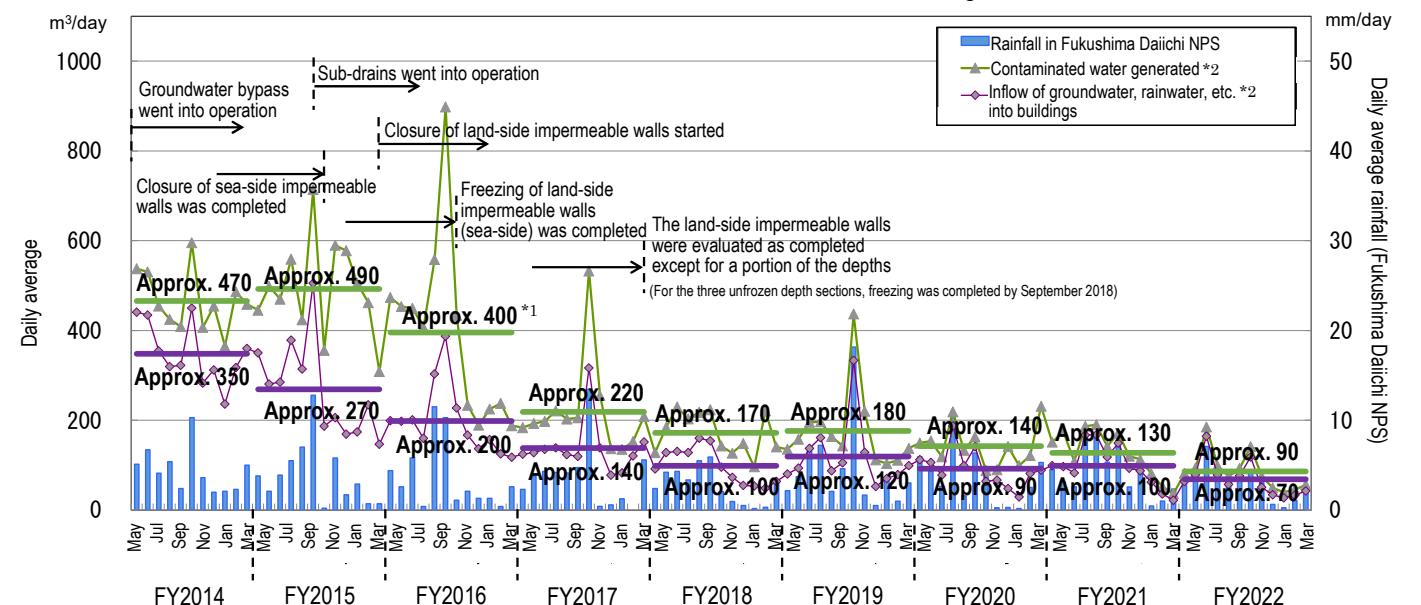
Figure 1: Changes in contaminated water generated and inflow of groundwater and rainwater into buildings

- Multi-layered measures, including pumping up by sub-drains and land-side impermeable walls, which were implemented to control the continued generation of contaminated water, suppressed the groundwater inflow into buildings.
- After implementing "redirecting" measures (groundwater bypass, sub-drains, land-side impermeable walls and others) and rainwater prevention measures, including repairing damaged portions of building roofs and due to less rainfall than in previous normal years without concentrated heavy rain of 100 mm/day or more, the amount of contaminated water generated within FY2022 declined to approx. 90 m³/day.
- Measures will continue to further reduce the amount of contaminated water generated.

*1 Values differ from those announced at the 20th Committee on Countermeasures for Contaminated Water Treatment (held on August 25, 2017) because the method of calculating the contaminated water volume generated was reviewed on March 1, 2018. Details of the review are described in the materials for the 50th and 51st meetings of the Secretariat of the Team for Countermeasures for Decommissioning and Contaminated Water Treatment.

*2: The monthly daily average is derived from the daily average from the previous Thursday to the last Wednesday, which is calculated based on the data measured at 7:00 on every Thursday.

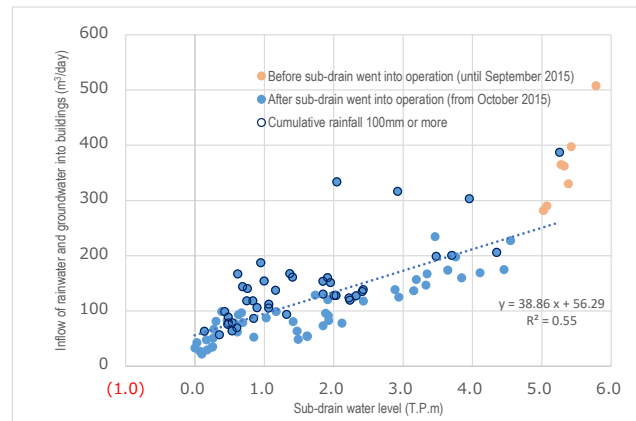
Figure 2: Correlation between inflow such as groundwater and rainwater into buildings and the water level of Units 1-4 sub-drains

- At the Water-Treatment Facility Special for Sub-drain & Groundwater drains, release started from September 14, 2015 and up until April 18, 2023, 2,133 release operations had been conducted.

The water quality of all temporary storage tanks satisfied the operational target.

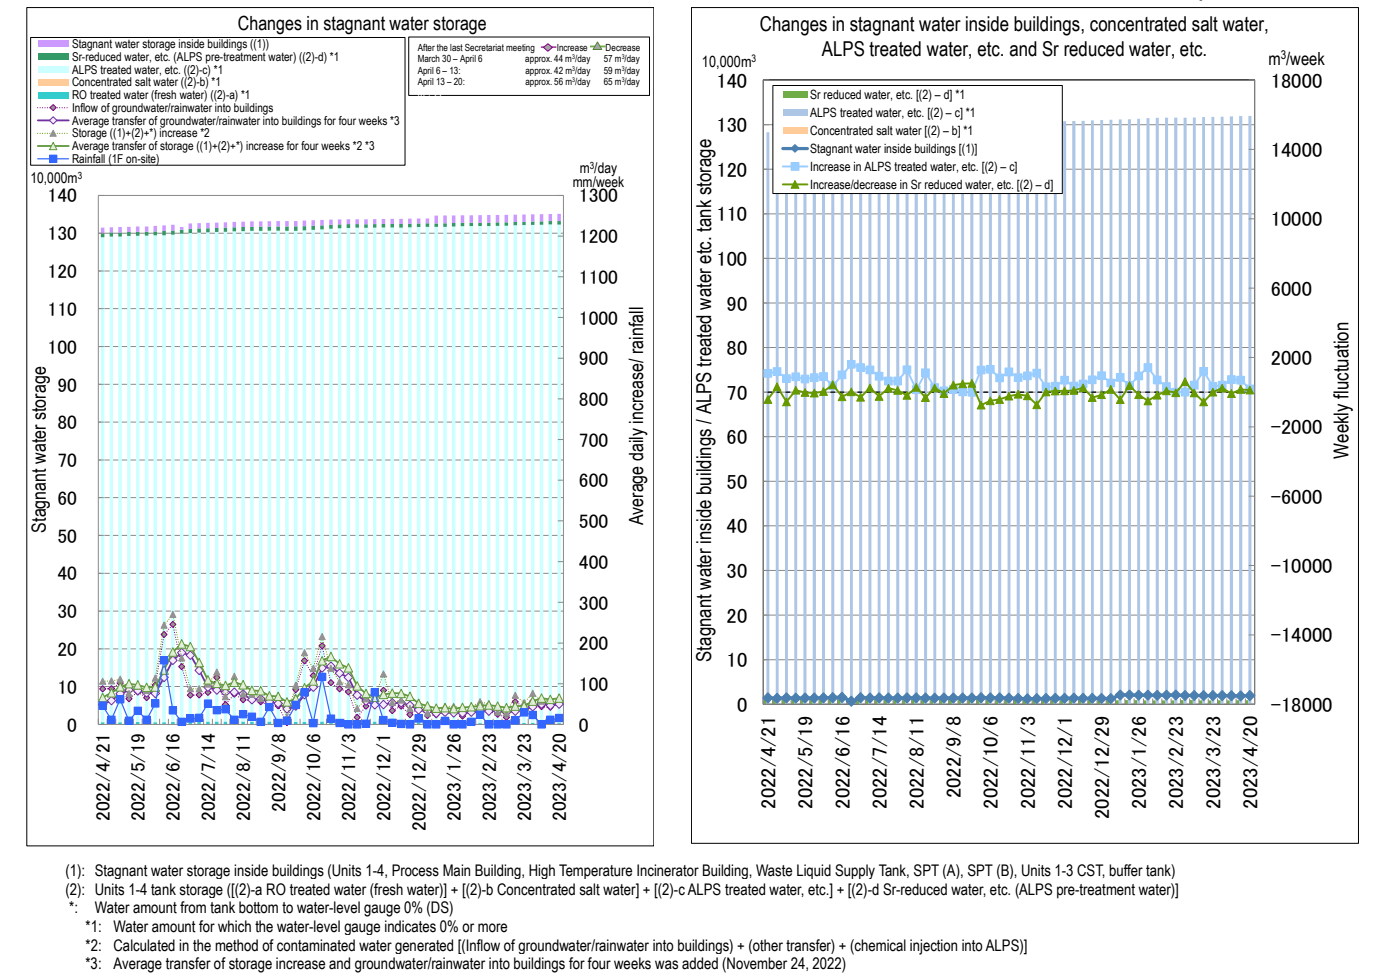
Figure 3: Status of stagnant water storage

- To reduce the risks of strontium-reduced water, treatment using existing, additional and high-performance multi-nuclide removal equipment is underway. Up until April 20, 2023, approx. 879,000 m³ had been treated.

As of April 20, 2023

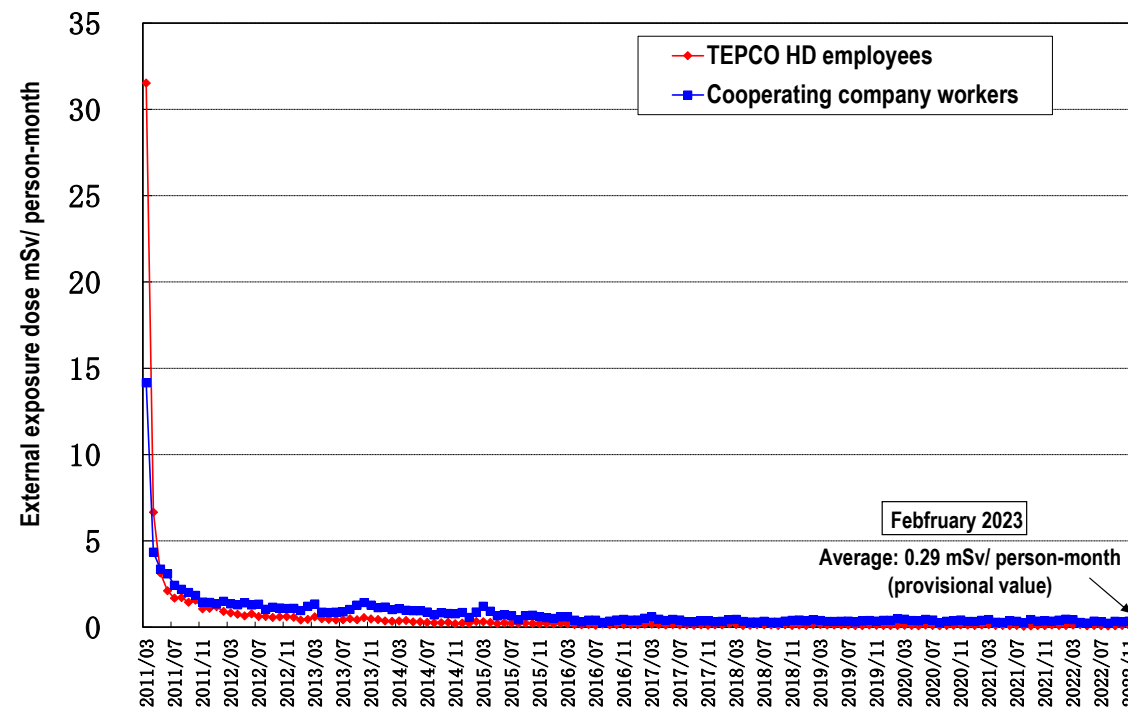
Figure 7: Changes in monthly average exposure dose of individual worker (monthly exposure dose since March 2011)

and 2021, respectively (The legal exposure dose limits are 100 mSv/person and 50 mSv/person-year over five years, the TEPCO HD management target is 20 mSv/person-year).

- For most workers, the exposure dose was sufficiently within the limit and allowed them to continue engaging in radiation work.

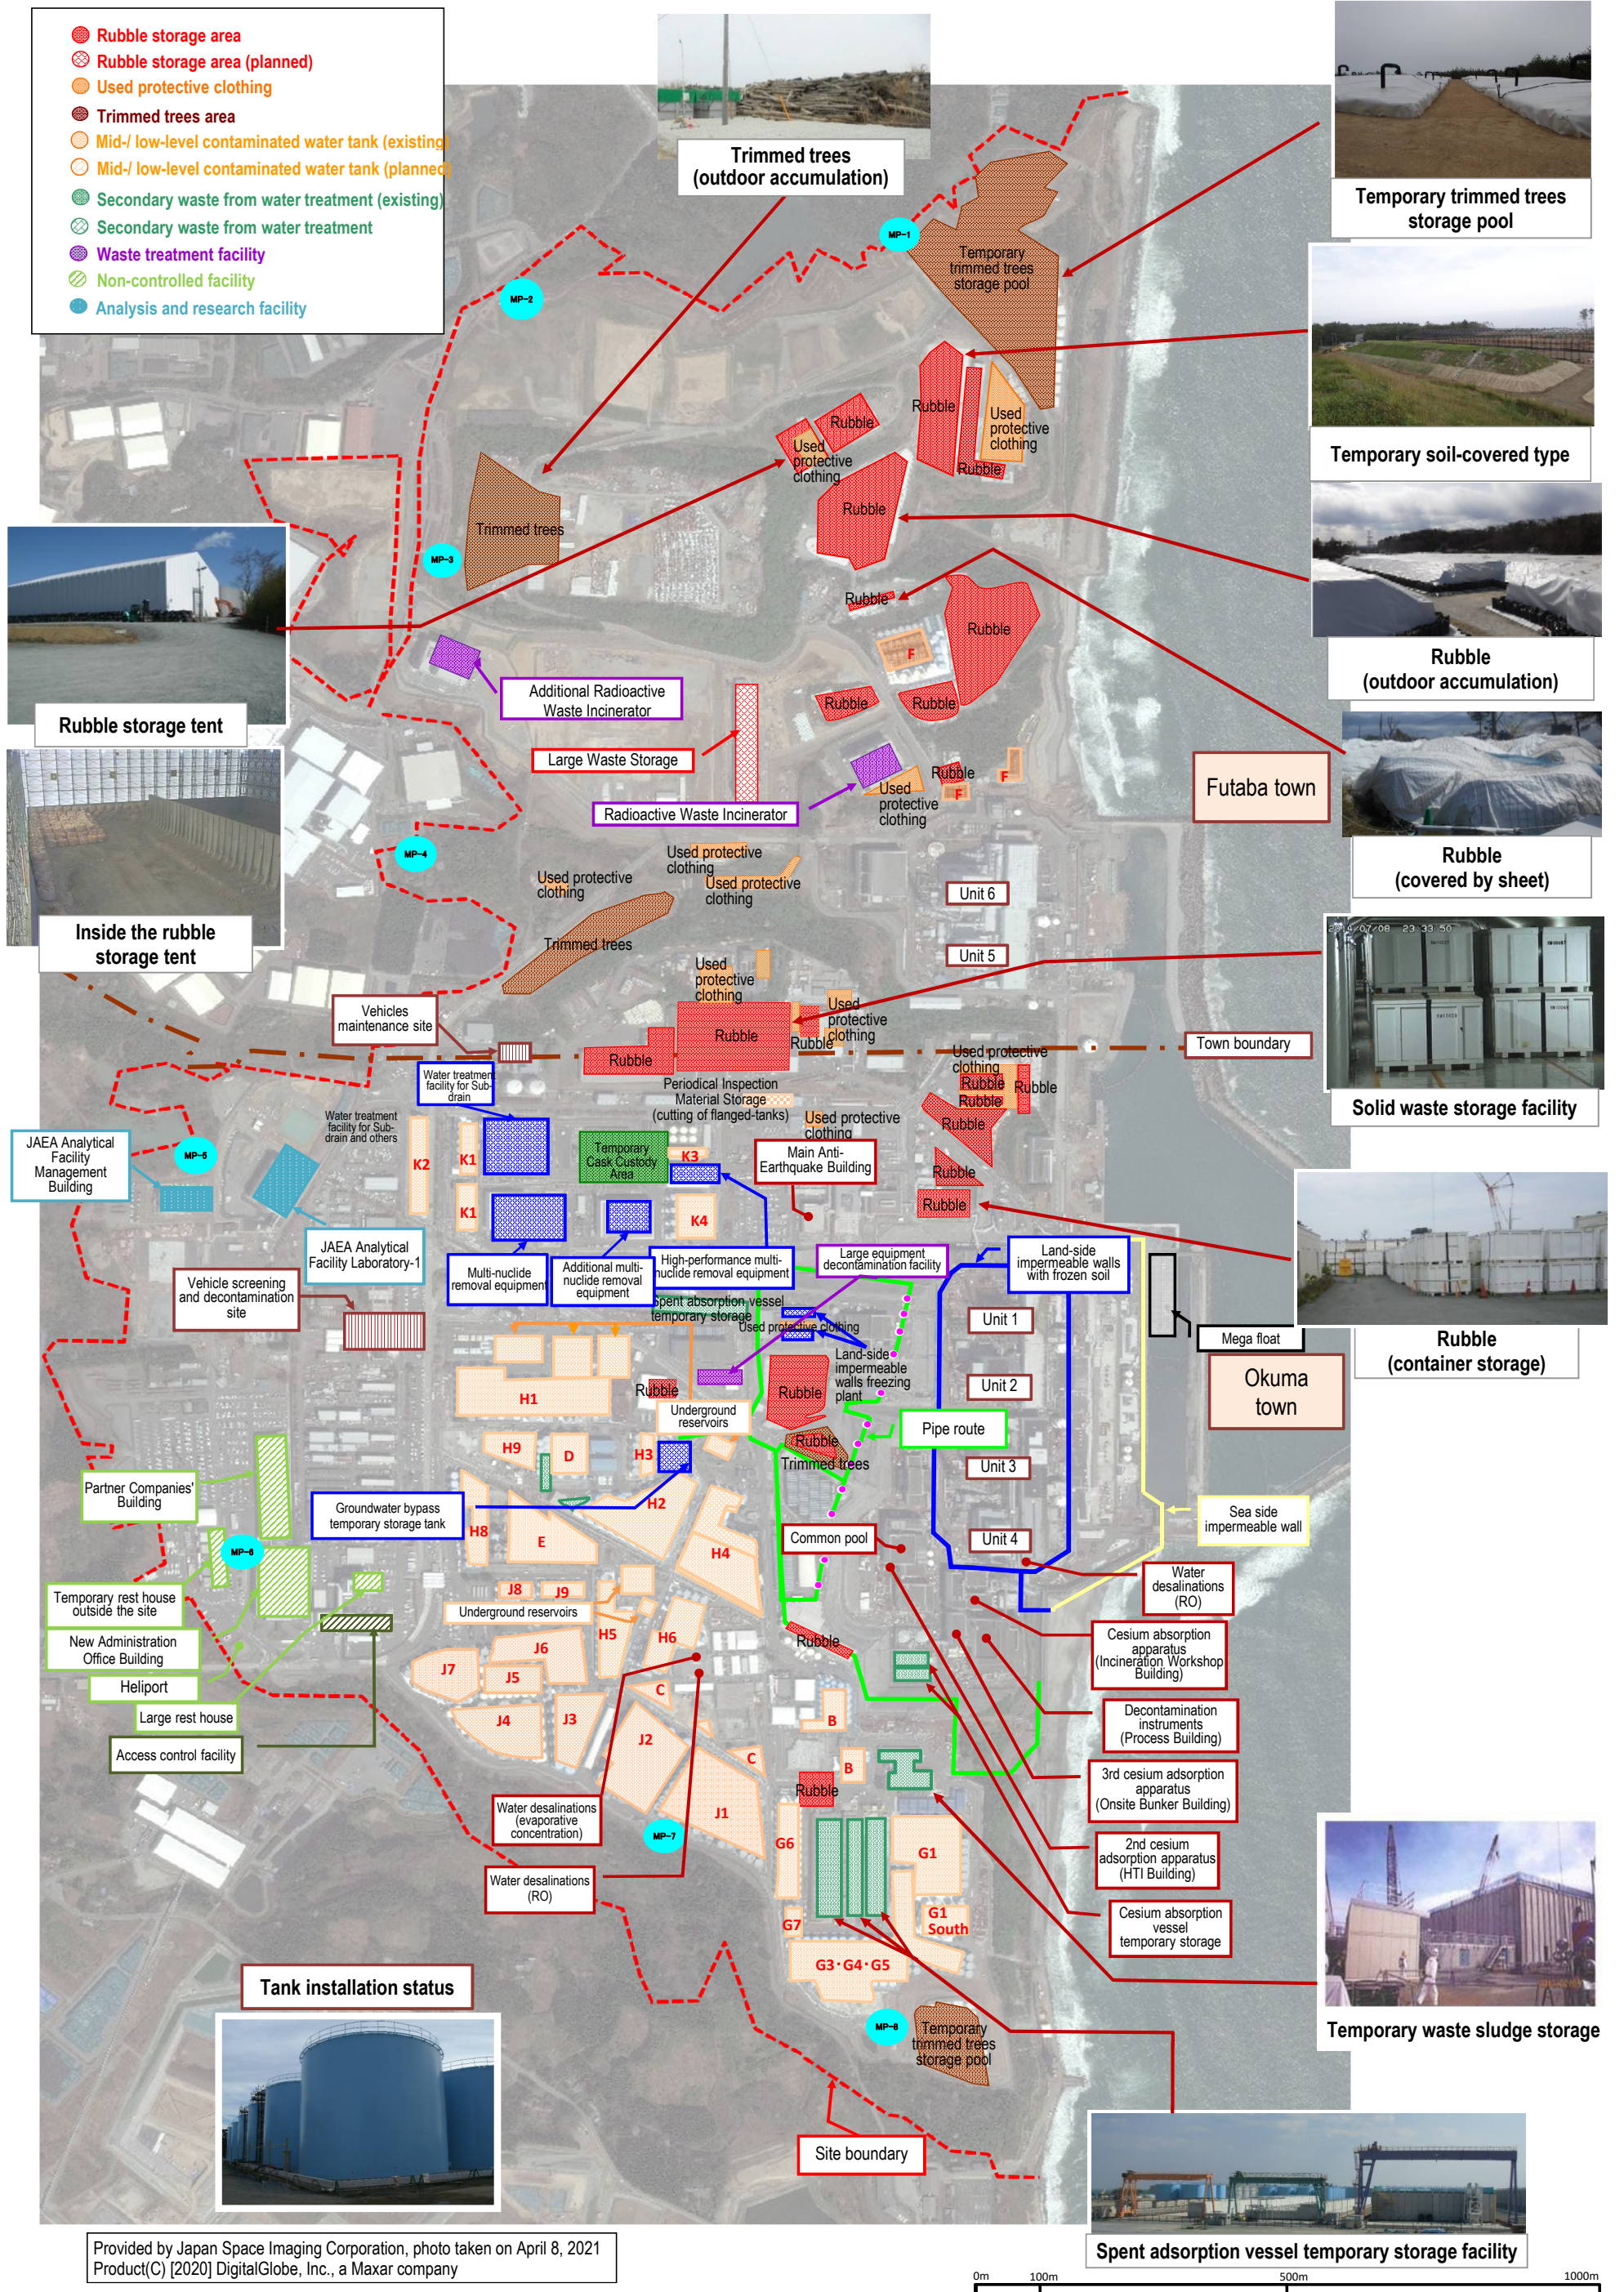
TEPCO Holdings Fukushima Daiichi Nuclear Power Station Site Layout

Provided by Japan Space Imaging Corporation, photo taken on April 8, 2021
 Product(C) [2020] DigitalGlobe, Inc., a Maxar company

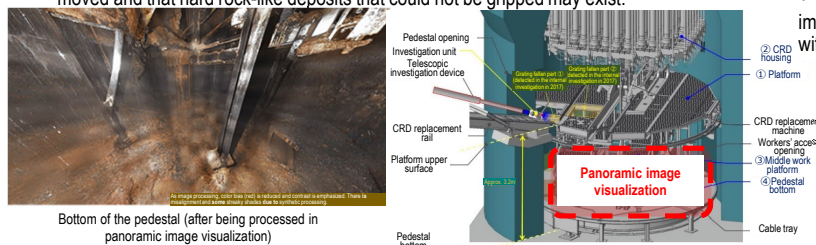
- In January 2017, a camera was inserted from the PCV penetration to inspect the conditions of the rail on which the robot traveled. The results of a series of investigations confirmed some gratings had fallen and deformed as well as a quantity of deposit inside the pedestal.

- In January 2018, the conditions below the platform inside the pedestal were investigated. Based on the analytical results of images obtained in the investigation, deposits, probably including fuel debris, were found at the bottom of the pedestal. Moreover, multiple parts exceeding the surrounding deposits were also detected. We presumed that there were multiple instances of fuel debris falling.

- In February 2019, an investigation touching the deposits at the bottom of the pedestal and on the platform was conducted and confirmed that the pebble-shaped deposits, etc. could be moved and that hard rock-like deposits that could not be gripped may exist.

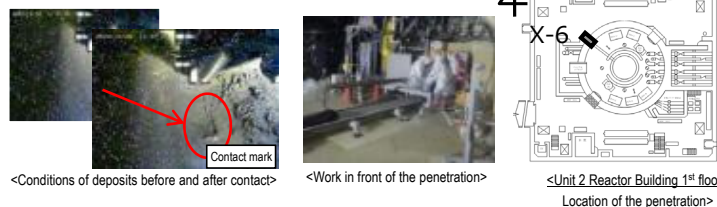
- In October 2020, as part of work to prepare for the PCV internal investigation and trial retrieval, a contact investigation to study deposits inside the penetration (X-6 penetration) was conducted, which involved inserting a guide pipe incorporating an investigative unit into the penetration. This confirmed that deposits inside the penetration had not deformed and come unstuck. The investigative information obtained will be utilized in the mockup test of the equipment to remove deposits inside the X-6 penetration.

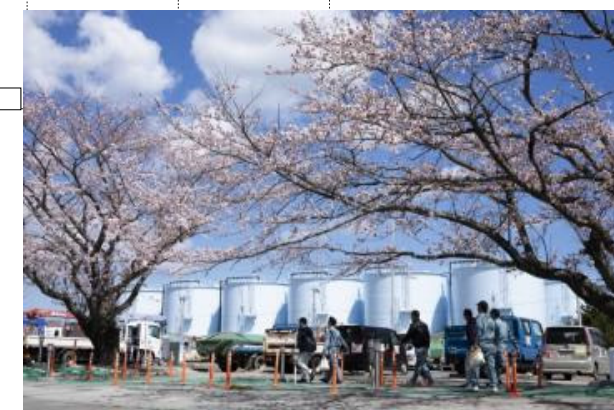
Facing (2017.4.13)

Regarding the site-wide reduction in the radiation dose and prevention of contamination spreading, the radiation dose on site was reduced by removal of rubble, topsoil and facing. Moreover, the operation was improved to use environmentally-improved areas as a Green Zone, within which workers are allowed to wear general work clothes and disposable dust-protective masks which are less of a physical burden.
