Main decommissioning work and steps

Fuel removal from the spent fuel pool was completed in December 2014 at Unit 4 and on February 28, 2021 at Unit 3.
 Work continues sequentially toward the start of fuel removal from Units 1 and 2 and debris (Note 1) retrieval from Units 1-3.
 (Note 1) Fuel assemblies having melted through in the accident.

Progress status

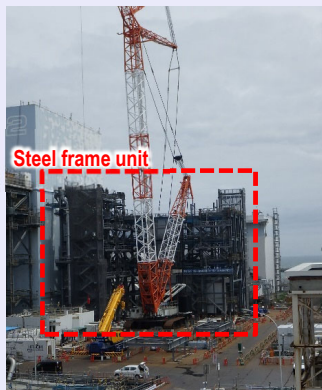
< Assembly of steel frame units (as of May 16) >

Outside the building, the steel frame assembled outside the site was transferred to the inside and assembly of the gantry steel frame for fuel removal is underway on the south side of the Reactor Building. As of May 25, installation of 19 of 45 steel frame units was completed.

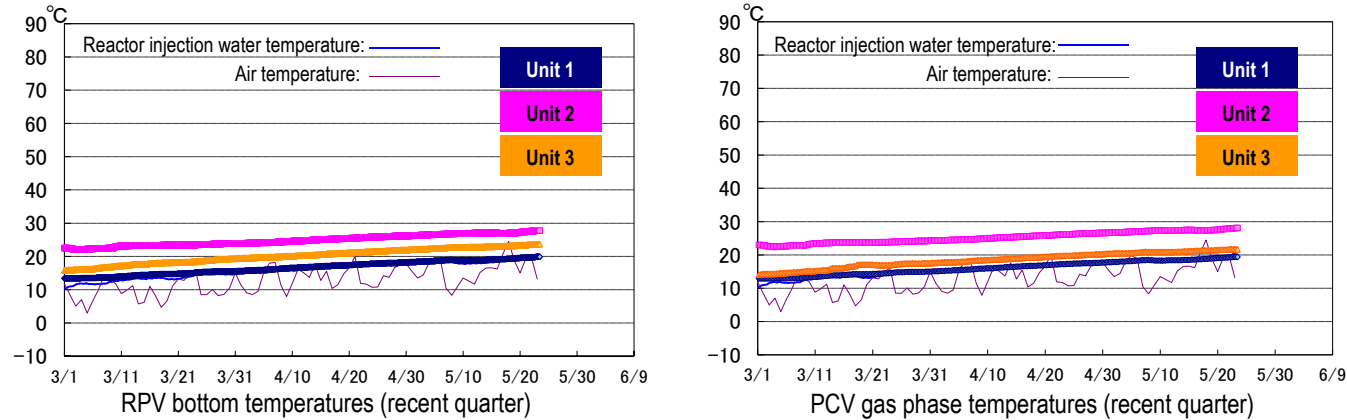
Temperatures inside the reactors

Through continuous reactor cooling by water injection, the temperatures of the Reactor Pressure Vessel (RPV) bottom and the Primary Containment Vessel (PCV) gas phase were maintained within the range of approx. 15 to 30°C for the past month, though it varied depending on the unit and location of the thermometer.

- *1 The trend graphs show part of the temperature data measured at multiple points.
- *2 A part of data could not be measured due to maintenance and inspection of the facility and other work.

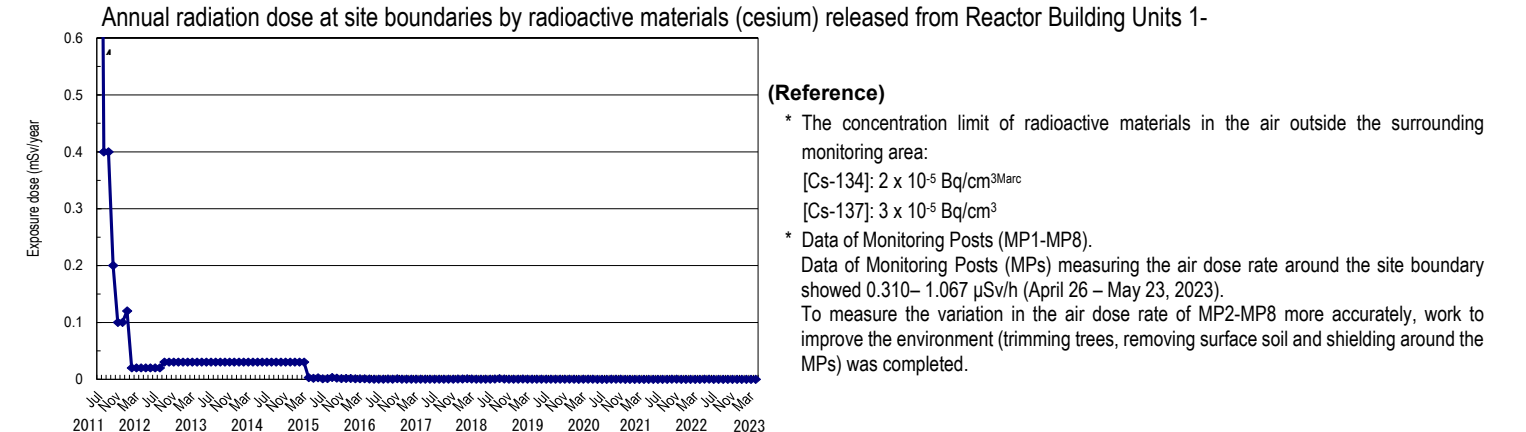
Release of radioactive materials from the Reactor Buildings

As of April 2023, the concentration of radioactive materials newly released from Reactor Building Units 1-4 into the air and measured at the site boundary was evaluated at approx. 2.1×10^{-12} Bq/cm³ and 1.9×10^{-12} Bq/cm³ for Cs-134 and -137 respectively, while the radiation exposure dose due to the release of radioactive materials there was less than 0.00004 mSv/year.

- Note 1: Different formulas and coefficients were used to evaluate the radiation dose in the facility operation plan and monthly report. The evaluation methods were integrated in September 2012. As the fuel removal from the spent fuel pool (SFP) commenced for Unit 4, the radiation exposure dose from Unit 4 was added to the items subject to evaluation since November 2013. The evaluation has been changed to a method considering the values of continuous dust monitors since FY2015, with data to be evaluated monthly and announced the following month.

- Note 2: Radiation dose was calculated using the evaluation values of release amount from Units 1-4 and Units 5 and 6. The radiation dose of Unit 5 and 6 was evaluated based on expected release amount during operation until September 2019 but the evaluation method was reviewed and changed to calculate based on the actual measurement results of Units 5 and 6 from October.

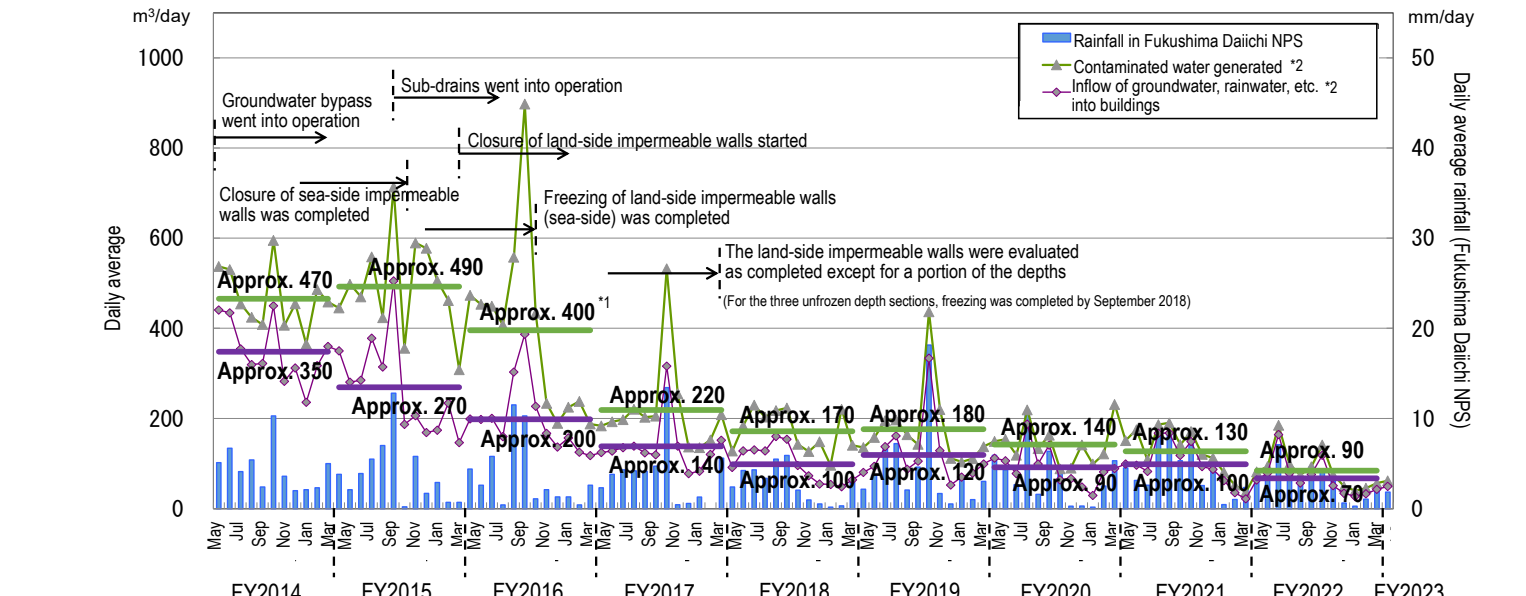
Figure 1: Changes in contaminated water generated and inflow of groundwater and rainwater into buildings

- Status of contaminated water generated
 - Multi-layered measures, including pumping up by sub-drains and land-side impermeable walls, which were implemented to control the continued generation of contaminated water, suppressed the groundwater inflow into buildings.
 - After implementing “redirecting” measures (groundwater bypass, sub-drains, land-side impermeable walls and others) and rainwater prevention measures, including repairing damaged portions of building roofs, the amount of contaminated water generated within FY2021 declined to approx. 130 m³/day.
 - Measures will continue to further reduce the amount of contaminated water generated.

*1 Values differ from those announced at the 20th Committee on Countermeasures for Contaminated Water Treatment (held on August 25, 2017) because the method of calculating the contaminated water volume generated was reviewed on March 1, 2018. Details of the review are described in the materials for the 50th and 51st meetings of the Secretariat of the Team for Countermeasures for Decommissioning and Contaminated Water Treatment.
 *2: The monthly daily average is derived from the daily average from the previous Thursday to the last Wednesday, which is calculated based on the data measured at 7:00 on every Thursday.

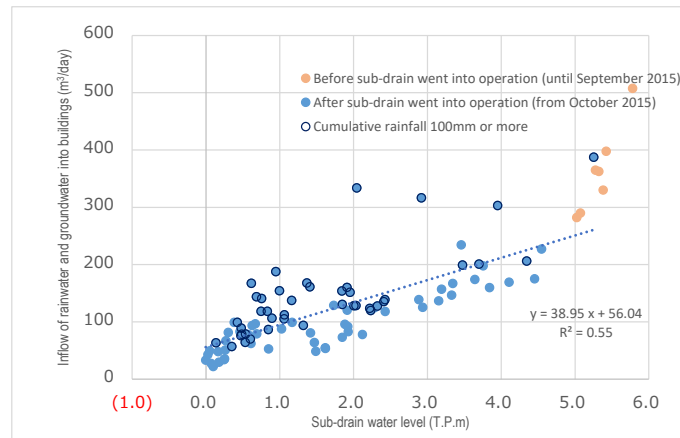
Figure 2: Correlation between inflow such as groundwater and rainwater into buildings and the water level of Units 1-4 sub-drains

➤ Operation of the Water-Treatment Facility special for Sub-drain & Groundwater drains

- At the Water-Treatment Facility Special for Sub-drain & Groundwater drains, release started from September 14, 2015 and up until May 16, 2023, 2,154 release operations had been conducted.

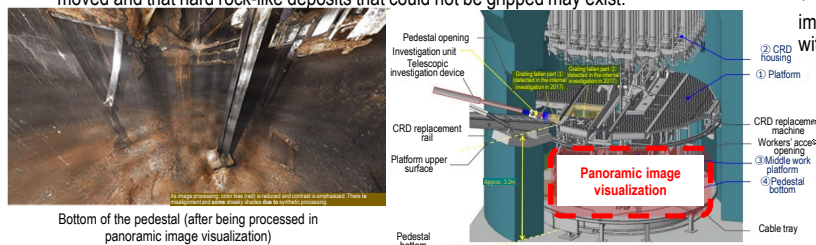
- In January 2017, a camera was inserted from the PCV penetration to inspect the conditions of the rail on which the robot traveled. The results of a series of investigations confirmed some gratings had fallen and deformed as well as a quantity of deposit inside the pedestal.

- In January 2018, the conditions below the platform inside the pedestal were investigated. Based on the analytical results of images obtained in the investigation, deposits, probably including fuel debris, were found at the bottom of the pedestal. Moreover, multiple parts exceeding the surrounding deposits were also detected. We presumed that there were multiple instances of fuel debris falling.

- In February 2019, an investigation touching the deposits at the bottom of the pedestal and on the platform was conducted and confirmed that the pebble-shaped deposits, etc. could be moved and that hard rock-like deposits that could not be gripped may exist.
