Main decommissioning work and steps

Fuel removal from the spent fuel pool was completed in December 2014 at Unit 4 and on February 28, 2021 at Unit 3. Work continues sequentially toward the start of fuel removal from Units 1 and 2 and debris (Note 1) retrieval from Units 1-3.

Unit 1 Progress status of work to decrease the water level in PCV

Unit 2 Progress status of work toward fuel removal

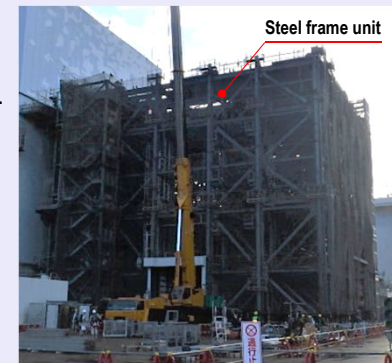
< Work on the south side of Unit 2 Reactor Building > (August 10, 2023)

Outside the building, on the south side of the Reactor Building, assembly of the gantry part (27 units) was completed on July 13 among steel frames of the gantry for fuel removal. To install the floor on the operating floor level, concrete placement started from August 23. Regarding the remaining steel frames (18 units) of the front room, ground assembly is underway in the yard outside the site.

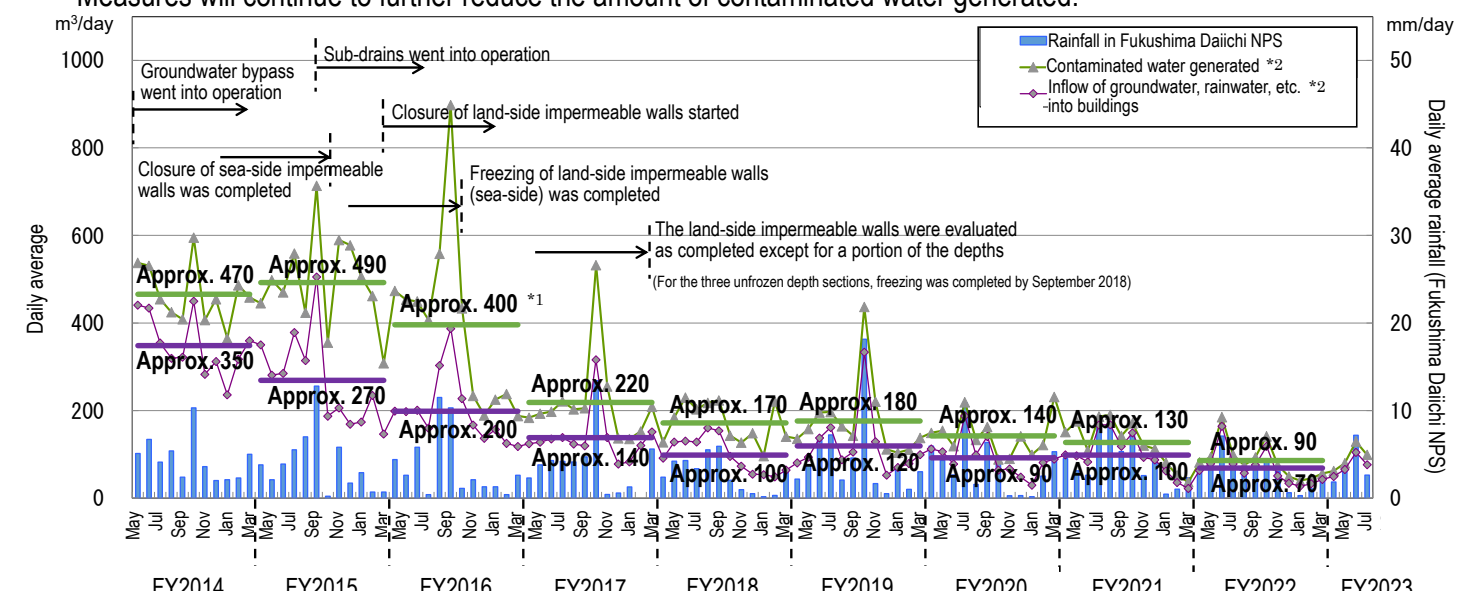
- Multi-layered measures, including pumping up by sub-drains and land-side impermeable walls, which were implemented to control the continued generation of contaminated water, suppressed the groundwater inflow into buildings.
- After implementing “redirecting” measures (groundwater bypass, sub-drains, land-side impermeable walls and others) and rainwater prevention measures, including repairing damaged portions of building roofs and due to less rainfall than in previous normal years without concentrated heavy rain of 100 mm/day or more, the amount of contaminated water generated within FY2022 declined to approx. 90 m³/day.
- Measures will continue to further reduce the amount of contaminated water generated.

*1 Values differ from those announced at the 20th Committee on Countermeasures for Contaminated Water Treatment (held on August 25, 2017) because the method of calculating the contaminated water volume generated was reviewed on March 1, 2018. Details of the review are described in the materials for the 50th and 51st meetings of the Secretariat of the Team for Countermeasures for Decommissioning and Contaminated Water Treatment.

*2: The monthly daily average is derived from the daily average from the previous Thursday to the last Wednesday, which is calculated based on the data measured at 7:00 on every Thursday.

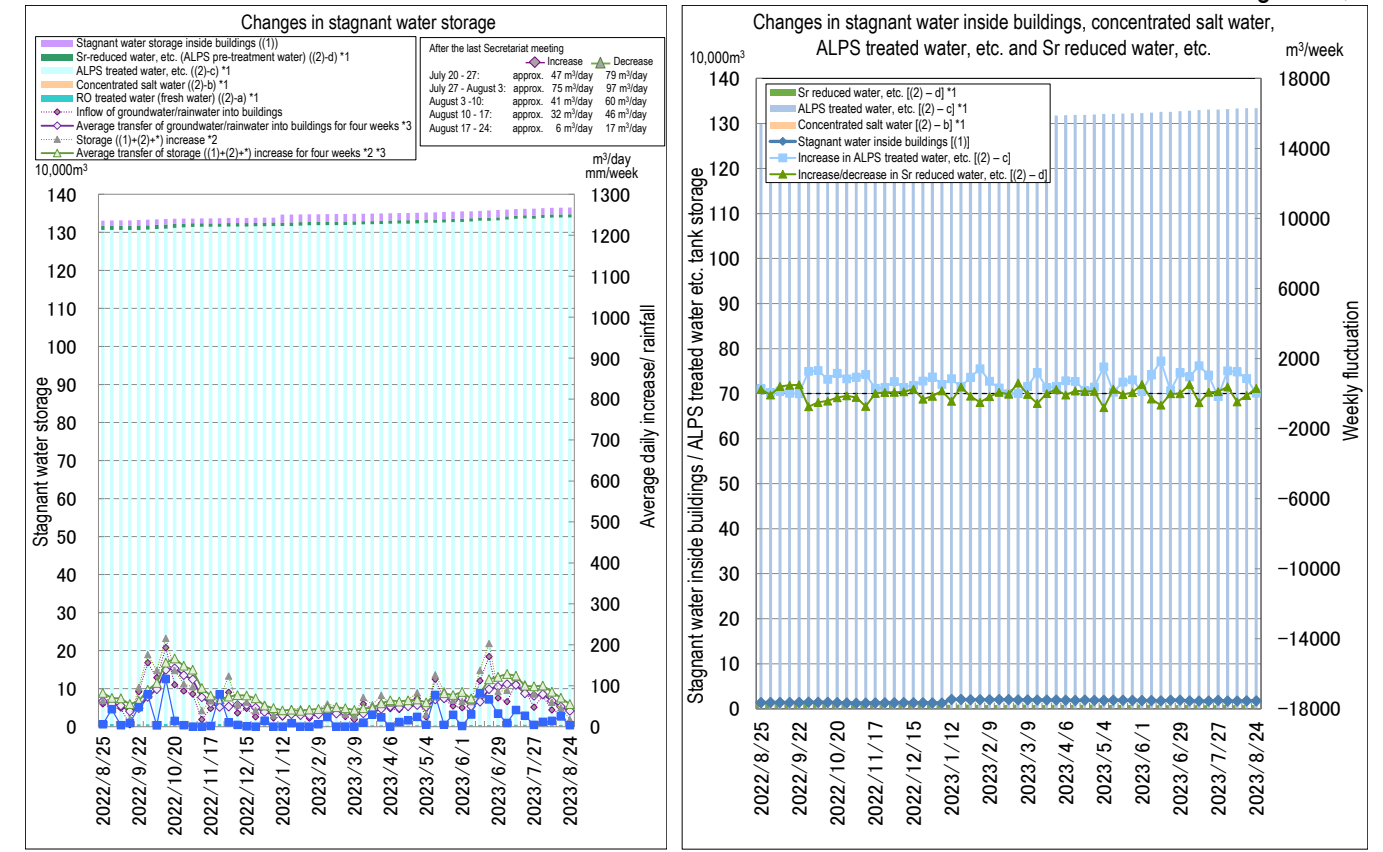
Figure 3: Status of stagnant water storage

(1): Stagnant water storage inside buildings (Units 1-4, Process Main Building, High Temperature Incinerator Building, Waste Liquid Supply Tank, SPT (A), SPT (B), Units 1-3 CST, buffer tank)
 (2): Units 1-4 tank storage [(2)-a RO treated water (fresh water)] + [(2)-b Concentrated salt water] + [(2)-c ALPS treated water, etc.] + [(2)-d Sr-reduced water, etc. (ALPS pre-treatment water)]
 *: Water amount from tank bottom to water-level gauge 0% (DS)
 *: Water amount for which the water-level gauge indicates 0% or more
 *: Calculated in the method of contaminated water generated [(Inflow of groundwater/rainwater into buildings) + (other transfer) + (chemical injection into ALPS)]
 *: Average transfer of storage increase and groundwater/rainwater into buildings for four weeks was added (November 24, 2022)

- To reduce the risks of strontium-reduced water, treatment using existing, additional and high-performance multi-nuclide removal equipment is underway. Up until August 24, 2023, approx. 895,000 m³ had been treated.

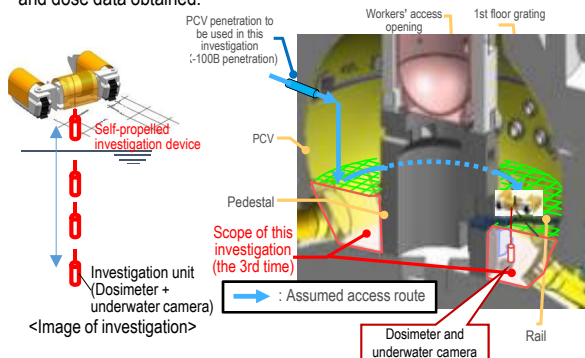
Unit 1 Investigation overview

- In April 2015, a device having entered the inside of the PCV via a narrow opening (bore:φ100 mm) collected information such as images and airborne dose inside the PCV 1st floor.
- In March 2017, an investigation using a self-propelled investigation device was conducted to inspect the spreading of debris to the basement floor outside the pedestal, with images taken of the PCV bottom status for the first time. The conditions inside the PCV will continue to be examined, based on the imagery and dose data obtained.

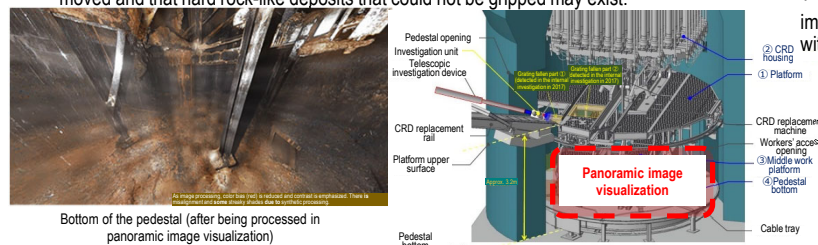
- In January 2017, a camera was inserted from the PCV penetration to inspect the conditions of the rail on which the robot traveled. The results of a series of investigations confirmed some gratings had fallen and deformed as well as a quantity of deposit inside the pedestal.

- In January 2018, the conditions below the platform inside the pedestal were investigated. Based on the analytical results of images obtained in the investigation, deposits, probably including fuel debris, were found at the bottom of the pedestal. Moreover, multiple parts exceeding the surrounding deposits were also detected. We presumed that there were multiple instances of fuel debris falling.

- In February 2019, an investigation touching the deposits at the bottom of the pedestal and on the platform was conducted and confirmed that the pebble-shaped deposits, etc. could be moved and that hard rock-like deposits that could not be gripped may exist.

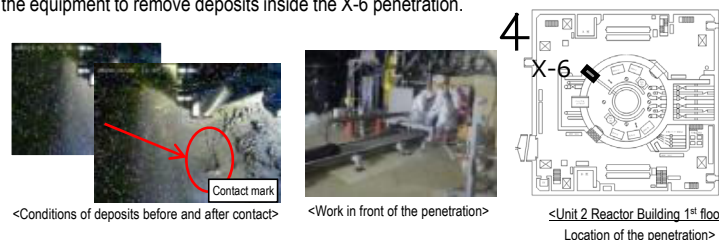
- In October 2020, as part of work to prepare for the PCV internal investigation and trial retrieval, a contact investigation to study deposits inside the penetration (X-6 penetration) was conducted, which involved inserting a guide pipe incorporating an investigative unit into the penetration. This confirmed that deposits inside the penetration had not deformed and come unstuck. The investigative information obtained will be utilized in the mockup test of the equipment to remove deposits inside the X-6 penetration.

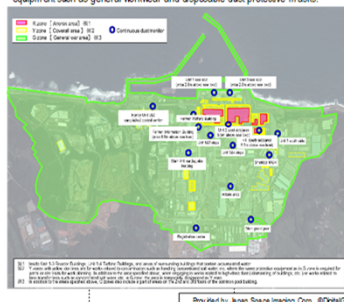
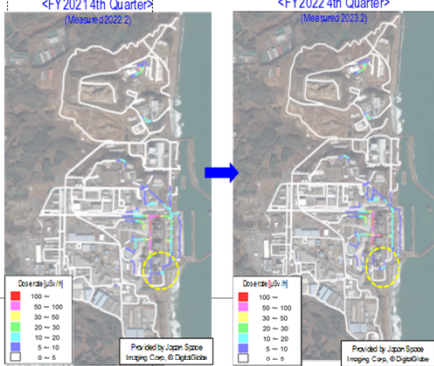
<p><Travel survey results of major roads within the site> It was confirmed that compared with the last fiscal year, the dose rate has been declining on roads near the southeast side of the Unit 4 Turbine Building and the west side of the Process Main Building (area circled by yellow dot line).</p>

<p><FY 2021 4th Quarter> (Measured 2022.2) <FY 2022 4th Quarter> (Measured 2023.2)</p>
