Main decommissioning work and steps

Fuel removal from the spent fuel pool was completed in December 2014 at Unit 4 and on February 28, 2021 at Unit 3. Work continues sequentially toward the start of fuel removal from Units 1 and 2 and debris (Note 1) retrieval from Units 1-3.

Progress status

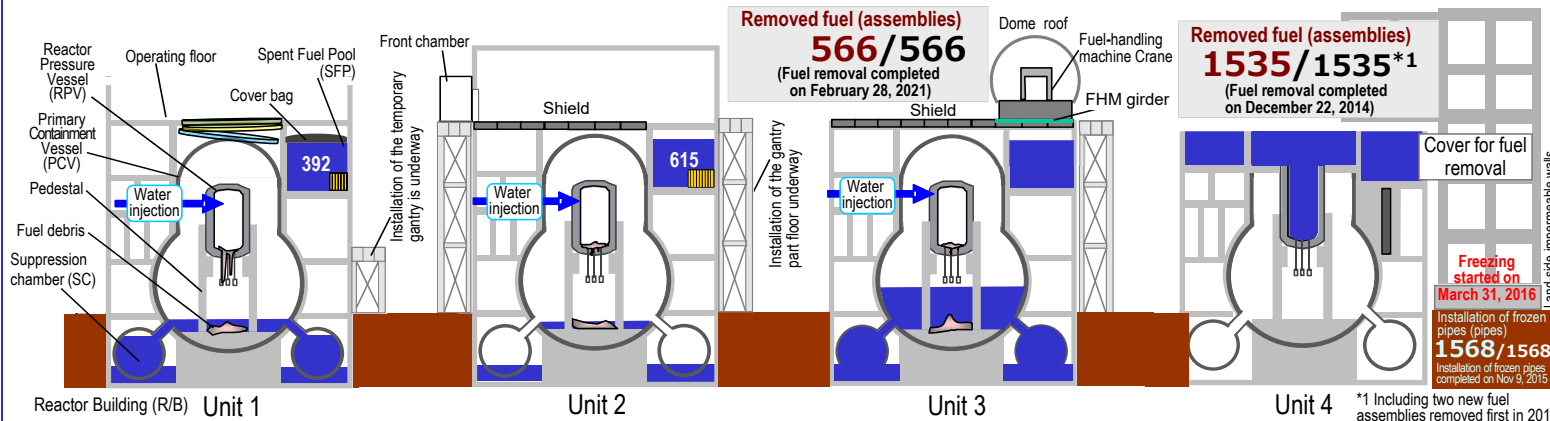
Unit 1 Status of measures to strengthen the PCV confinement function

During past internal investigations of the Unit 1 Primary Containment Vessel (PCV), damage to the pedestal was confirmed. TEPCO considers it unlikely to lead to significant damage and believes that even if the Reactor Pressure Vessel (RPV) were to lean or sink, there would be no significant risk of radiation exposure from radioactive dust generated in the PCV due to the leaning or sinking of the RPV.

On the other hand, in response to the assumption that dust in the PCV may increase due to abnormal occurrences attributable to earthquakes, measures to strengthen the confinement function are being examined.

For this examination, tests to change the rates of nitrogen injection into the PCV and exhaust and terminate nitrogen injection will be conducted. Moreover, an operation to terminate the nitrogen injection at the time of earthquakes with a seismic intensity of lower 6 or higher (AL earthquake) will commence.

- To check the impact on the RPV and PCV structures of losing the pedestal support function, the structural soundness of the Unit 1 PCV inner skirt was evaluated and the earthquake horizontal load support when the pedestal was damaged was examined.

- The Unit 1 PCV internal investigation revealed damage to the pedestal base concrete. However, the inner skirt embedded in the pedestal remained sufficiently strong by itself, even at an assumed earthquake of around Ss900. The remaining pedestal and inner skirt were thus deemed capable of supporting the upper pedestal structure.

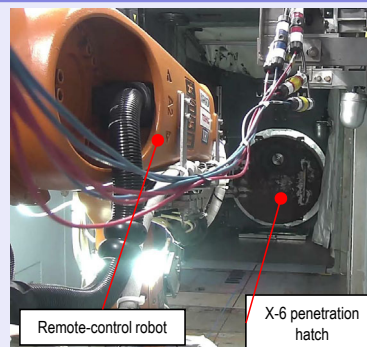
< Work to remove bolts >

On site, to open the PCV X-6 penetration hatch of PCV, work to remove 24 hatch bolts is underway. As of September 27, 21 bolts had been removed.

After work to open the hatch, deposits inside the X-6 penetration will be removed. However, the exact status of the debris is not determined at present. Accordingly, based on the fixation status of hatch bolts and other factors, methods capable of retrieving the debris must be considered in readiness for cases where deposits cannot be fully removed. At the same time, methods to complement the internal investigation and trial retrieval by the robot arm are also being examined.

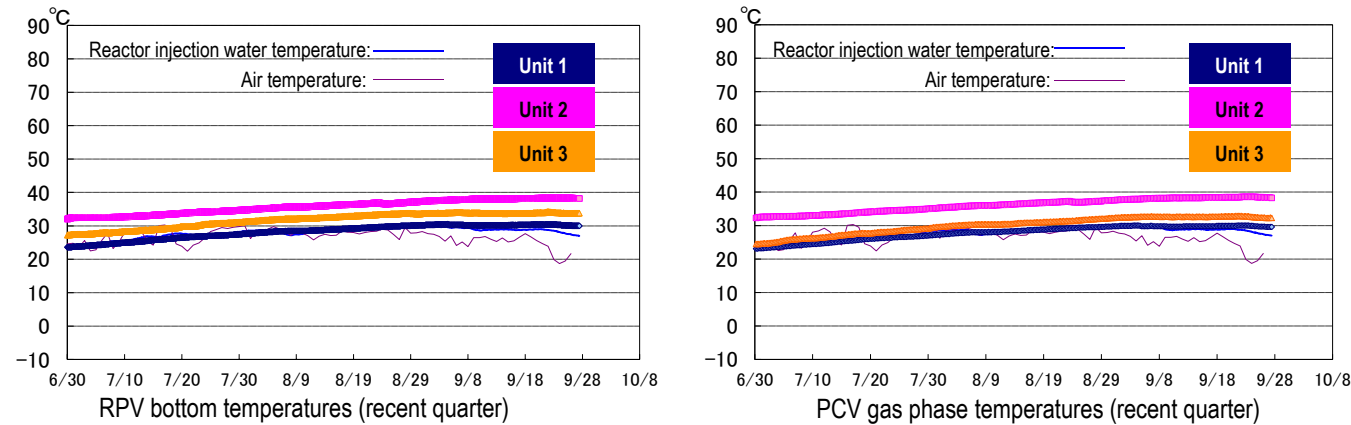
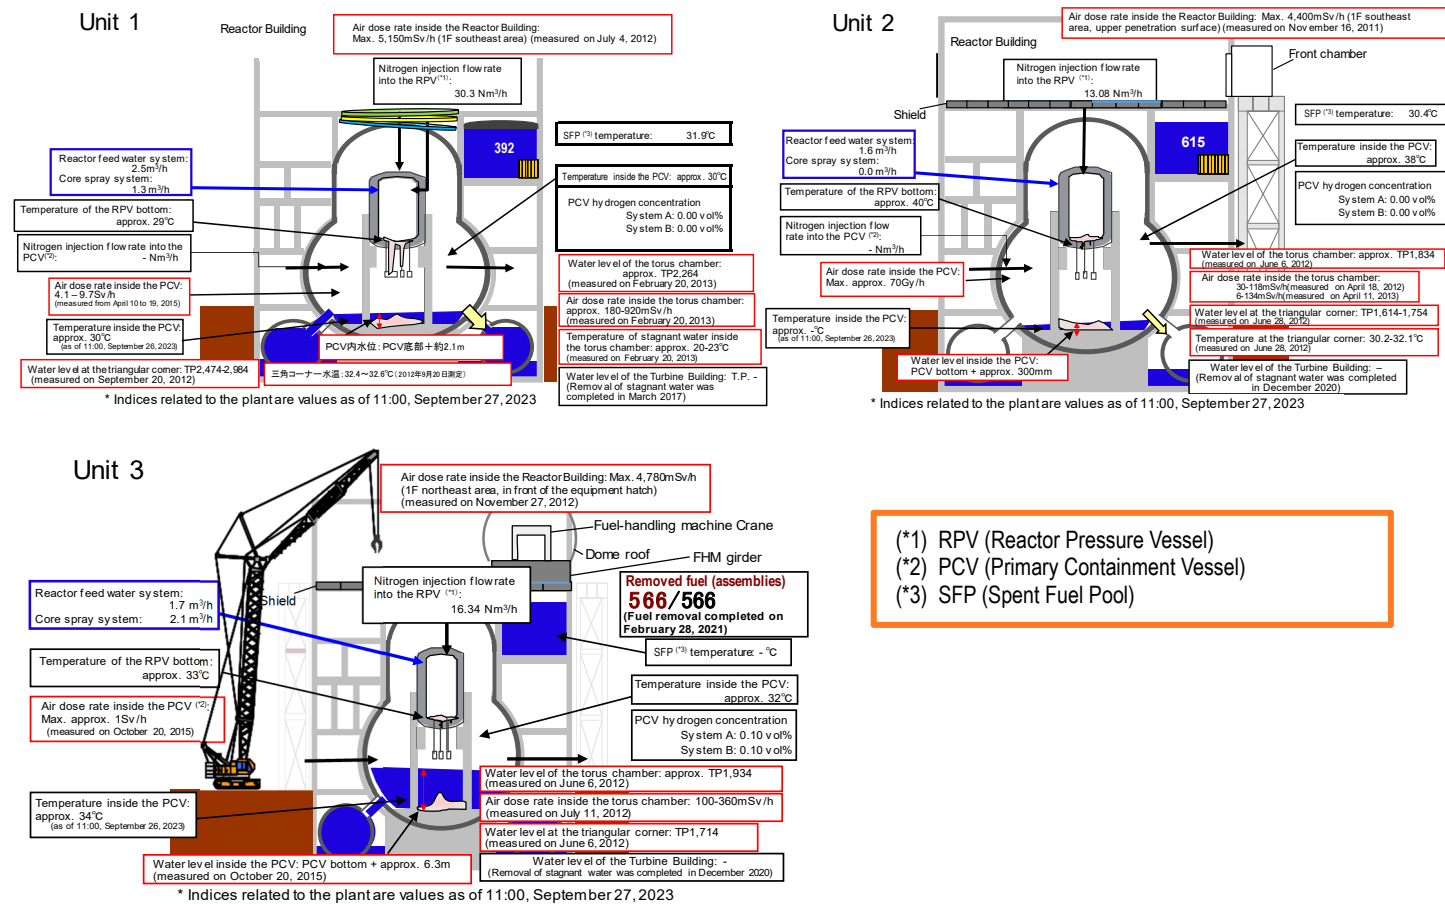
Temperatures inside the reactors

Through continuous reactor cooling by water injection, the temperatures of the Reactor Pressure Vessel (RPV) bottom and the Primary Containment Vessel (PCV) gas phase were maintained as shown below for the past month, though it varied depending on the unit and location of the thermometer.

*1 The trend graphs show part of the temperature data measured at multiple points.
*2 A part of data could not be measured due to maintenance and inspection of the facility and other work.

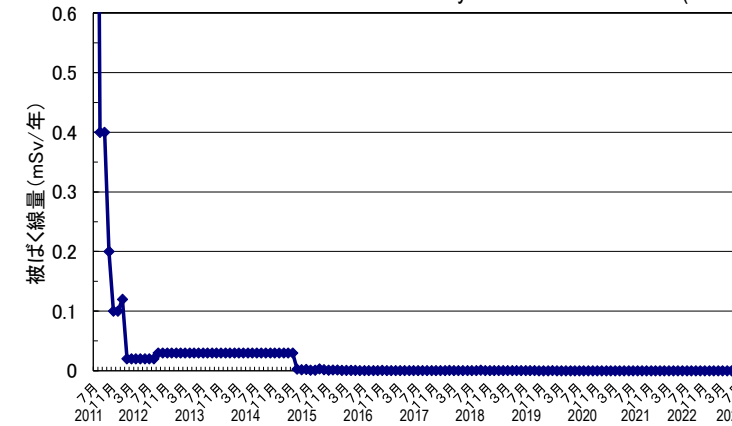
Annual radiation dose at site boundaries by radioactive materials (cesium) released from Reactor Building Units 1-4

As of August 2023, the concentration of radioactive materials newly released from Reactor Building Units 1-4 into the air and measured at the site boundary was evaluated at approx. 4.1×10^{-12} Bq/cm³ and 2.8×10^{-12} Bq/cm³ for Cs-134 and -137 respectively, while the radiation exposure dose due to the release of radioactive materials there was less than 0.00008 mSv/year.

- * The concentration limit of radioactive materials in the air outside the surrounding monitoring area:
[Cs-134]: 2×10^{-5} Bq/cm³ Marc
[Cs-137]: 3×10^{-5} Bq/cm³
- * Data of Monitoring Posts (MP1-MP8).
Data of Monitoring Posts (MPs) measuring the air dose rate around the site boundary showed 0.238–1.062 μSv/h (August 30–September 26, 2023).
To measure the variation in the air dose rate of MP2-MP8 more accurately, work to improve the environment (trimming trees, removing surface soil and shielding around the MPs) was completed.

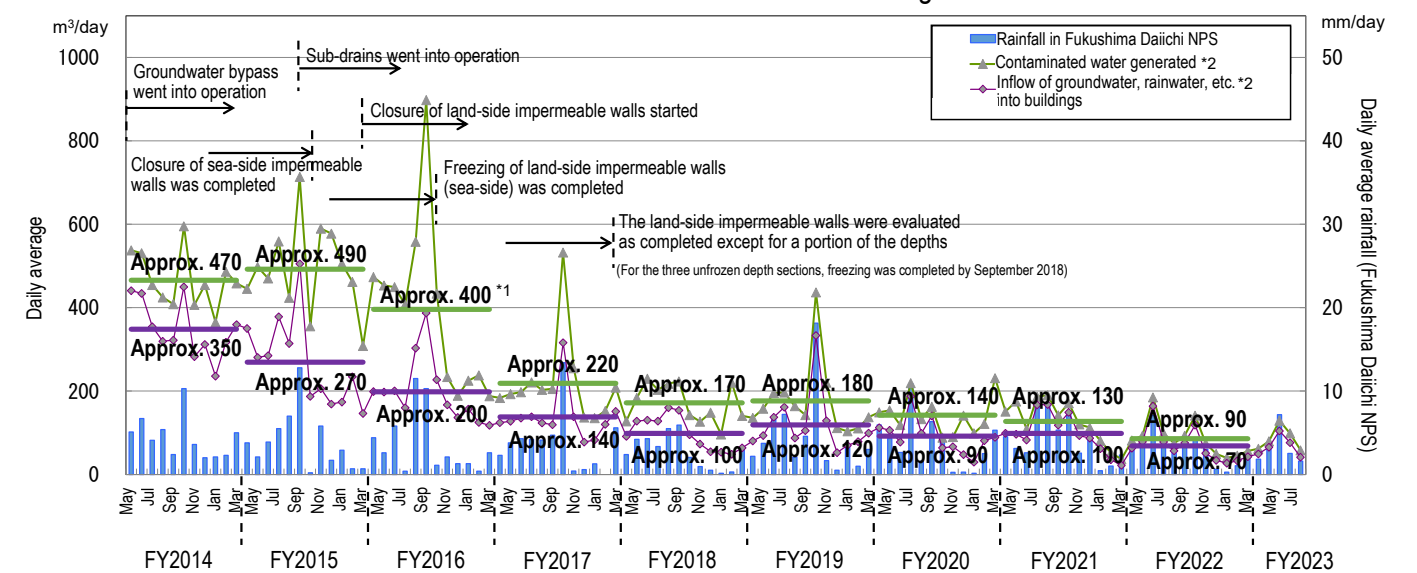
- Multi-layered measures, including pumping up by sub-drains and land-side impermeable walls, which were implemented to control the continued generation of contaminated water, suppressed the groundwater inflow into buildings.
- After implementing “redirecting” measures (groundwater bypass, sub-drains, land-side impermeable walls and others) and rainwater prevention measures, including repairing damaged portions of building roofs and due to less rainfall than in previous normal years without concentrated heavy rain of 100 mm/day or more, the amount of contaminated water generated within FY2022 declined to approx. 90 m³/day.
- Measures will continue to further reduce the amount of contaminated water generated.

*1 Values differ from those announced at the 20th Committee on Countermeasures for Contaminated Water Treatment (held on August 25, 2017) because the method of calculating the contaminated water volume generated was reviewed on March 1, 2018. Details of the review are described in the materials for the 50th and 51st meetings of the Secretariat of the Team for Countermeasures for Decommissioning and Contaminated Water Treatment.

*2: The monthly daily average is derived from the daily average from the previous Thursday to the last Wednesday, which is calculated based on the data measured at 7:00 on every Thursday.

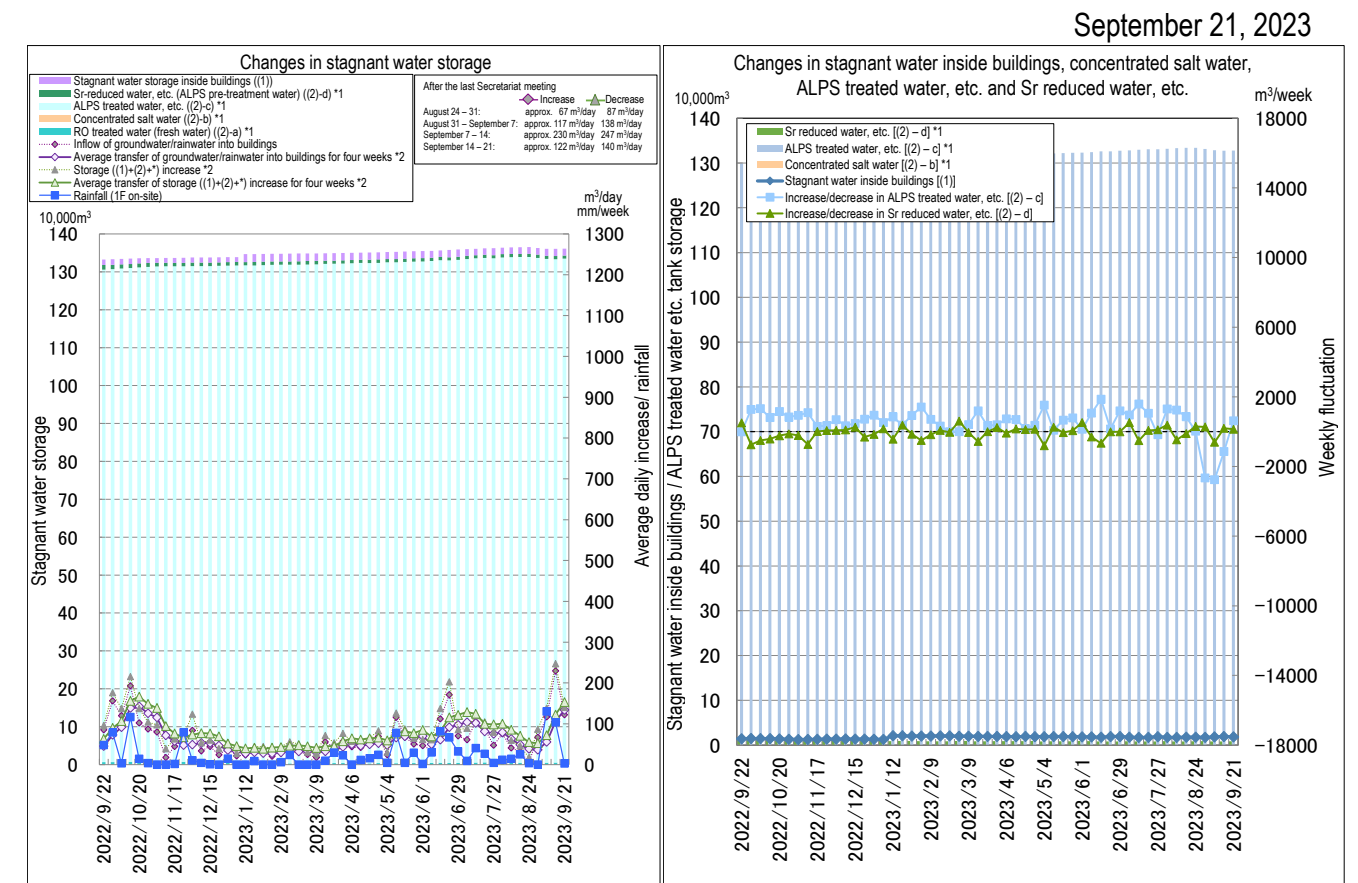
- Amount of ALPS treated water, etc. was approx. 1,330,574 m³ as of September 21, 2023.
- Amount of ALPS treated water, discharged into the sea was approx. 7,788 m³ as of September 21, 2023.

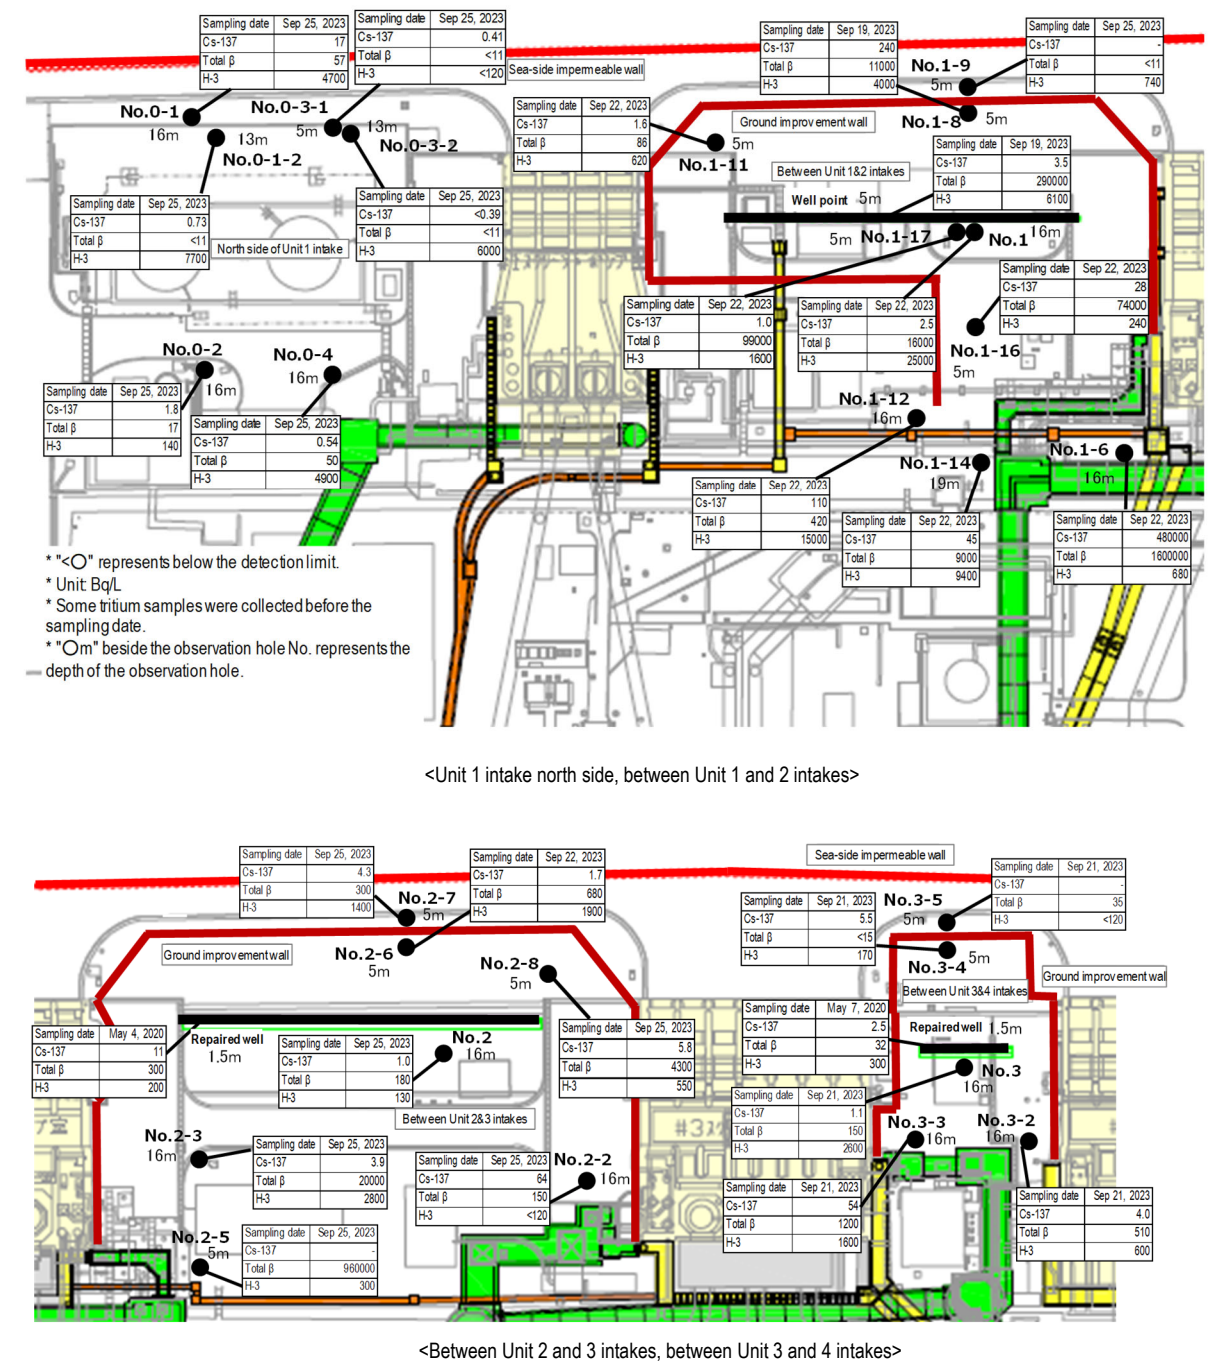
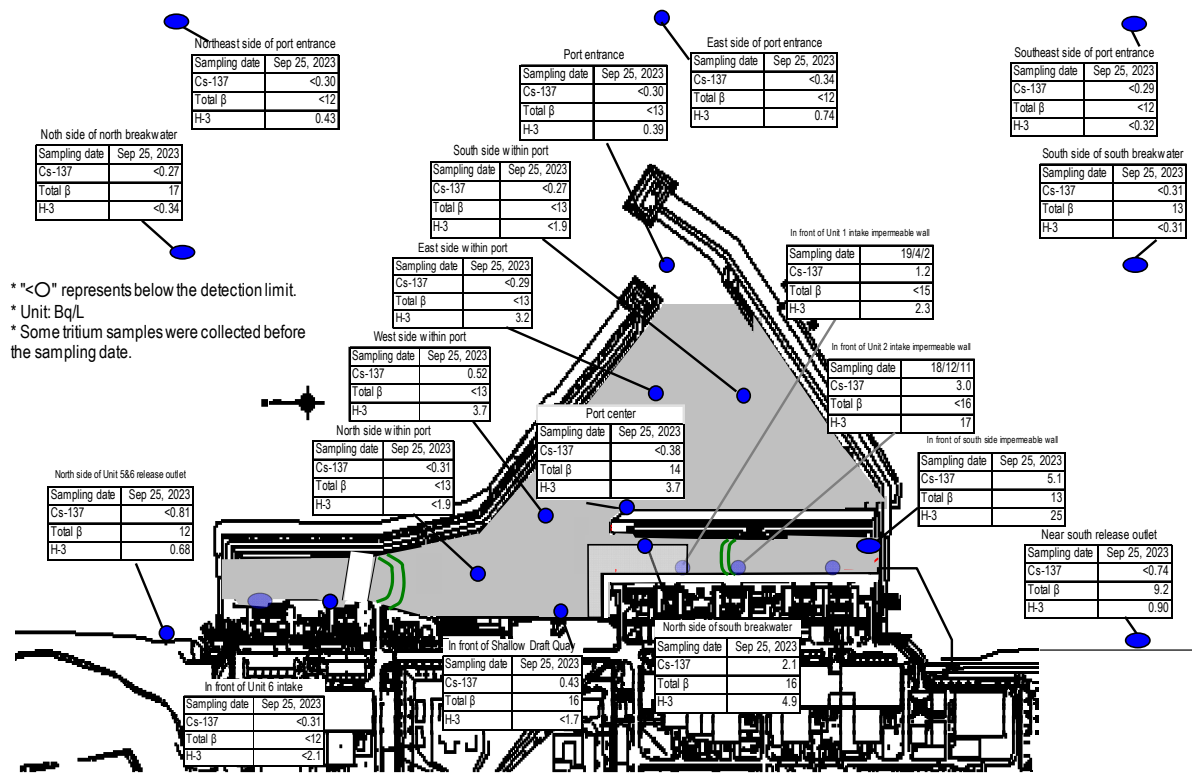
Figure 5: Seawater concentration around the port

- In the open channel area of seawater intake for Units 1 to 4, the concentration of radioactive materials in seawater has remained below the legal discharge limit and been declining long term, despite the temporary increases in Cs-137 and Sr-90 observed during rainfall. They have also been declining following the completed installation and the connection of steel pipe sheet piles for the sea-side impermeable walls. The concentration of Cs-137 remained slightly higher in front of the south-side impermeable walls and slightly lower on the north side of the east breakwater since March 20, 2019, when the silt fence was transferred to the center of the open channel due to mega float-related

- In the port area, the concentration of radioactive materials in seawater has remained below the legal discharge limit and has been declining long term, despite temporary increases in Cs-137 and Sr-90 observed during rainfall. They have remained below the level of those in the Units 1-4 intake open channel area and been declining following the completed installation and connection of steel pipe sheet piles for the sea-side impermeable walls.

- In the area outside the port, regarding the concentration of radioactive materials in seawater, those of Cs-137 and Sr-90 declined and remained low after steel pipe sheet piles for the sea-side impermeable walls were installed and connected. Regarding the concentration of Cs-137, a temporary increase was sometimes observed on the north side of the Unit 5 and 6 outlets and near the south outlet due to the influence of weather, marine meteorology and other factors. Regarding the concentration of Sr-90, variation was observed in FY2021 in the area outside the port (north and south outlets). Monitoring of the tendency continues, including the potential influence of the weather, marine meteorology and others.

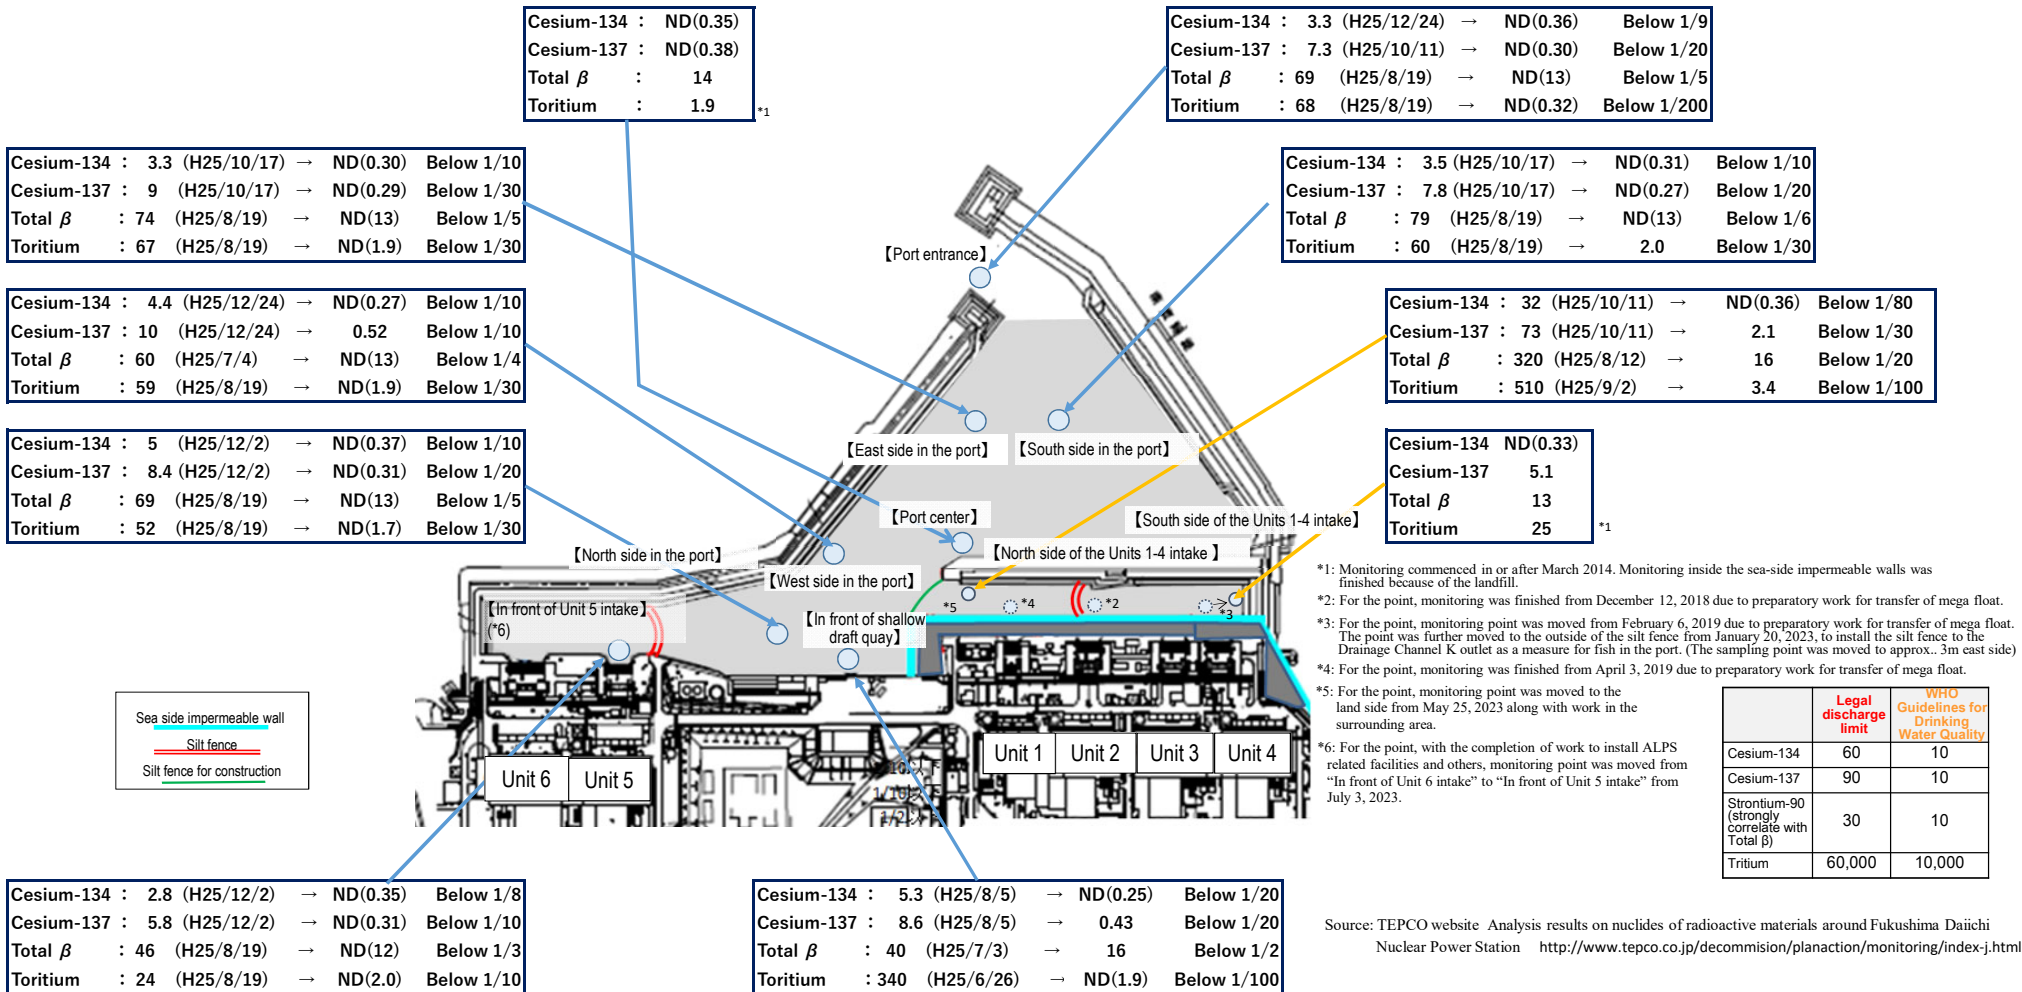
Note: The Total β measurement values include natural potassium 40 (approx. 12 Bq/L). They also include the contribution of yttrium 90, which radioactively balance strontium 90.

Summary of TEPCO data as of September 26, 2023

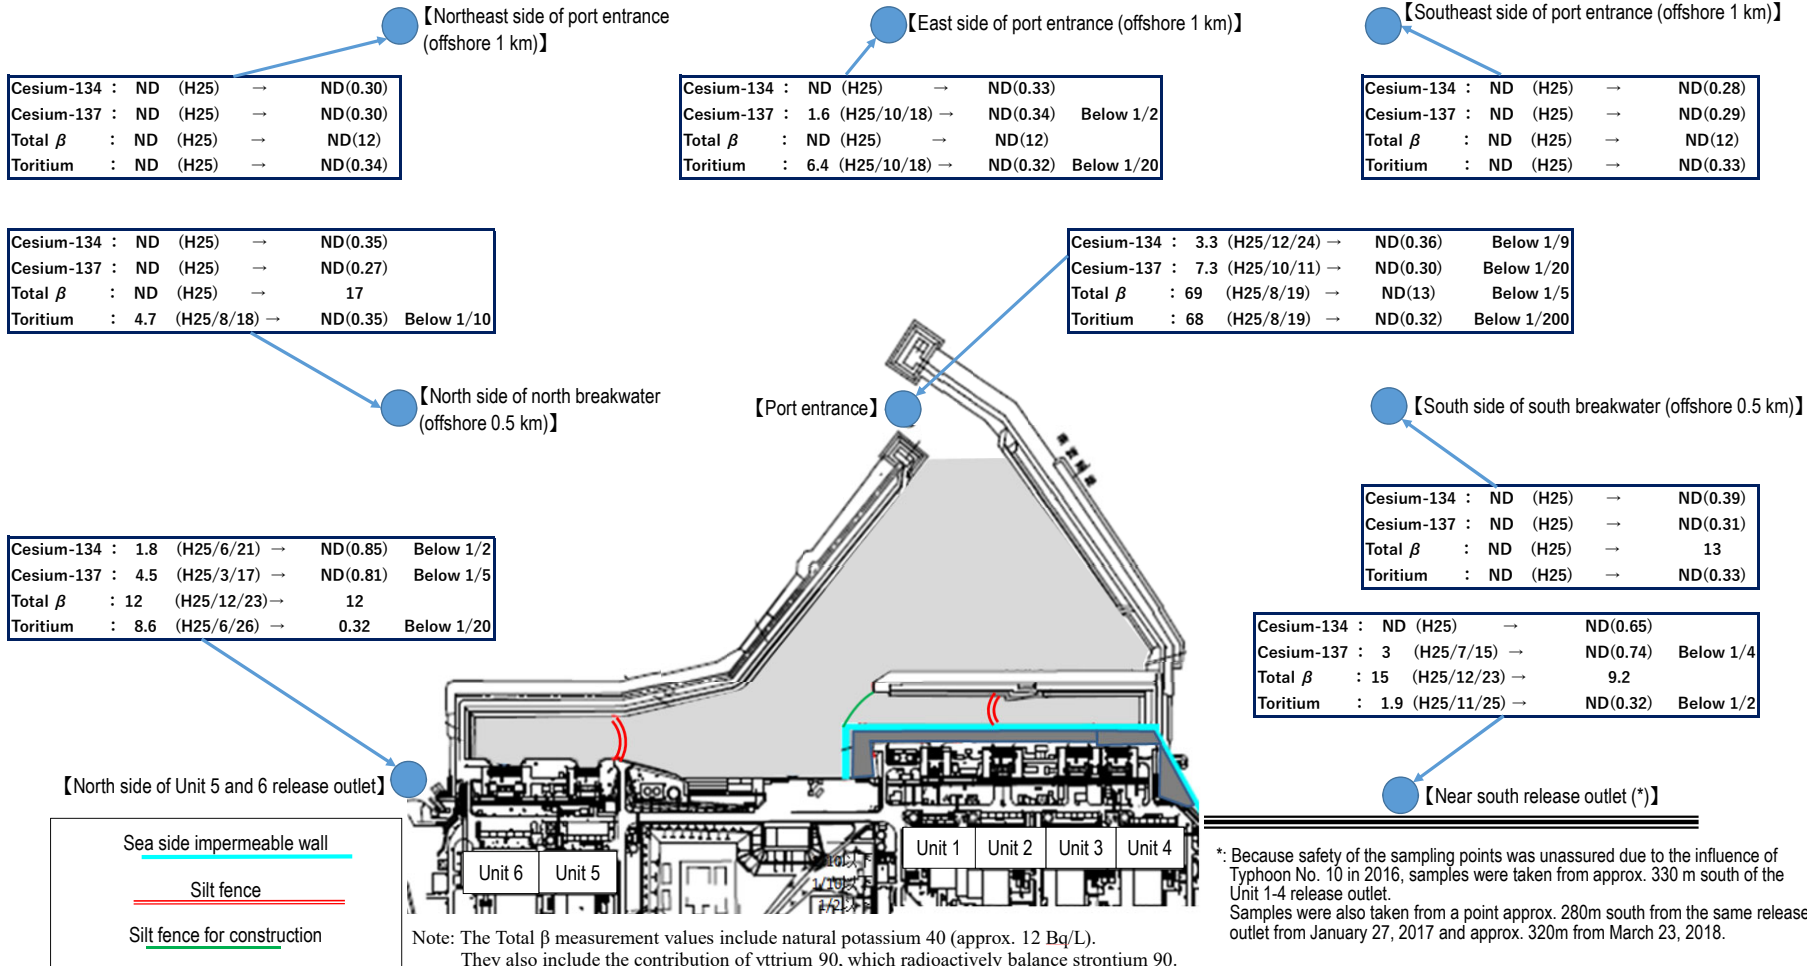
Status of seawater monitoring around outside of the port (comparison between the highest values in 2013 and the latest values)

Unit (Bq/L); ND represents a value below the detection limit; values in () represent the detection limit; ND (2013) represents ND throughout 2013 (The latest values sampled during August 21 - September 25)

Legal discharge limit	WHO Guidelines for Drinking Water Quality
Cesium-134	60	10
Cesium-137	90	10
Strontium-90 (strongly correlate with Total β)	30	10
Tritium	60,000	10,000

*: Because safety of the sampling points was unassured due to the influence of Typhoon No. 10 in 2016, samples were taken from approx. 330 m south of the Unit 1-4 release outlet. Samples were also taken from a point approx. 280m south from the same release outlet from January 27, 2017 and approx. 320m from March 23, 2018.

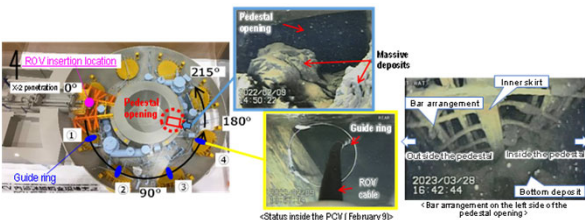
In February 2022, the guide ring* was installed to facilitate the investigation. From March 28, 2023, the investigation inside the pedestal by ROV-A2 started and confirmed that a portion of the bar arrangement was exposed. Regarding the soundness of the pedestal, based on the past earthquake resistant evaluation by the International Research Institute for Nuclear Decommissioning (IRID), it was evaluated that even though a portion of the pedestal was lost, there would be no serious risk. However, as the present information is very limited, the investigation will continue to acquire as much information as possible for continued evaluation.

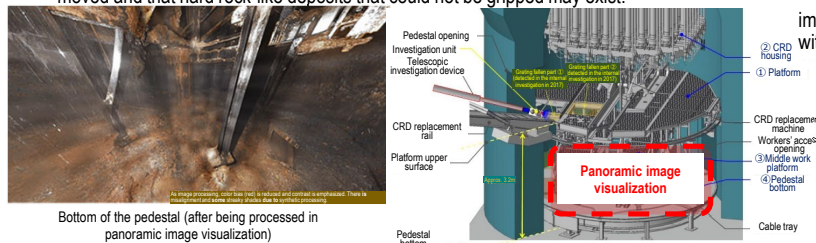
- In January 2017, a camera was inserted from the PCV penetration to inspect the conditions of the rail on which the robot traveled. The results of a series of investigations confirmed some gratings had fallen and deformed as well as a quantity of deposit inside the pedestal.

- In January 2018, the conditions below the platform inside the pedestal were investigated. Based on the analytical results of images obtained in the investigation, deposits, probably including fuel debris, were found at the bottom of the pedestal. Moreover, multiple parts exceeding the surrounding deposits were also detected. We presumed that there were multiple instances of fuel debris falling.

- In February 2019, an investigation touching the deposits at the bottom of the pedestal and on the platform was conducted and confirmed that the pebble-shaped deposits, etc. could be moved and that hard rock-like deposits that could not be gripped may exist.

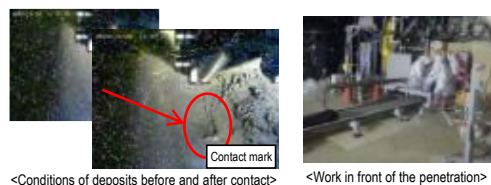
- In October 2020, as part of work to prepare for the PCV internal investigation and trial retrieval, a contact investigation to study deposits inside the penetration (X-6 penetration) was conducted, which involved inserting a guide pipe incorporating an investigative unit into the penetration. This confirmed that deposits inside the penetration had not deformed and come unstuck. The investigative information obtained will be utilized in the mockup test of the equipment to remove deposits inside the X-6 penetration.

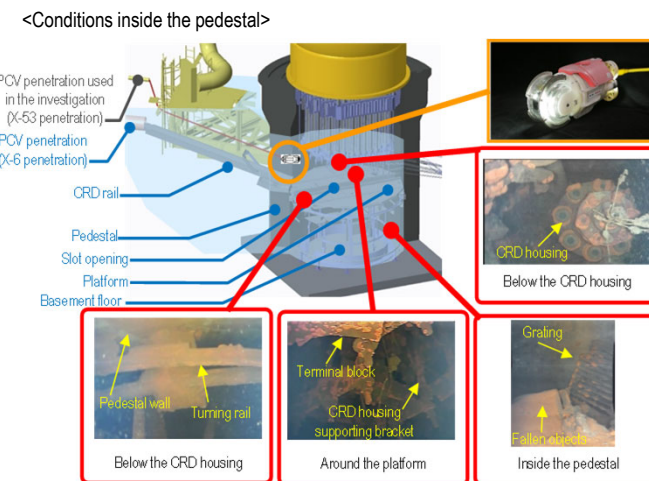
- In July 2017, the inside of the PCV was investigated using the underwater ROV (remotely operated underwater vehicle) to inspect the inside of the pedestal. Analysis of the imagery obtained in the investigation identified damage to multiple structures and the supposed core internals.

- Videos obtained in the investigation were reproduced in 3D. Based on the reproduced images, the relative positions of the structures, such as the rotating platform slipping off the rail with a portion buried in deposits, were visually understood.
