Main decommissioning work and steps

Fuel removal from the spent fuel pool was completed in December 2014 at Unit 4 and on February 28, 2021 at Unit 3. Work continues sequentially toward the start of fuel removal from Units 1 and 2 and debris (Note 1) retrieval from Units 1-3.

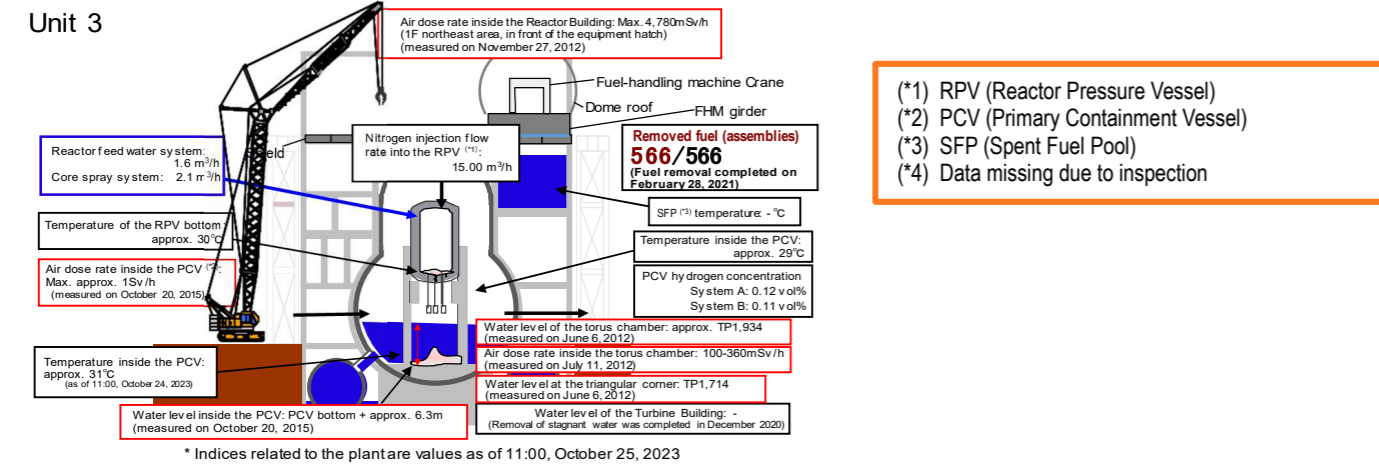
Temperatures inside the reactors

Through continuous reactor cooling by water injection, the temperatures of the Reactor Pressure Vessel (RPV) bottom and the Primary Containment Vessel (PCV) gas phase were maintained as shown below for recent, though it varied depending on the unit and location of the thermometer.

*1 The trend graphs show part of the temperature data measured at multiple points.
*2 A part of data could not be measured due to maintenance and inspection of the facility and other work.

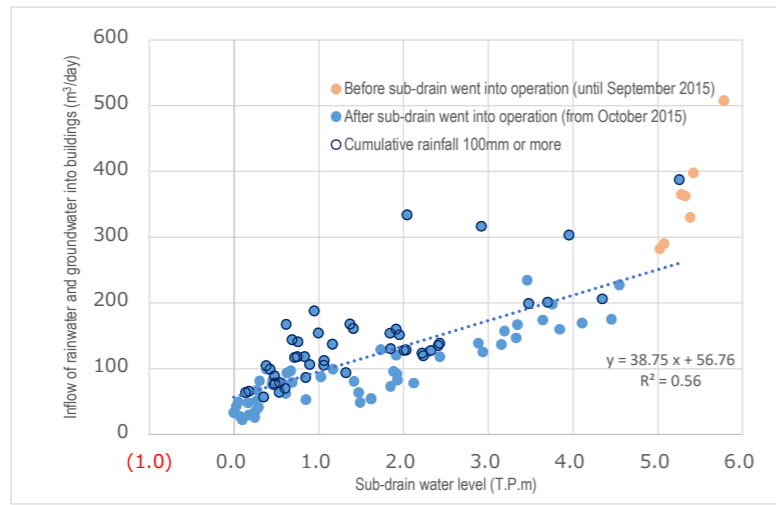
Figure 2: Correlation between inflow such as groundwater and rainwater into buildings and the water level of Units 1-4 sub-drains

- At the Water-Treatment Facility Special for Sub-drain & Groundwater drains, release started from September 14, 2015 and up until October 16, 2023, 2,299 release operations had been conducted.

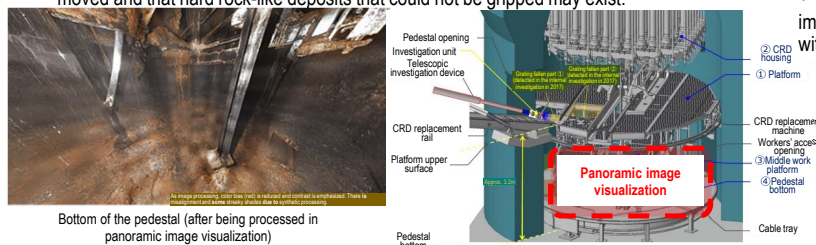
- In January 2017, a camera was inserted from the PCV penetration to inspect the conditions of the rail on which the robot traveled. The results of a series of investigations confirmed some gratings had fallen and deformed as well as a quantity of deposit inside the pedestal.

- In January 2018, the conditions below the platform inside the pedestal were investigated. Based on the analytical results of images obtained in the investigation, deposits, probably including fuel debris, were found at the bottom of the pedestal. Moreover, multiple parts exceeding the surrounding deposits were also detected. We presumed that there were multiple instances of fuel debris falling.

- In February 2019, an investigation touching the deposits at the bottom of the pedestal and on the platform was conducted and confirmed that the pebble-shaped deposits, etc. could be moved and that hard rock-like deposits that could not be gripped may exist.

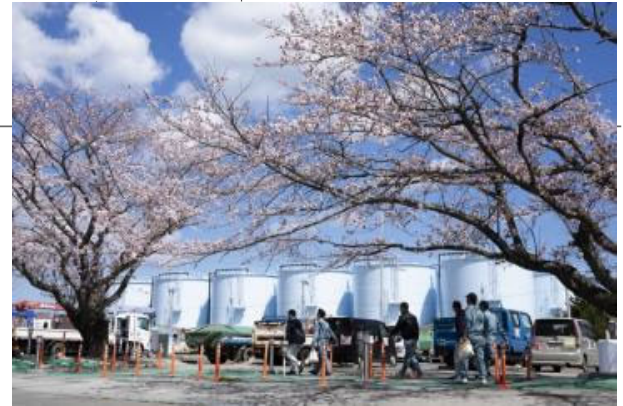
Facing (2017.4.13)

Regarding the site-wide reduction in the radiation dose and prevention of contamination spreading, the radiation dose on site was reduced by removal of rubble, topsoil and facing. Moreover, the operation was improved to use environmentally-improved areas as a Green Zone, within which workers are allowed to wear general work clothes and disposable dust-protective masks which are less of a physical burden.
