Main decommissioning work and steps

Progress status

Major initiatives – Locations on site

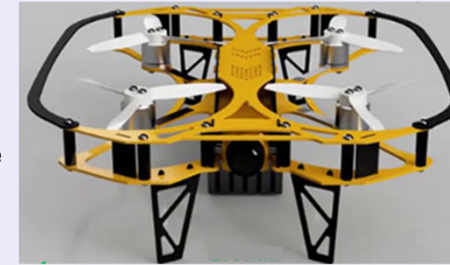
< Small drone >

This survey, to be conducted within the dark and confined space inside the PCV, will use a small drone and snake-type robot.

Size: approx. 19×18×5 [cm]
Weight: 185 [g] (including battery)

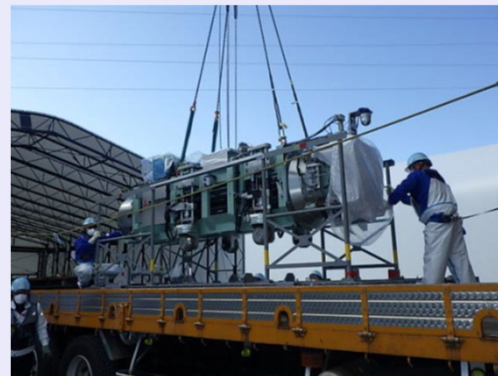
< Transportation of deposit removal equipment >

On site, before removing deposits inside the X-6 penetration, from which the robot arm would be inserted into the PCV, installation of the deposit removal equipment was completed on December 14. Subsequently, installation of the spray equipment to X-53 penetration is underway.
