Main decommissioning work and steps

Mid-and-Long-Term Decommissioning Action Plan 2024

TEPCO Holdings Fukushima Daiichi Nuclear Power Station Site Layout

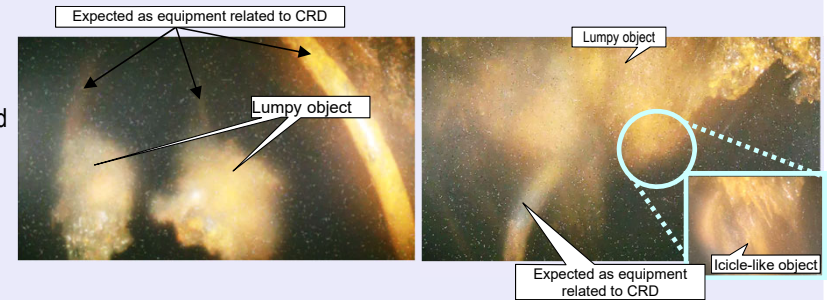
Unit 1 PCV internal investigation (aerial survey)

On March 14, an aerial survey inside PCV by a small drone (Day 2) was conducted to inspect the inner wall and structures inside the pedestal, the status of the fallen Control Rod Drive (CRD) housing and others.

Moreover, the survey also detected icicle-like and lumpy objects near the opening for CRD replacement and confirmed the absence of significant damage on the concrete of the inner wall.

<Objects near the opening for the CRD replacement inside the pedestal>

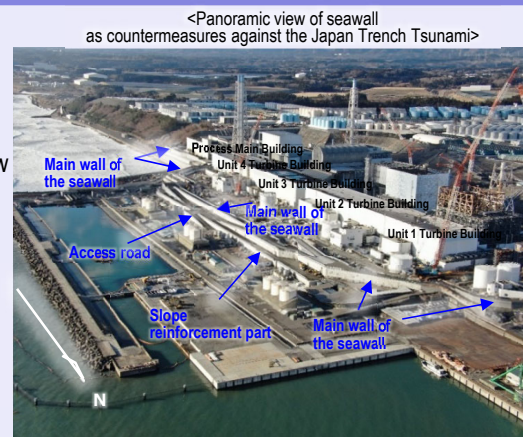
Completion of the seawall as countermeasures against the Japan Trench Tsunami

Installation of the seawall as countermeasures against the Japan Trench Tsunami, which commenced from June 21, 2021, was completed on March 15, 2024 (main wall: total length, approx. 1km and height, 13.5-16m above sea level).

The seawall will suppress flooding caused by the Japan Trench Tsunami, the imminent occurrence of which is evaluated and prevent any increase in contaminated water associated with inflow into buildings. Moreover, it will also help mitigate damage to key decommissioning facilities.

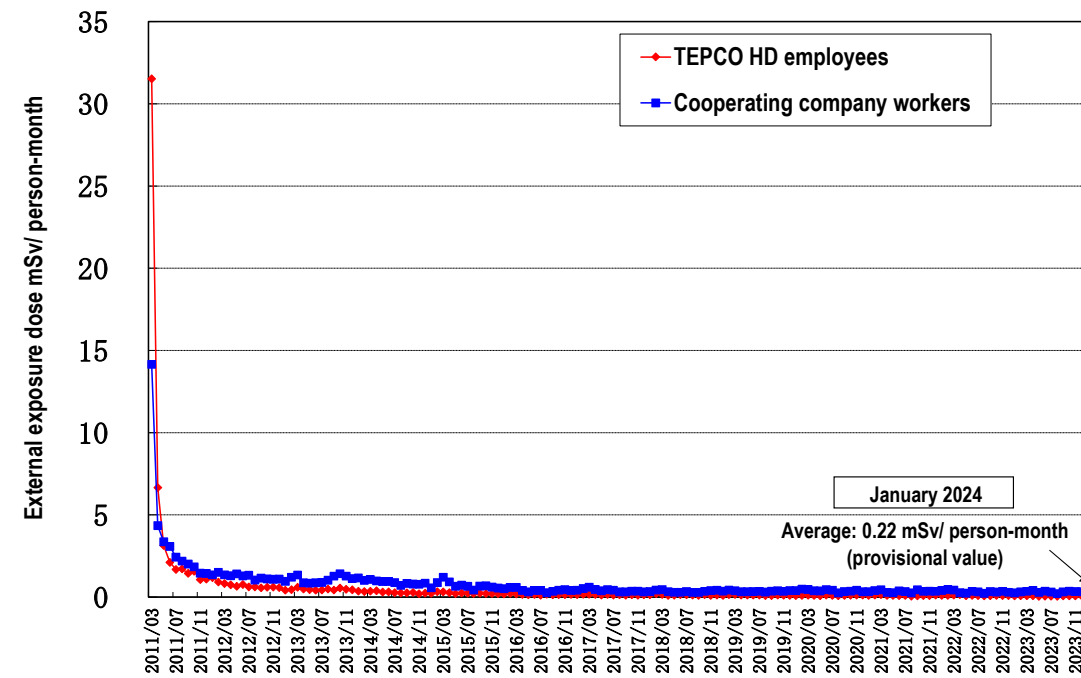
Figure 7: Changes in monthly average exposure dose of individual worker (monthly exposure dose since March 2011)

- The average exposure doses of workers were approx. 2.60, 2.51 and 2.16 mSv/person-year during FY2020, 2021 and 2022, respectively (The legal exposure dose limits are 100 and 50 mSv/person-year respectively over five years, the TEPCO HD management target is 20 mSv/person-year).

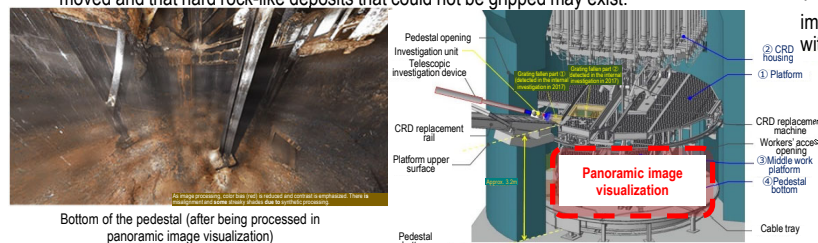
- In January 2017, a camera was inserted from the PCV penetration to inspect the conditions of the rail on which the robot traveled. The results of a series of investigations confirmed some gratings had fallen and deformed as well as a quantity of deposit inside the pedestal.

- In January 2018, the conditions below the platform inside the pedestal were investigated. Based on the analytical results of images obtained in the investigation, deposits, probably including fuel debris, were found at the bottom of the pedestal. Moreover, multiple parts exceeding the surrounding deposits were also detected. We presumed that there were multiple instances of fuel debris falling.

- In February 2019, an investigation touching the deposits at the bottom of the pedestal and on the platform was conducted and confirmed that the pebble-shaped deposits, etc. could be moved and that hard rock-like deposits that could not be gripped may exist.

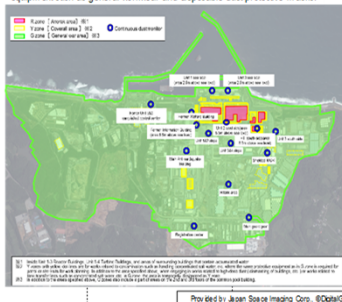
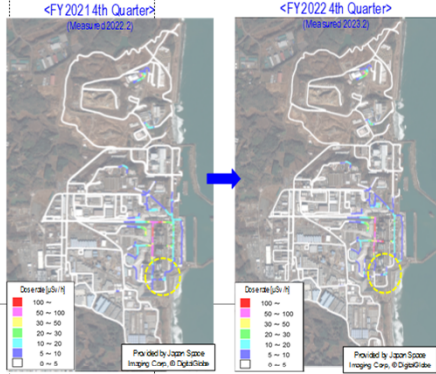
<p><Travel survey results of major roads within the site> It was confirmed that compared with the last fiscal year, the dose rate has been declining on roads near the southeast side of the Unit 4 Turbine Building and the west side of the Process Main Building (area circled by yellow dot line).</p>

<p><FY2021 4th Quarter> (Measured 2022.2) <FY2022 4th Quarter> (Measured 2023.2)</p>
