## Main decommissioning work and steps

Fuel removal from the spent fuel pool was completed in December 2014 at Unit 4 and on February 28, 2021 at Unit 3. Work continues sequentially toward the start of fuel removal from Units 1 and 2 and debris (Note 1) retrieval from Units 1-3.

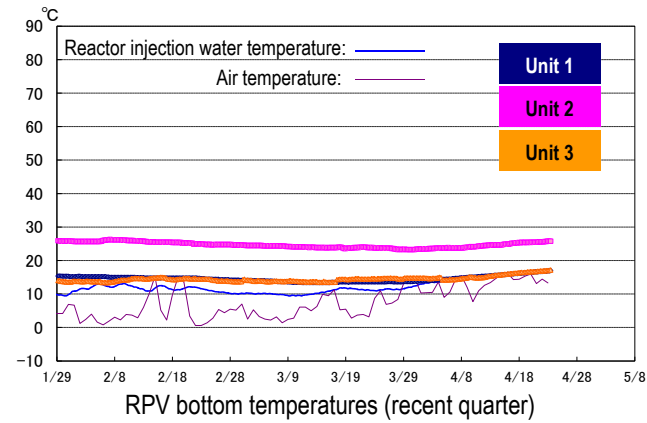
Through continuous reactor cooling by water injection, the temperatures of the Reactor Pressure Vessel (RPV) bottom and the Primary Containment Vessel (PCV) gas phase were maintained as shown below for recent, though it varied depending on the unit and location of the thermometer.

- \*1 The trend graphs show part of the temperature data measured at multiple points.  
\*2 A part of data could not be measured due to maintenance and inspection of the facility and other work.

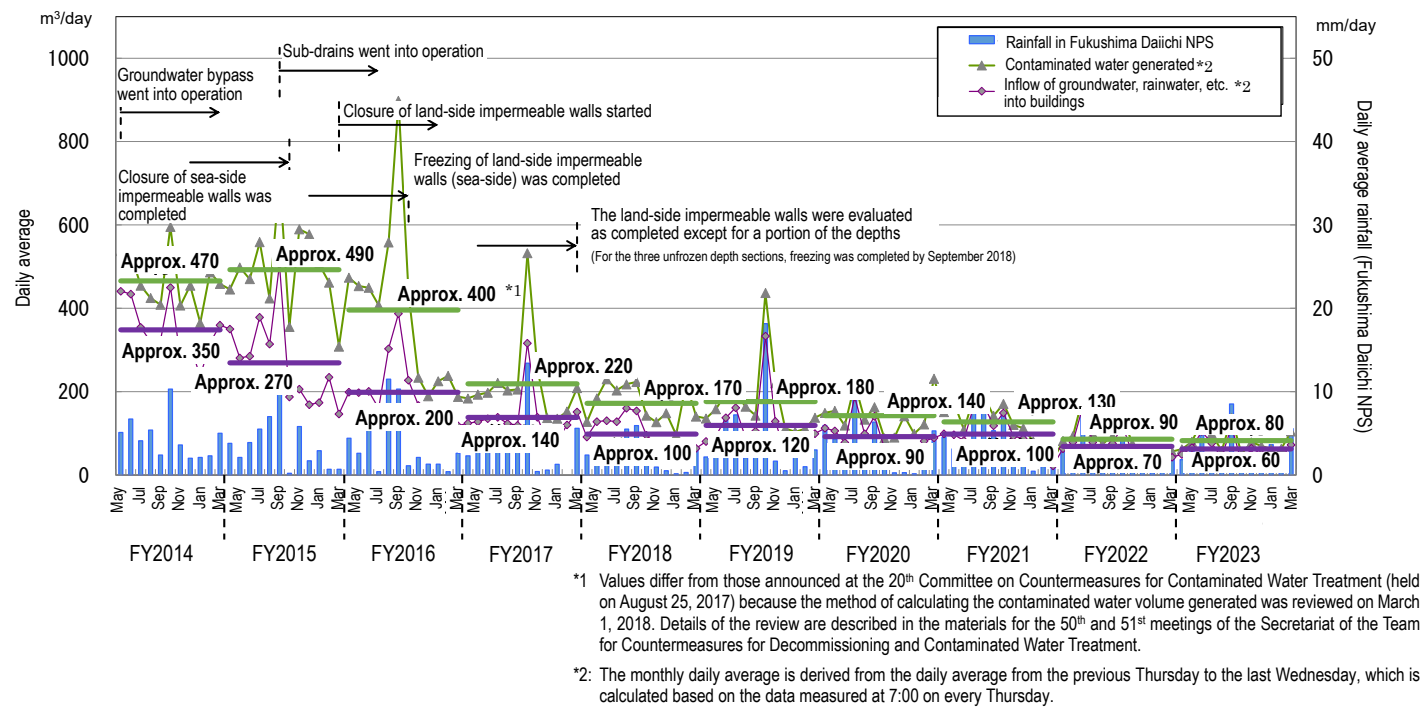
Figure 1: Changes in contaminated water generated and inflow of groundwater and rainwater into buildings

- Status of contaminated water generated
  - Multi-layered contaminated water management measures, including land-side impermeable walls and sub-drains, have stabilized the groundwater at a low level and the increased contaminated water generated during rainfall is being suppressed by repairing damaged portions of building roofs facing onsite. Through these measures, the generation of contaminated water has been suppressed and reduced from approx. 540 m<sup>3</sup>/day (in May 2014) before implementing measures to approx. 80 m<sup>3</sup>/day (in FY2023), achieving the milestone to "suppress the amount of contaminated water generated to 100 m<sup>3</sup>/day or less during average rainfall within FY2025."
  - Measures will proceed to further reduce the amount of contaminated water generated and suppress to approx. 50-70 m<sup>3</sup>/day by FY2028.

### Amount of contaminated water generated in FY2023: approx. 80 m<sup>3</sup>/day, achieving the milestone prescribed in the Mid-and-Long-Term Roadmap

Rainfall in FY2023 was 1,275 mm, less than in normal years (approx. 1,470 mm), the amount of contaminated water generated was approx. 80 m<sup>3</sup>/day and even when being evaluated with the average rainfall, approx. 90 m<sup>3</sup>/day, which was evaluated that the milestone prescribed in the Mid-and-Long-Term Roadmap “suppressing the amount of contaminated water generated to less than 100 m<sup>3</sup>/day during average rainfall within FY2025” was achieved ahead of schedule.

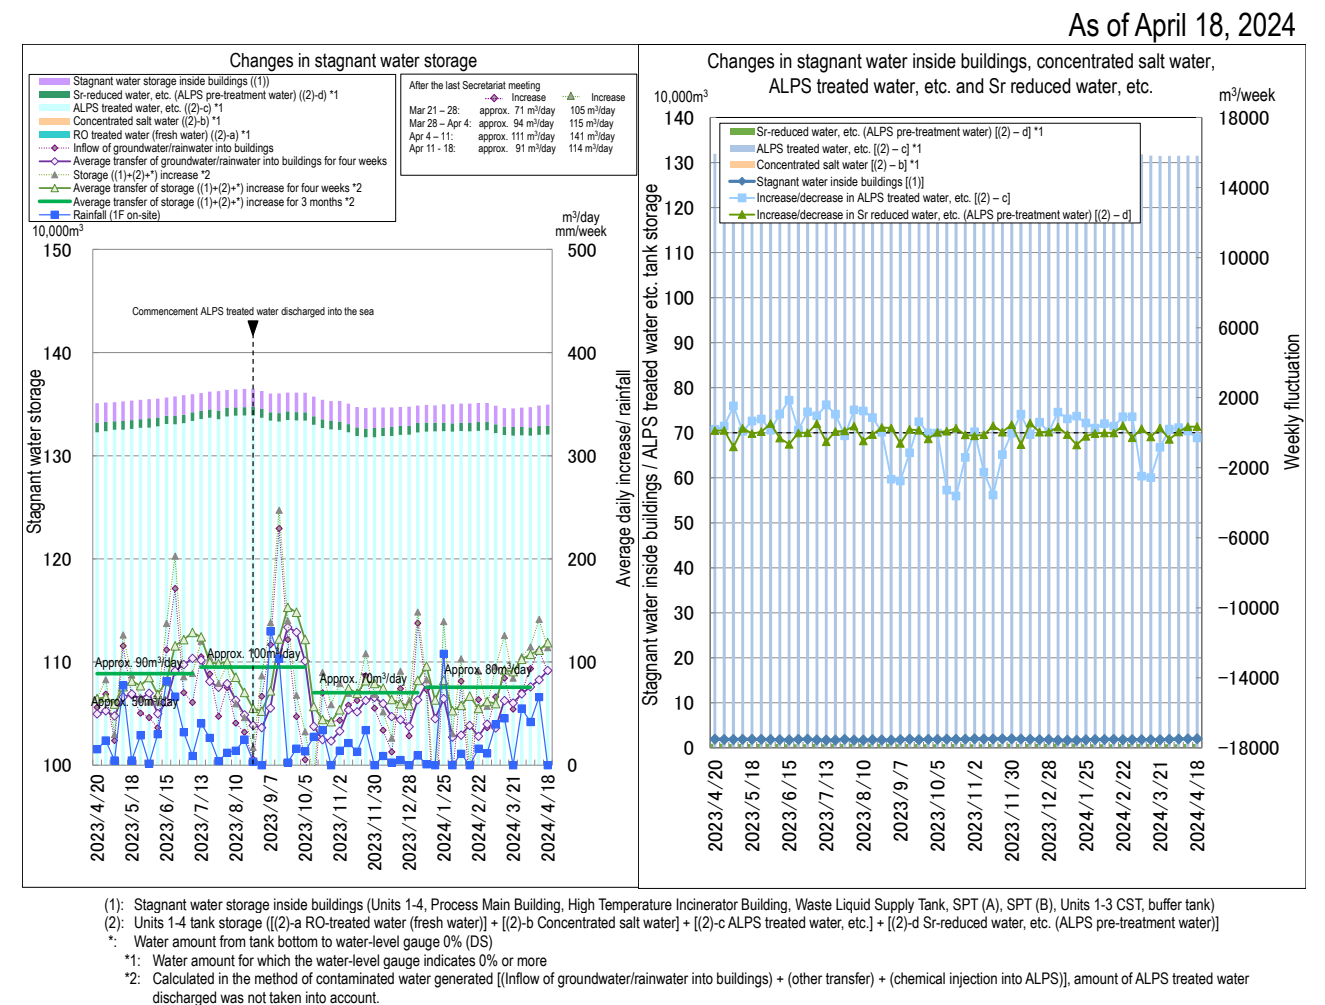
Figure 3: Status of stagnant water storage

- Storage status of contaminated water and amount of ALPS treated water, etc. stored in tanks.
  - The amount of ALPS treated water, etc. was approx. 1,317,616 m³ as of April 18, 2024.

- The amount of ALPS treated water discharged into the sea was approx. 33,416m³ as of April 24, 2024.

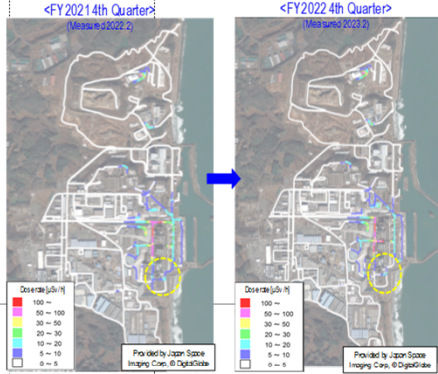
<p>&lt;FY 2021 4th Quarter&gt; (Measured 2022.2)          &lt;FY 2022 4th Quarter&gt; (Measured 2023.2)</p> <p>Provided by Japan Space Imaging Corp. ©Digitallobe</p>
