Main decommissioning work and steps

Fuel removal from the spent fuel pool was completed in December 2014 at Unit 4 and on February 28 2021 at Unit 3.
Work continues sequentially toward the start of fuel removal from Units 1 and 2 and debris (Note 1) retrieval from Units 1-3.

TEPCO Holdings Fukushima Daiichi Nuclear Power Station Site Layout

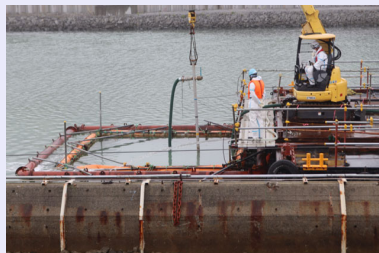
< Seafloor re-covering construction (layer of cover) >

Construction to re-cover the seafloor of the Units 1-4 intake open channel was completed on June 13. This formed a covering layer, thereby improving the environment and has further enhanced measures for the fish inside the port.
