## Main decommissioning work and steps

## Progress status

# I. Confirmation of the reactor conditions

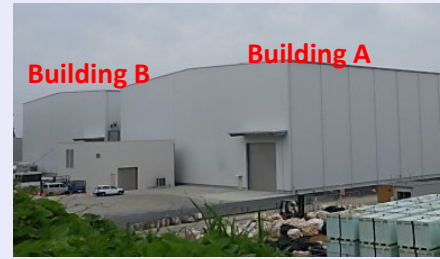
< Solid Waste Storage 10 Facility >

The Solid Waste Storage 10 Facility was installed to temporarily store contaminated soil generated in decommissioning and rubble after compaction in containers. Installation of A of three buildings (A-C) was completed.

Building A received a certificate of the pre-service inspection by the Nuclear Regulation Authority on July 24. Preparation for setting controlled areas is underway and operation will commence from August.

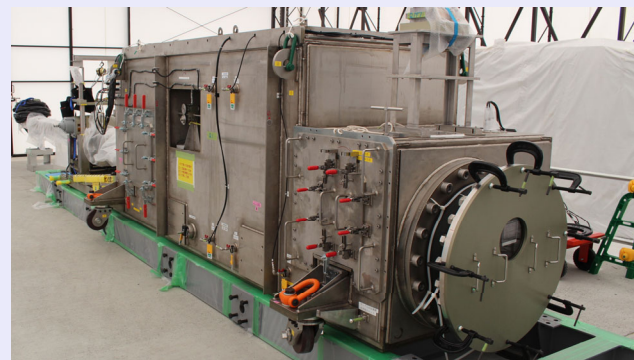
< Whole view of the telescopic-type equipment after arrival at the on-site tent house >

Regarding the telescopic-type equipment to be used in the Unit 2 fuel debris trial retrieval, transportation to the Fukushima Daiichi Nuclear Power Station commenced on July 3 and reached the station on July 10.

During the next phase, the equipment was transported into the Reactor Building on July 19 and work to fix it to the connection pipe, which was installed at X-6 penetration, is underway.

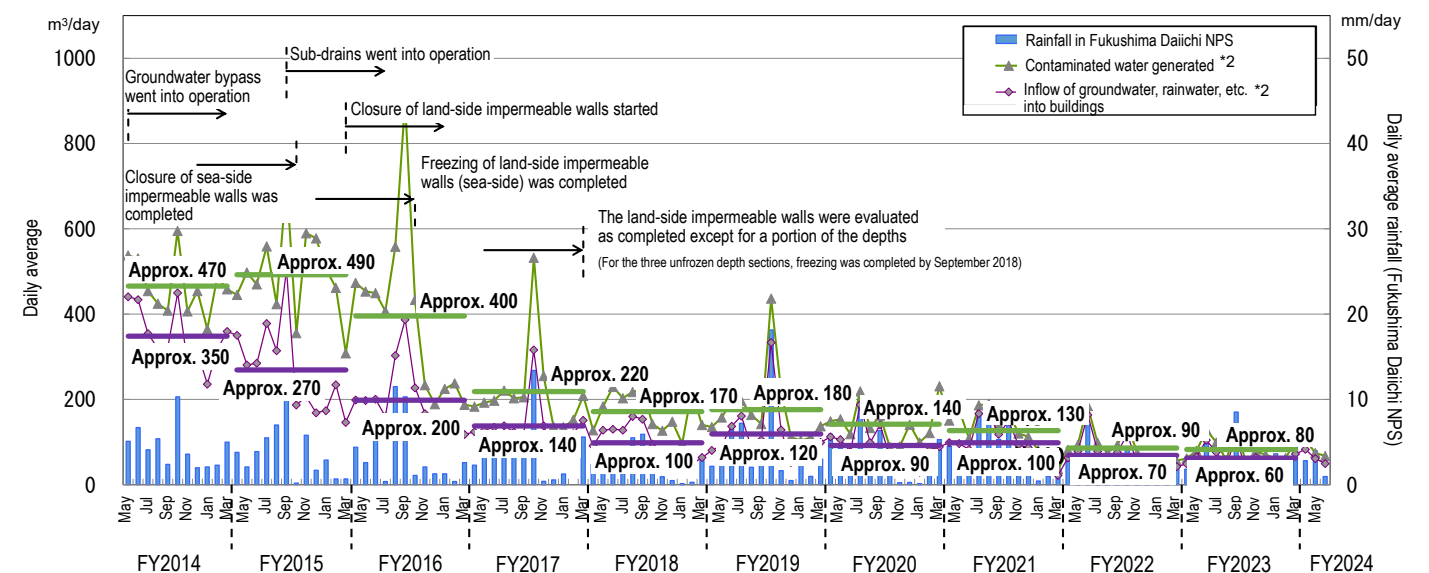
- Multi-layered contaminated water management measures, including land-side impermeable walls and sub-drains, have stabilized the groundwater at a low level and the increased contaminated water generated during rainfall is being suppressed by repairing damaged portions of building roofs facing onsite. Through these measures, the generation of contaminated water has been suppressed and reduced from approx. 540 m<sup>3</sup>/day (in May 2014) before implementing measures to approx. 80 m<sup>3</sup>/day (in FY2023), achieving the milestone to “suppress the amount of contaminated water generated to 100 m<sup>3</sup>/day or less during average rainfall within FY2025.”
- Measures will proceed to further reduce the amount of contaminated water generated and suppress to approx. 50-70 m<sup>3</sup>/day by FY2028.

\*1 Values differ from those announced at the 20<sup>th</sup> Committee on Countermeasures for Contaminated Water Treatment (held on August 25, 2017) because the method of calculating the contaminated water volume generated was reviewed on March 1, 2018. Details of the review are described in the materials for the 50<sup>th</sup> and 51<sup>st</sup> meetings of the Secretariat of the Team for Countermeasures for Decommissioning and Contaminated Water Treatment.

\*2: The monthly daily average is derived from the daily average from the previous Thursday to the last Wednesday, which is calculated based on the data measured at 7:00 on every Thursday.

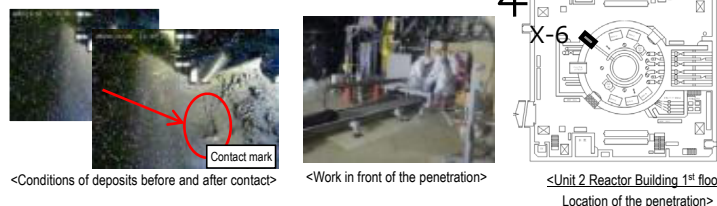
Unit 2 PCV internal investigation

- In October 2020, as part of work to prepare for the PCV internal investigation and trial retrieval, a contact investigation to study deposits inside the penetration (X-6 penetration) was conducted, which involved inserting a guide pipe incorporating an investigative unit into the penetration. This confirmed that deposits inside the penetration had not deformed and come unstuck. The investigative information obtained will be utilized in the mockup test of the equipment to remove deposits inside the X-6 penetration.

Investigations inside the PCV	1st (2012.1)	- Acquiring images - Measuring the air temperature
	2nd (2012.3)	- Confirming water surface - Measuring the water temperature - Measuring the dose rate
	3rd (2013.2 - 2014.6)	- Acquiring images - Sampling stagnant water - Measuring water level - Installing permanent monitoring instrumentation
	4th (2017.1-2)	- Acquiring images - Measuring the dose rate - Measuring the air temperature
	5th (2018.1)	- Acquiring images - Measuring the dose rate - Measuring the air temperature
	6th (2019.2)	- Acquiring images - Measuring the dose rate - Measuring the air temperature - Determining characteristics of a portion of deposit
Leakage points from PCV	- No leakage from the torus chamber rooftop - No leakage from any internal/external surfaces of S/C	
Evaluation of the location of fuel debris inside the reactor by measurement using muons The existence of high-density materials, which were considered to constitute fuel debris, was confirmed at the bottom of RPV and in the lower part and outer periphery of the reactor core. It was assumed that a significant portion of fuel debris existed at the bottom of RPV. (2016.3-7)

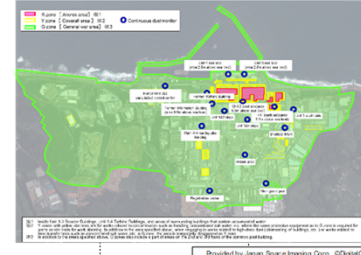
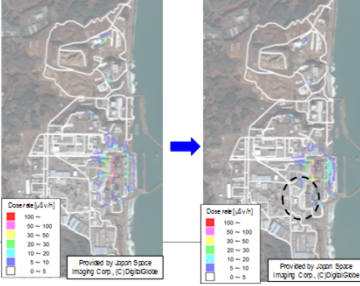
<p>▼ Travel survey results of major roads within the site&gt; It was confirmed that, compared with the last fiscal year, the dose rate has been declining on roads on the west and south sides of the High Temperature Incinerator Building (area circled by black dot line).</p>
