Main decommissioning work and steps

Fuel removal from the spent fuel pool was completed in December 2014 at Unit 4 and on February 28 2021 at Unit 3.
 Work continues sequentially toward the start of fuel removal from Units 1 and 2 and debris (Note 1) retrieval from Units 1-3.

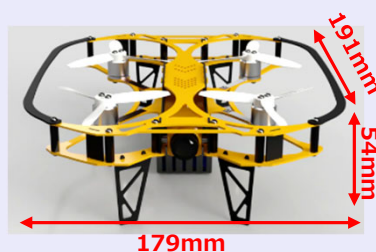
< Small drone used in the investigation in Unit 1 >

Regarding the X-53 penetration, an access route into the Unit 3 PCV, an investigation using a smaller micro drone than that used in the Unit 1 investigation is planned due to the small diameter of the penetration. Simultaneously, construction of a new access route is being examined to insert the same drone as with Unit 1.
