Main decommissioning work and steps

Progress status

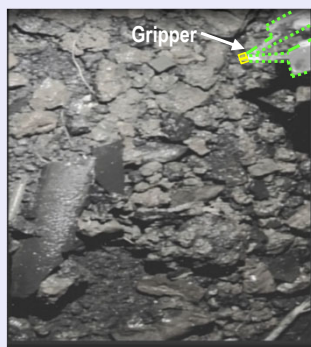
< State at the bottom of the pedestal >

For fuel debris at the bottom of the pedestal, visual confirmation by a camera mounted at the end of the telescopic-type equipment and contact confirmation by the end of the gripper were conducted on September 14.

As preparation for gripping fuel debris, the operation of the telescopic-type equipment was verified on September 17 and it was confirmed that camera images were not being sent to the monitor in the remote control room appropriately.

Afterward, the telescopic-type equipment was replaced inside the enclosure on September 25.

Recovery can be expected by placement in a low-dosage area and maintaining the power-on or -off states to reduce accumulated charge. Subsequently, as part of efforts to identify the cause, the state of camera images will be verified while in standby mode and with relatively low dosage exposure inside the enclosure to verify the impact of radiation.

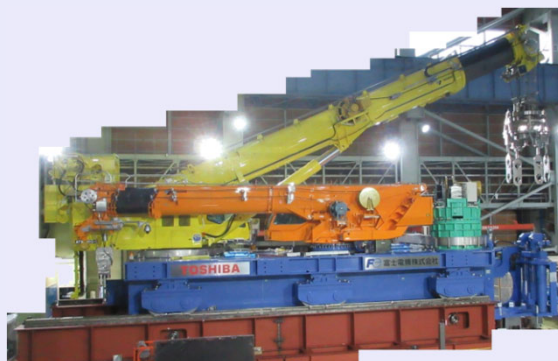
< Fuel-Removal System >

At the factory, assembly of the Fuel-Removal System was completed and test operation of each component of the system is underway. The Fuel-Removal System will be installed behind the runway garter and transported by sea after trial operation.

- Within the site, before installing the gantry for fuel removal, the foundation of the existing Fuel Handling Machine Operation Room, which interfered with the runway garter, was cut on September 10. An opening will be created on the south side of the Unit 2 Reactor Building operating floor.
- Among the equipment attached to the gantry for fuel removal, the completion inspection of the overhead crane was finished on August 9. Test operation of the ventilation equipment has been underway since September 3.
- At the factory, assembly of the Fuel-Removal System was completed and the test operation of each system component is underway. The Fuel-Removal System will be installed behind the runway garter and transported by sea after trial operation.

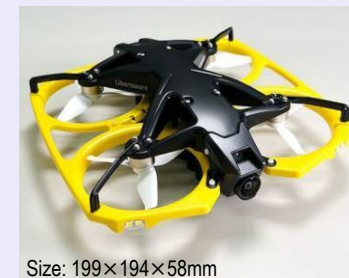
< Investigation drone >

Given the high dose of radiation in the area, an investigation to identify the leakage point will be conducted in early October via drone.

After identifying the leakage point via drone, a visual inspection by TEPCO will be conducted.

Size: 199×194×58mm

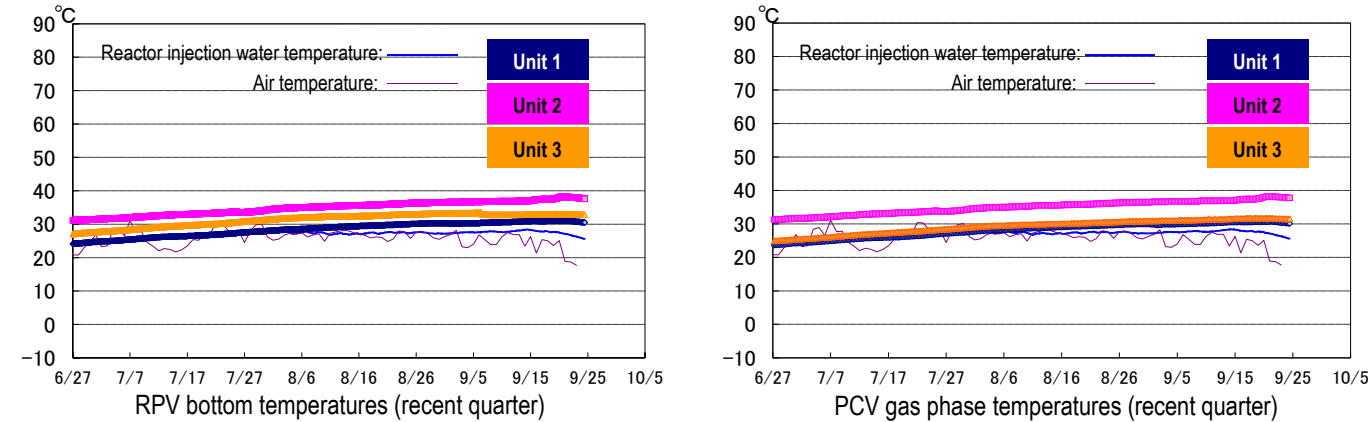
Through continuous reactor cooling by water injection, the temperatures of the Reactor Pressure Vessel (RPV) bottom and the Primary Containment Vessel (PCV) gas phase were maintained as shown below for recent, though it varied depending on the unit and location of the thermometer.

*1 The trend graphs show part of the temperature data measured at multiple points.
*2 A part of data could not be measured due to maintenance and inspection of the facility and other work.

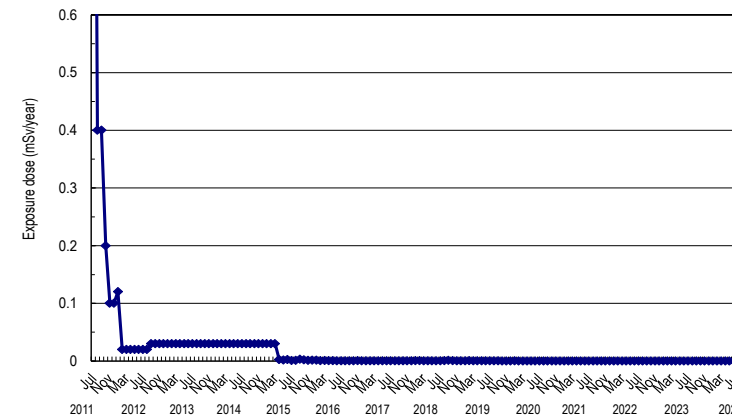
Annual radiation dose at site boundaries by radioactive materials (cesium) released from Reactor Building Units 1-4

As of August 2024, the concentration of radioactive materials newly released from Reactor Building Units 1-4 into the air and measured at the site boundary was evaluated at approx. 9.6×10^{-12} Bq/cm³ and 8.8×10^{-12} Bq/cm³ for Cs-134 and -137 respectively, while the radiation exposure dose due to the release of radioactive materials there was less than 0.00004 mSv/year.

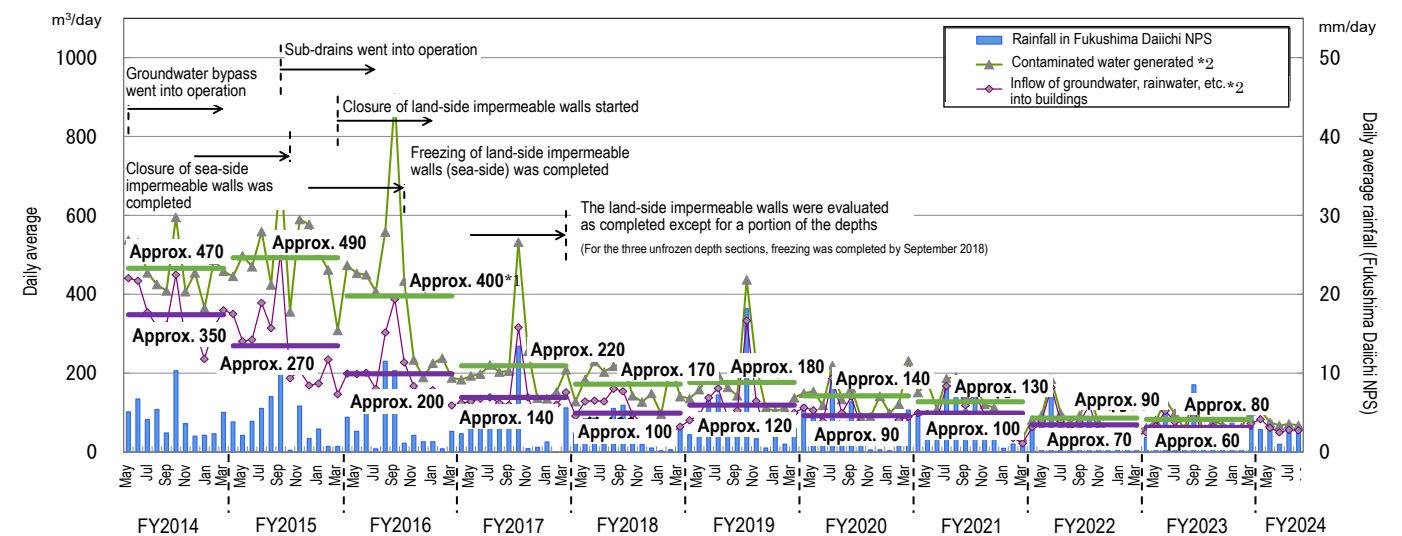
- Multi-layered contaminated water management measures, including land-side impermeable walls and sub-drains, have stabilized the groundwater at a low level and the increased contaminated water generated during rainfall is being suppressed by repairing damaged portions of building roofs facing onsite. Through these measures, the generation of contaminated water has been suppressed and reduced from approx. 540 m³/day (in May 2014) before implementing measures to approx. 80 m³/day (in FY2023), achieving the milestone to “suppress the amount of contaminated water generated to 100 m³/day or less during average rainfall within FY2025.”
- Measures will proceed to further reduce the amount of contaminated water generated and suppress to approx. 50-70 m³/day by FY2028.

*1 Values differ from those announced at the 20th Committee on Countermeasures for Contaminated Water Treatment (held on August 25, 2017) because the method of calculating the contaminated water volume generated was reviewed on March 1, 2018. Details of the review are described in the materials for the 50th and 51st meetings of the Secretariat of the Team for Countermeasures for Decommissioning and Contaminated Water Treatment.

*2: The monthly daily average is derived from the daily average from the previous Thursday to the last Wednesday, which is calculated based on the data measured at 7:00 on every Thursday.

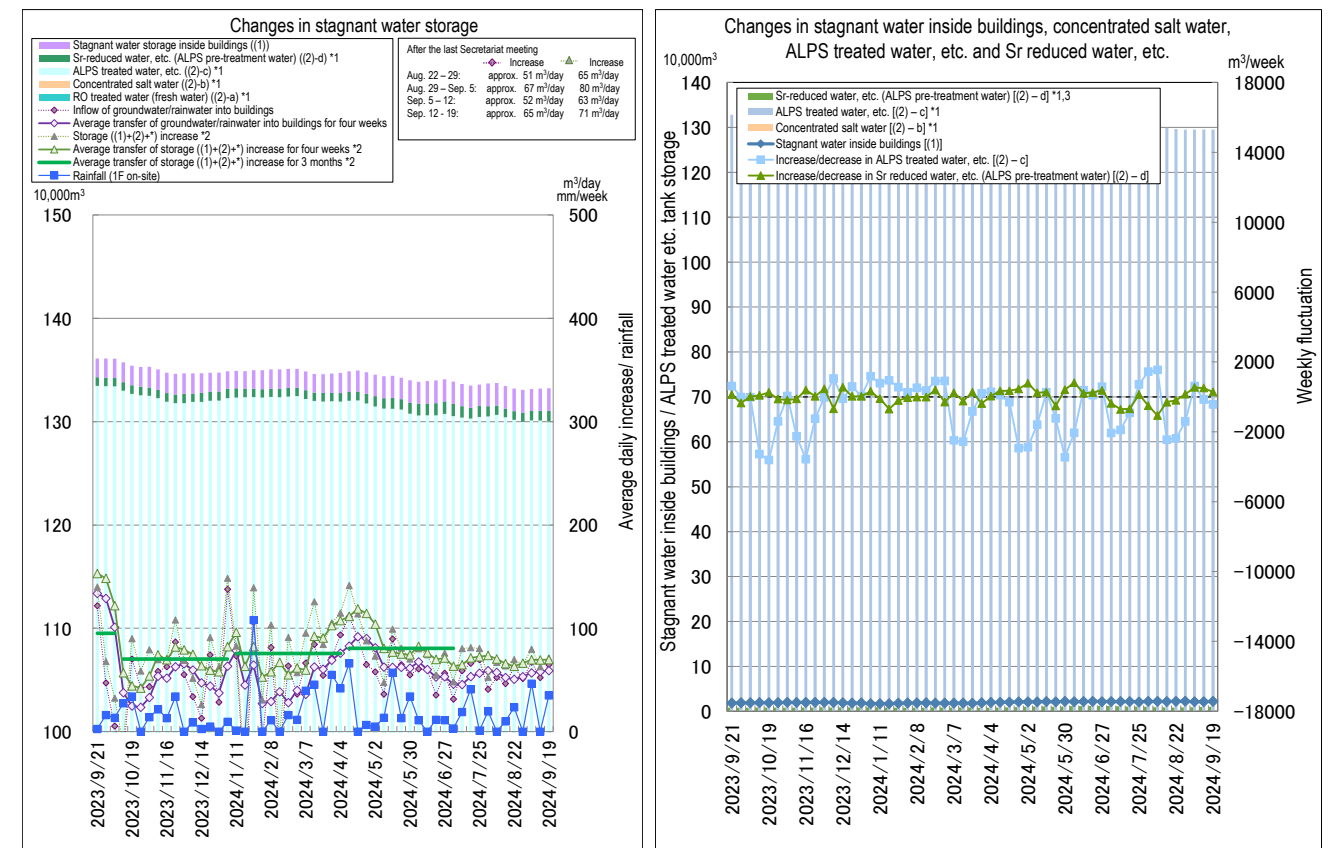
- The amount of ALPS treated water, etc. was approx. 1,297,464 m³ as of September 19, 2024.
- The total amount of ALPS treated water discharged into the sea since the discharge commenced on August 24, 2023 was approx. 62,631 m³ as of August 26, 2024.

(1): Stagnant water storage inside buildings (Units 1-4, Process Main Building, High Temperature Incinerator Building, Waste Liquid Supply Tank, SPT (A), SPT (B), Units 1-3 CST, buffer tank)

(2): Units 1-4 tank storage [(2)-a RO-treated water (fresh water)] + [(2)-b Concentrated salt water] + [(2)-c ALPS treated water, etc.] + [(2)-d Sr-reduced water, etc. (ALPS pre-treatment water)]
 *: Water amount from tank bottom to water-level gauge 0% (DS)
 *1: Water amount for which the water-level gauge indicates 0% or more
 *2: Calculated in the method of contaminated water generated [(Inflow of groundwater/rainwater into buildings) + (other transfer) + (chemical injection into ALPS)], amount of ALPS treated water discharged was not taken into account.
 *3: Amount of Sr-reduced water and others increased and decreased depending on the operation status of facilities due to clog of the cross-flow filter for the multi-nuclide removal equipment.

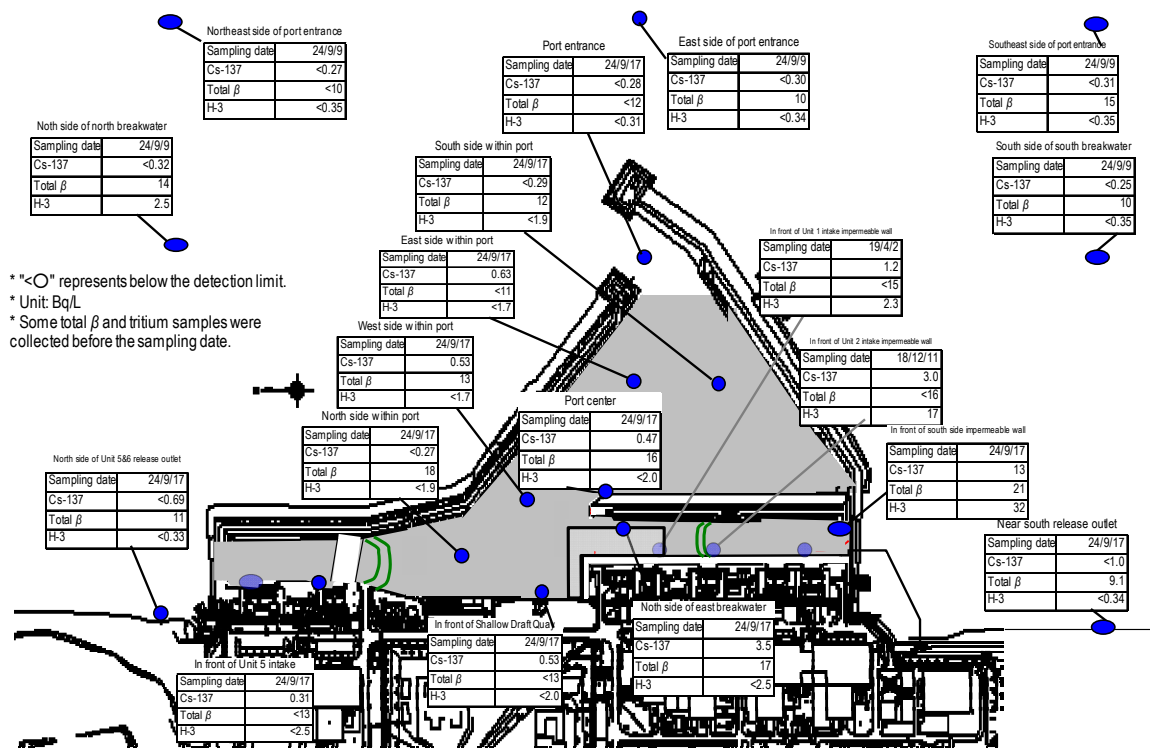
Figure 5: Seawater concentration around the port

- In the port area, the concentration of radioactive materials in seawater has remained below the legal discharge limit and been declining long term, despite temporary increases in Cs-137 and Sr-90 observed during rainfall. They have remained below the level of those in the Units 1-4 intake open channel area and been declining following the completed installation and connection of steel pipe sheet piles for the sea-side impermeable walls.

- In the area outside the port, regarding the concentration of radioactive materials in seawater, those of Cs-137 and Sr-90 declined and remained low after steel pipe sheet piles for the sea-side impermeable walls were installed and connected. Regarding the concentration of Cs-137, a temporary increase was sometimes observed on the north side of the Unit 5 and 6 outlets and near the south outlet due to the influence of weather, marine meteorology and other factors. Regarding the concentration of Sr-90, variation was observed in FY2021 in the area outside the port (north and south outlets). Monitoring of the tendency continues, including the potential influence of the weather, marine meteorology and others. During the period of discharge of ALPS treated water, the tritium concentration increased at the sampling point near the discharge outlet, but this was considered within the assumed range based on the results of the oceanic dispersion simulation.

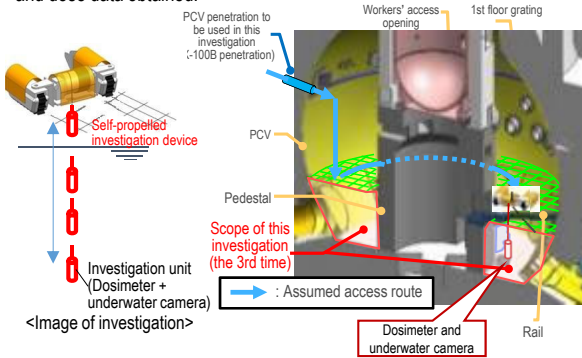
- In April 2015, a device having entered the inside of the PCV via a narrow opening (bore:φ100 mm) collected information such as images and airborne dose inside the PCV 1st floor.
- In March 2017, an investigation using a self-propelled investigation device was conducted to inspect the spreading of debris to the basement floor outside the pedestal, with images taken of the PCV bottom status for the first time. The conditions inside the PCV will continue to be examined, based on the imagery and dose data obtained.

In February 2022, "the guide ring" was installed to facilitate the investigation. From March 28, 2023, the investigation inside the pedestal by ROV-A2 started and confirmed that a portion of the bar arrangement was exposed. Regarding the soundness of the pedestal, based on the past earthquake resistant evaluation by the International Research Institute for Nuclear Decommissioning (IRID), it was evaluated that even though a portion of the pedestal was lost, there would be no serious risk. However, as the present information is very limited, the investigation will continue to acquire as much information as possible for continued evaluation.

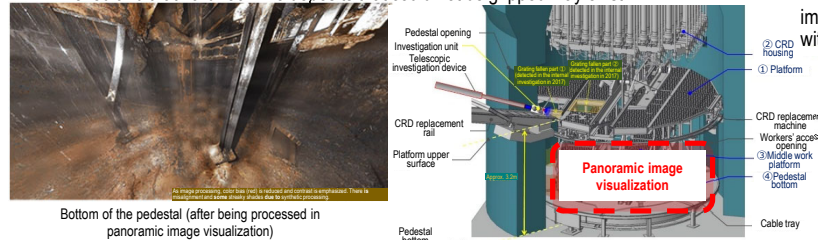
- In January 2017, a camera was inserted from the PCV penetration to inspect the conditions of the rail on which the robot traveled. The results of a series of investigations confirmed some gratings had fallen and deformed as well as a quantity of deposit inside the pedestal.

- In January 2018, the conditions below the platform inside the pedestal were investigated. Based on the analytical results of images obtained in the investigation, deposits, probably including fuel debris, were found at the bottom of the pedestal. Moreover, multiple parts exceeding the surrounding deposits were also detected. We presumed that there were multiple instances of fuel debris falling.

- In February 2019, an investigation touching the deposits at the bottom of the pedestal and on the platform was conducted and confirmed that the pebble-shaped deposits, etc. could be moved and that hard rock-like deposits that could not be gripped may exist.

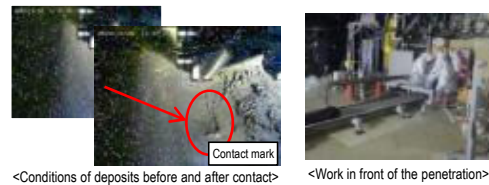
- In October 2020, as part of work to prepare for the PCV internal investigation and trial retrieval, a contact investigation to study deposits inside the penetration (X-6 penetration) was conducted, which involved inserting a guide pipe incorporating an investigative unit into the penetration. This confirmed that deposits inside the penetration had not deformed and come unstuck. The investigative information obtained will be utilized in the mockup test of the equipment to remove deposits inside the X-6 penetration.

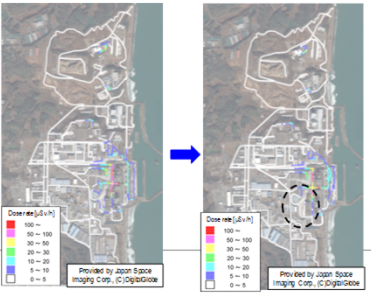
<p>Facing (2017.4.13)</p>	<p><Travel survey results of major roads within the site> It was confirmed that, compared with the last fiscal year, the dose rate has been declining on roads on the west and south sides of the High Temperature Incinerator Building (area circled by black dot line).</p>

<p><FY2022 4th Quarter> (Measured in February 2023) Provided by Japan Space Imaging Corp., ©DigitalGlobe</p> <p><FY2023 4th Quarter> (Measured in February 2024) Provided by Japan Space Imaging Corp., ©DigitalGlobe</p>
