## Main decommissioning work and steps

## Measures for treated water

## Contaminated water management - triple-pronged efforts -

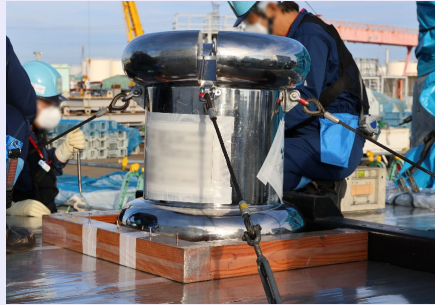
<Off-site transportation cask mounted on the off-site transportation vehicle>

On November 7, Unit 2 trial fuel debris retrieval using the telescopic device was completed.

Sampled fuel debris was transported to the Japan Atomic Energy Agency (JAEA) Oarai Nuclear Engineering Institute on November 12.

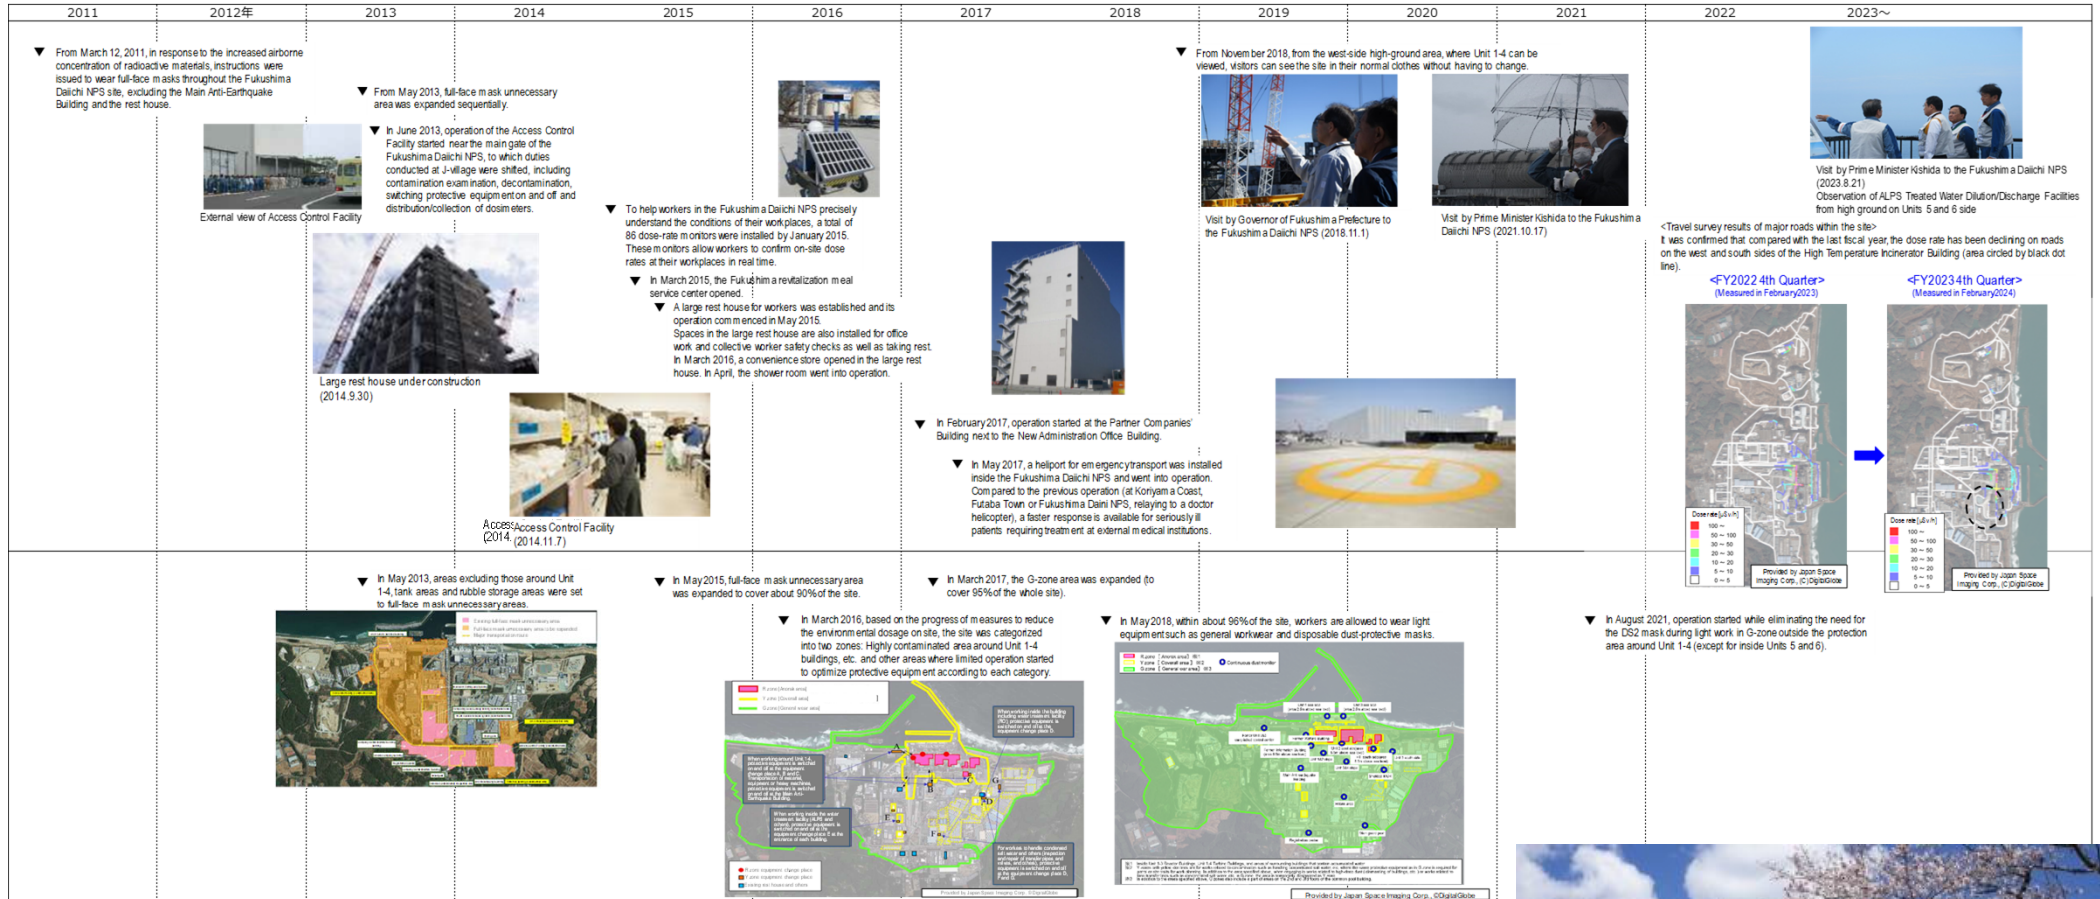
Regarding the site-wide reduction in the radiation dose and prevention of contamination spreading, the radiation dose on site was reduced by removal of rubble, topsoil and facing. Moreover, the operation was improved to use environmentally-improved areas as a Green Zone, within which workers are allowed to wear general work clothes and disposable dust-protective masks which are less of a physical burden.
