## Main decommissioning work and steps

## Progress status

# I. Confirmation of the reactor conditions

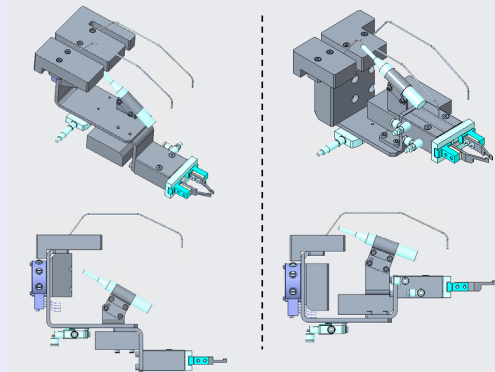
The telescopic device, which has proven results in fuel debris collection, will be used. Work to replace the camera at the end of the device, improve the tip jig, upskill and other preparation will proceed and examination is underway to commence in around spring 2025.

< Current tip jig >

< Tip jig after change >

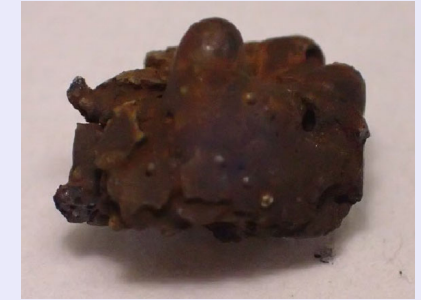
Americium and others were detected in the gamma-ray spectrometry measurement and a portion with uranium spreading on the surface was also detected in the SEM-WDX measurement, which showed that fuel components were included.

< External appearance of fuel debris sample (approx. 9 × 7 mm) >

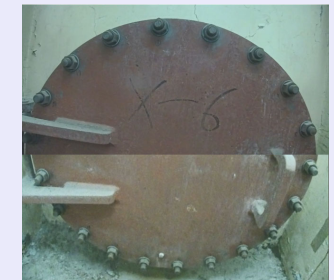
Regarding the flange of X-6 penetration, no molten material adhering was detected as in Unit 2 and the external appearance broadly resembled that before the earthquake. The maximum air dose rate in the front room was 124mSv/h, which was lower compared with in Unit 2 and no molten material deposit was detected on the floor.

< Photo of X-6 penetration >

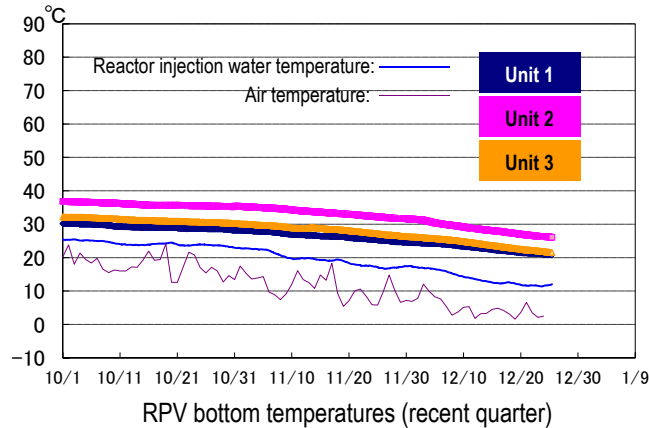
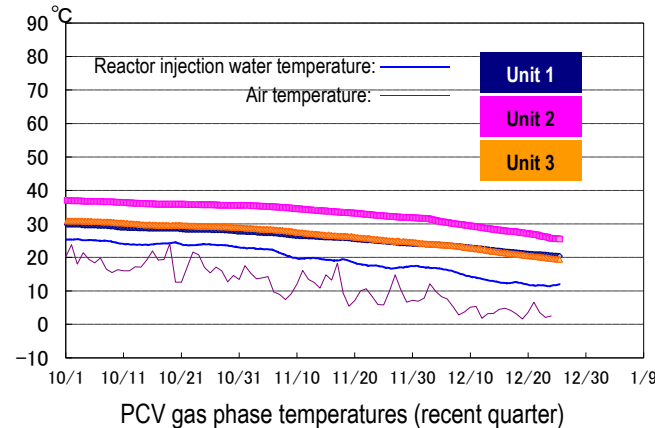
Through continuous reactor cooling by water injection, the temperatures of the Reactor Pressure Vessel (RPV) bottom and the Primary Containment Vessel (PCV) gas phase were maintained as shown below for recent, though they varied depending on the unit and location of the thermometer.

\*1 The trend graphs show part of the temperature data measured at multiple points.  
\*2 A part of data could not be measured due to maintenance and inspection of the facility and other work.

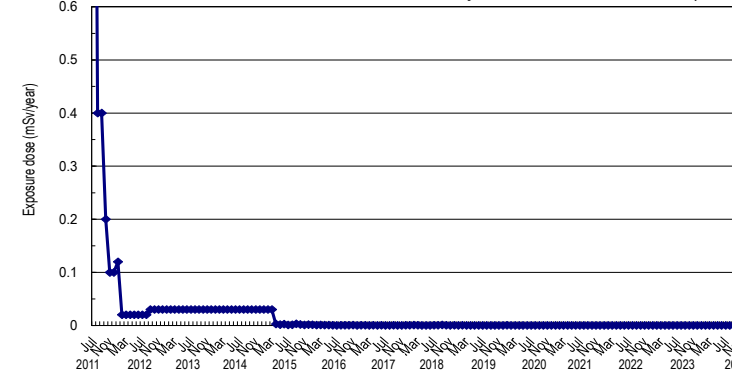
As of November 2024, the concentration of radioactive materials newly released from Reactor Building Units 1-4 into the air and measured at the site boundary was evaluated at approx.  $9.6 \times 10^{-12}$  Bq/cm<sup>3</sup> and  $1.4 \times 10^{-11}$  Bq/cm<sup>3</sup> for Cs-134 and -137 respectively, while the radiation exposure dose due to the release of radioactive materials there was less than 0.00005 mSv/year.

## Annual radiation dose at site boundaries by radioactive materials (cesium) released from Reactor Building Units 1-4

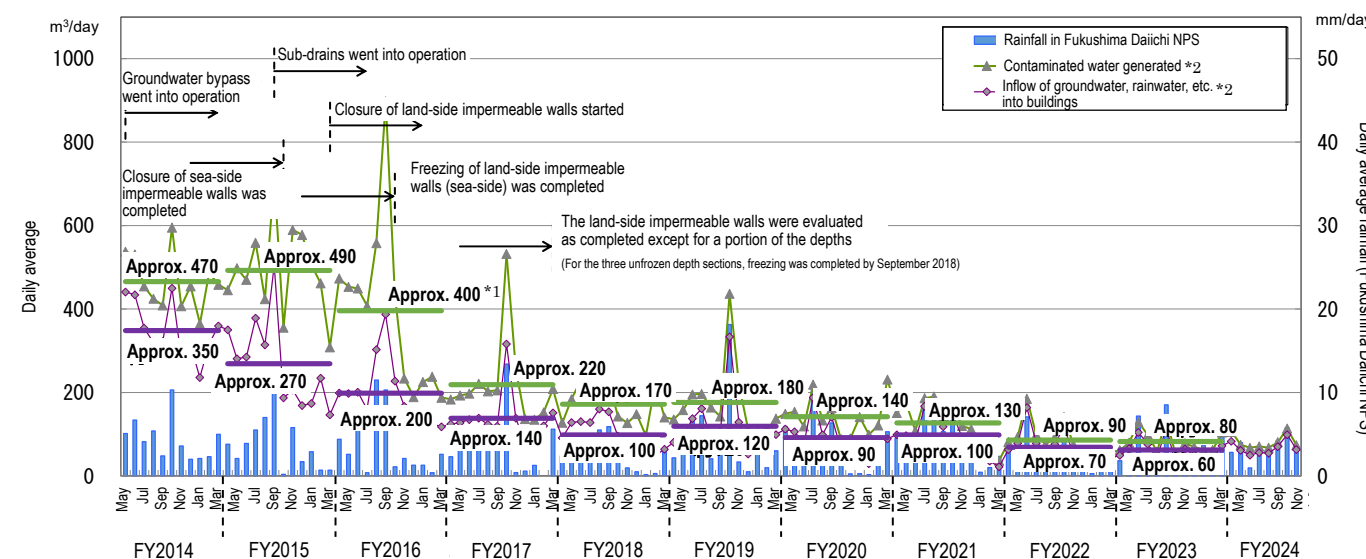
- Multi-layered contaminated water management measures, including land-side impermeable walls and subdrains, have stabilized the groundwater at a low level and the increased contaminated water generated during rainfall is being suppressed by repairing damaged portions of building roofs facing onsite. Through these measures, the generation of contaminated water has been suppressed and reduced from approx. 540 m<sup>3</sup>/day (in May 2014) before implementing measures to approx. 80 m<sup>3</sup>/day (in FY2023), achieving the milestone to “suppress the amount of contaminated water generated to 100 m<sup>3</sup>/day or less during average rainfall within FY2025.”
- Measures will proceed to further reduce the amount of contaminated water generated and suppress to approx. 50-70 m<sup>3</sup>/day by FY2028.

\*1 Values differ from those announced at the 20<sup>th</sup> Committee on Countermeasures for Contaminated Water Treatment (held on August 25, 2017) because the method of calculating the contaminated water volume generated was reviewed on March 1, 2018. Details of the review are described in the materials for the 50<sup>th</sup> and 51<sup>st</sup> meetings of the Secretariat of the Team for Countermeasures for Decommissioning and Contaminated Water Treatment.

\*2: The monthly daily average is derived from the daily average from the previous Thursday to the last Wednesday, which is calculated based on the data measured at 7:00 on every Thursday.

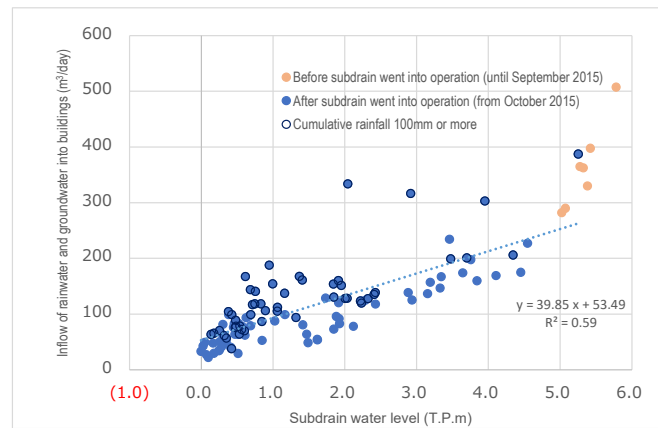
Figure 2: Correlation between inflow such as groundwater and rainwater into buildings and the water level of Units 1-4 subdrains

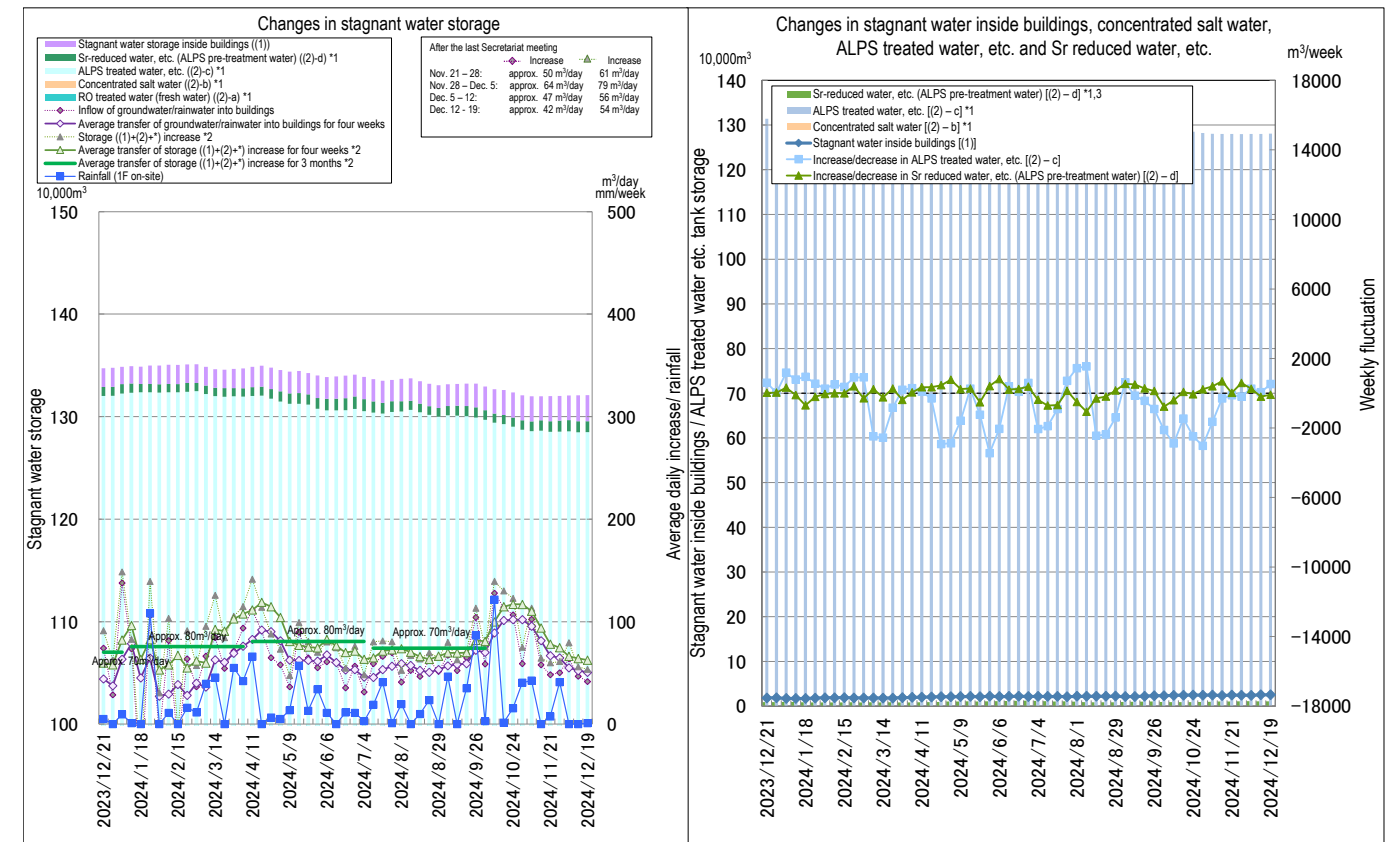
➤ Storage status of stagnant water and amount of ALPS treated water, etc. stored in tanks

- The volume of ALPS-treated water, etc. was approx. 1,283,179 m³ as of December 19, 2024.
- The total volume of ALPS-treated water discharged into the sea since the discharge commenced on August 24 2023 was approx. 78,285 m³ as of December 25 2024.

(1): Stagnant water storage inside buildings (Units 1-4, Process Main Building, High Temperature Incinerator Building, Waste Liquid Supply Tank, SPT (A), SPT (B), Units 1-3 CST, buffer tank)

(2): Units 1-4 tank storage [(2)-a RO-treated water (fresh water)] + [(2)-b Concentrated salt water] + [(2)-c ALPS treated water, etc.] + [(2)-d Sr-reduced water, etc. (ALPS pre-treatment water)]  
 \*: Water amount from tank bottom to water-level gauge 0% (DS)  
 \*1: Water amount for which the water-level gauge indicates 0% or more  
 \*2: Calculated in the method of contaminated water generated [(Inflow of groundwater/rainwater into buildings) + (other transfer) + (chemical injection into ALPS)], amount of ALPS treated water discharged was not taken into account.  
 \*3: Amount of Sr-reduced water and others increased and decreased depending on the operation status of facilities due to clog of the cross-flow filter for the multi-nuclide removal system.

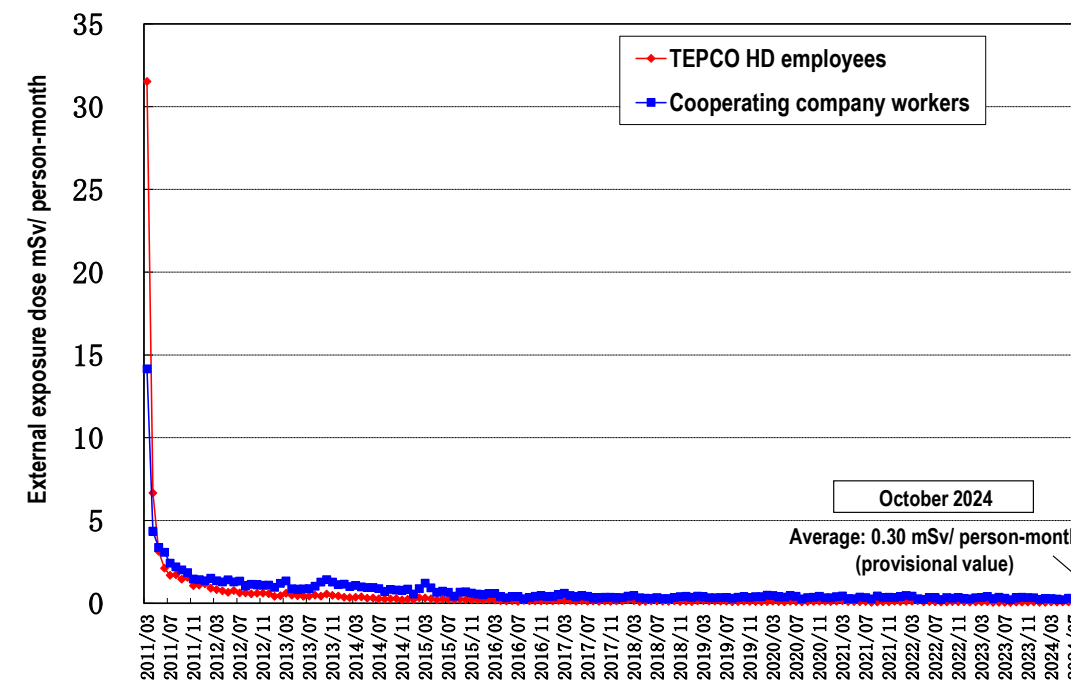
- The average exposure doses of workers were approx. 2.51, 2.16 and 2.18 mSv/person-year during FY2021, 2022 and 2023, respectively (The legal exposure dose limits are 100 and 50 mSv/person-year respectively over five years, the TEPCO HD management target is 20 mSv/person-year).

Figure 7: Changes in monthly average exposure dose of individual worker (monthly exposure dose since March 2011)

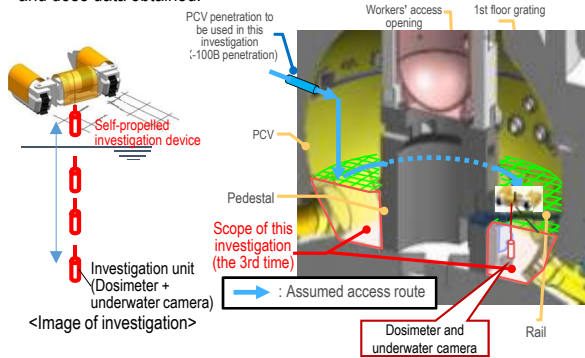
Unit 1 Investigation overview

- In April 2015, a device having entered the inside of the PCV via a narrow opening (bore:φ100 mm) collected information such as images and airborne dose inside the PCV 1st floor.
- In March 2017, an investigation using a self-propelled investigation device was conducted to inspect the spreading of debris to the basement floor outside the pedestal, with images taken of the PCV bottom status for the first time. The conditions inside the PCV will continue to be examined, based on the imagery and dose data obtained.

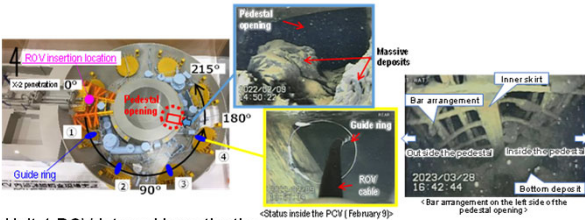
In February 2022, "the guide ring" was installed to facilitate the investigation. From March 28, 2023, the investigation inside the pedestal by ROV-A2 started and confirmed that a portion of the bar arrangement was exposed. Regarding the soundness of the pedestal, based on the past earthquake resistant evaluation by the International Research Institute for Nuclear Decommissioning (IRID), it was evaluated that even though a portion of the pedestal was lost, there would be no serious risk. However, as the present information is very limited, the investigation will continue to acquire as much information as possible for continued evaluation.

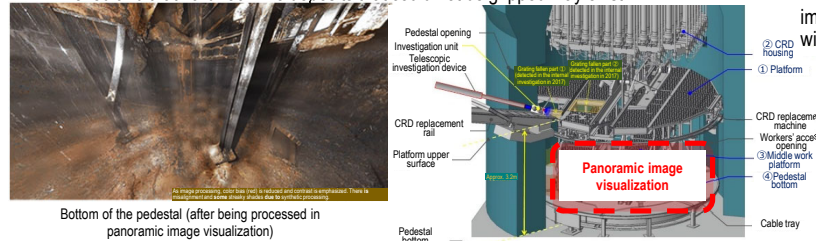
- In January 2017, a camera was inserted from the PCV penetration to inspect the conditions of the rail on which the robot traveled. The results of a series of investigations confirmed some gratings had fallen and deformed as well as a quantity of deposit inside the pedestal.

- In January 2018, the conditions below the platform inside the pedestal were investigated. Based on the analytical results of images obtained in the investigation, deposits, probably including fuel debris, were found at the bottom of the pedestal. Moreover, multiple parts exceeding the surrounding deposits were also detected. We presumed that there were multiple instances of fuel debris falling.

- In February 2019, an investigation touching the deposits at the bottom of the pedestal and on the platform was conducted and confirmed that the pebble-shaped deposits, etc. could be moved and that hard rock-like deposits that could not be gripped may exist.

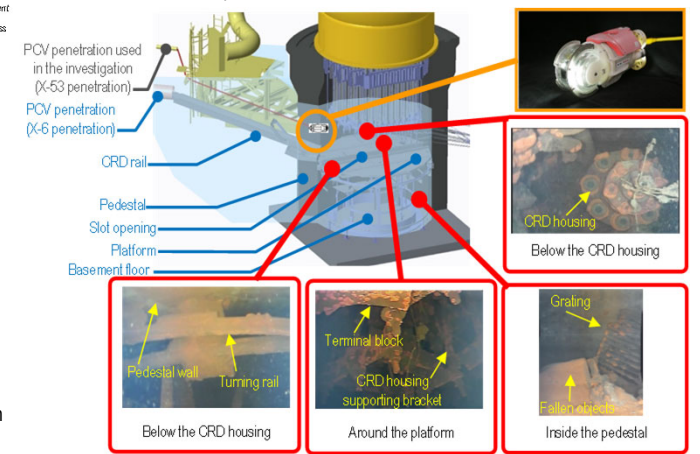
<Conditions inside the pedestal>

- In July 2017, the inside of the PCV was investigated using the underwater ROV (remotely operated underwater vehicle) to inspect the inside of the pedestal. Analysis of the imagery obtained in the investigation identified damage to multiple structures and the supposed core internals.

- Videos obtained in the investigation were reproduced in 3D. Based on the reproduced images, the relative positions of the structures, such as the rotating platform slipping off the rail with a portion buried in deposits, were visually understood.

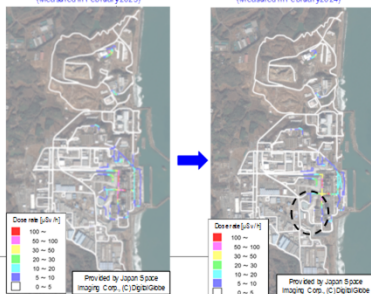
<p>&lt;Travel survey results of major roads within the site&gt;</p> <p>It was confirmed that compared with the last fiscal year, the dose rate has been declining on roads on the west and south sides of the High Temperature Incinerator Building (area circled by black dot line).</p> <p>&lt;FY2022 4th Quarter&gt;                  (Measured in February 2023)</p> <p>&lt;FY2023 4th Quarter&gt;                  (Measured in February 2024)</p>
