Main decommissioning work and steps

Progress status

I. Confirmation of the reactor conditions

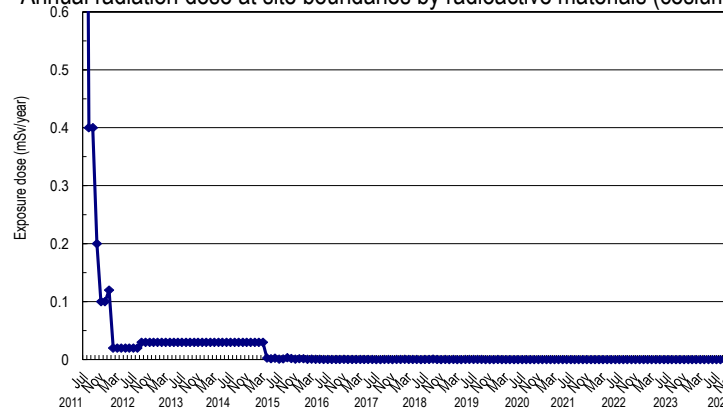
Annual radiation dose at site boundaries by radioactive materials (cesium) released from Reactor Building Units 1-4

As of December 2024, the concentration of radioactive materials newly released from Reactor Building Units 1-4 into the air and measured at the site boundary was evaluated at approx. 7.5×10^{-12} Bq/cm³ and 1.3×10^{-11} Bq/cm³ for Cs-134 and -137 respectively, while the radiation exposure dose due to the release of radioactive materials there was less than 0.00004 mSv/year.
