Main decommissioning work and steps

Progress status

I. Confirmation of the reactor conditions

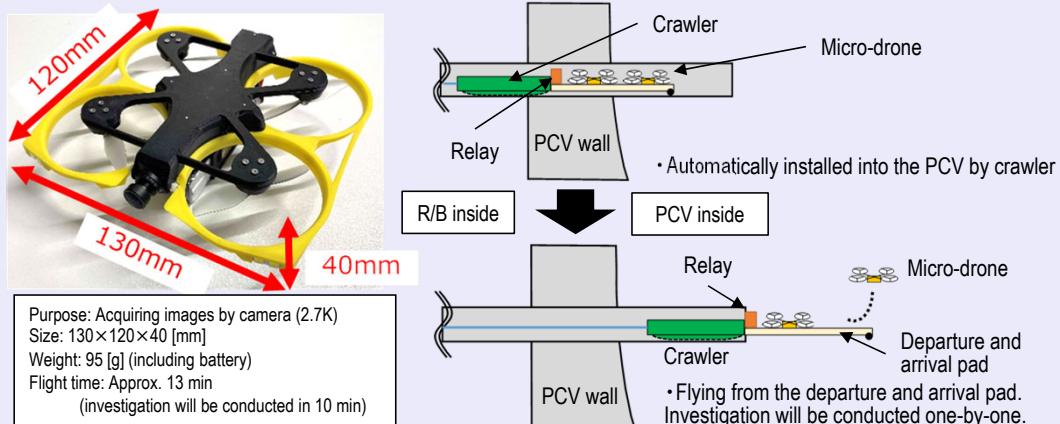
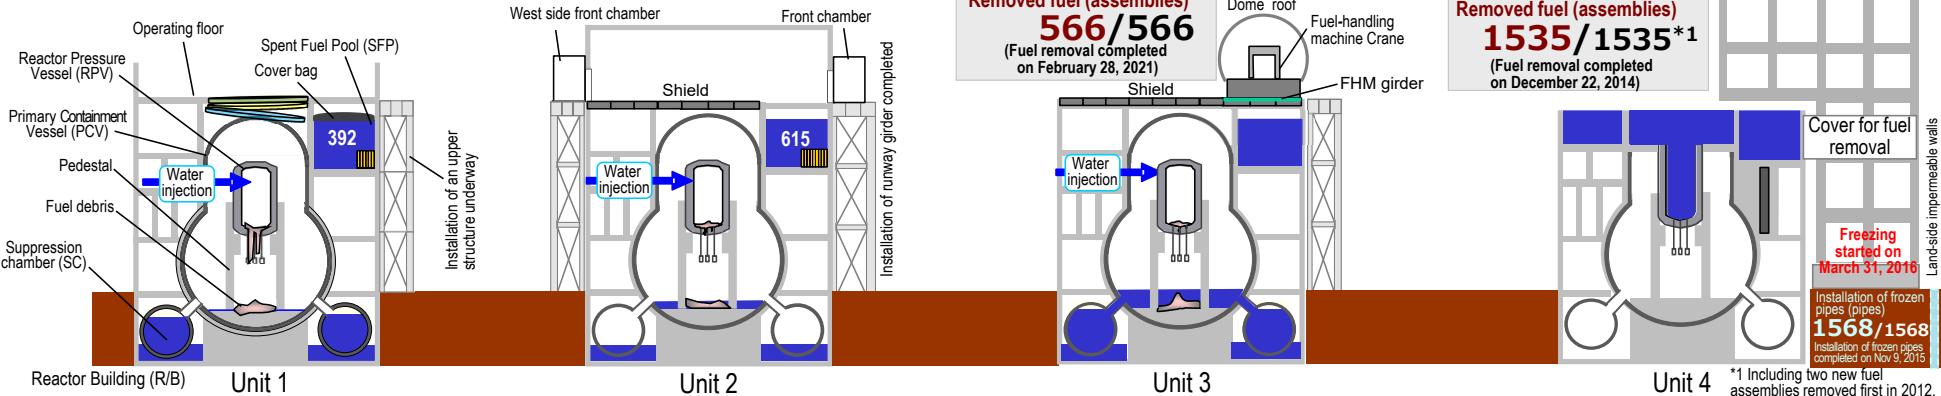
Among existing available penetrations, using a small diameter penetration of X-53, the inside of the PCV will be accessed.

To match the small-diameter X-53 penetration, an investigation inside the PCV using an "ultra-small" but "highly maneuverable" "micro-drone" with high "photographic ability" is planned.

In this investigation, within the scope where the micro-drone can fly, work to acquire images inside the D/W 1FL and the pedestal is planned. In particular, the main purpose is information collection around X-6 penetration and inside the pedestal which are important for future investigation and horizontal access to fuel debris retrieval. Moreover, as in the drone investigation in Unit 1, work to acquire point cloud data from images and estimate the dose rate using radiation noise is scheduled.

Unit 3 Aerial investigation (by micro-drone) inside PCV

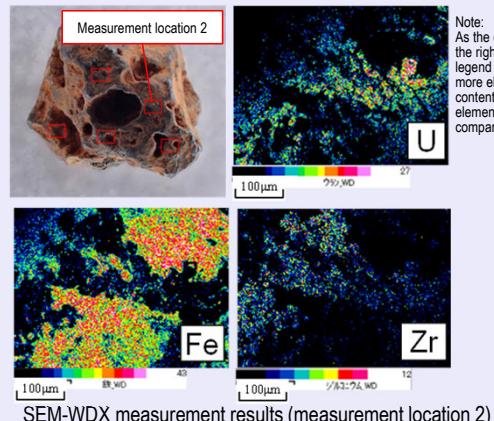
This is the report on the results of the non-destructive analysis (X-ray CT and SEM-WDX) and preparative results.

The X-ray CT measurement results confirmed non-uniform CT values and the fact that space-like openings were distributed widely.

The results of the SEM-WDX measurement showed that U was distributed widely on the surface and from any perspective, U, Zr, Fe, Cr, Ni and O were detected, but Si, Ca, Al and others, which were detected in the 1st sampling were not detected.

Note:
As the color towards the right side of the legend indicates more element contents between elements cannot be compared.

Results of the non-destructive analysis of the fuel debris sample (2nd) (update)

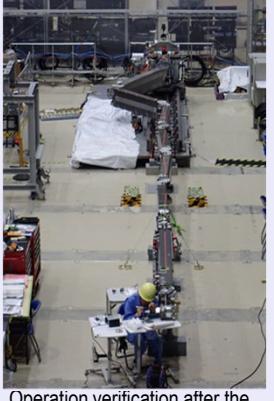
Regarding the robot arm, based on the age-related deterioration of parts detected during the test, an overall inspection, including replacement of cables inside the arm and similar parts, was conducted. Replacement of cables inside the arm was completed and the overall inspection of the robot arm was completed as planned. The next phase will involve operational verification after the overall inspection.

Conversely, in response to the problems affecting the camera of the telescopic device, a radiation test was conducted on the camera to be mounted on the robot arm. The result showed the presence of a camera of which the radiation resistance, as mentioned in the manufacturer's specifications, could not be confirmed under conditions harsher than those of the on-site environment. The radiation test of the camera will continue to examine the response and scrutinize the entire process.

Unit 2 Status of investigation inside the PCV and trial retrieval

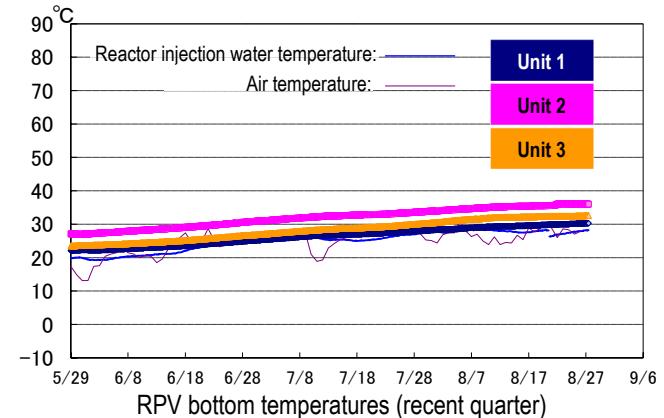
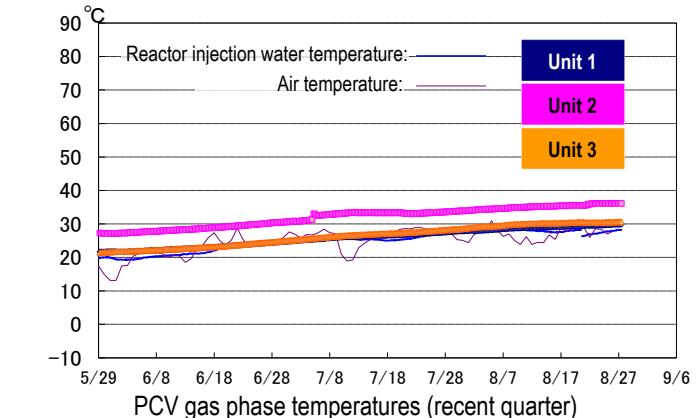
Temperatures inside the reactors

Through continuous reactor cooling by water injection, the temperatures of the Reactor Pressure Vessel (RPV) bottom and the Primary Containment Vessel (PCV) gas phase were maintained as shown below for recent, though they varied depending on the unit and location of the thermometer.

*1 The trend graphs show part of the temperature data measured at multiple points.

*2 A part of data could not be measured due to maintenance and inspection of the facility and other work.

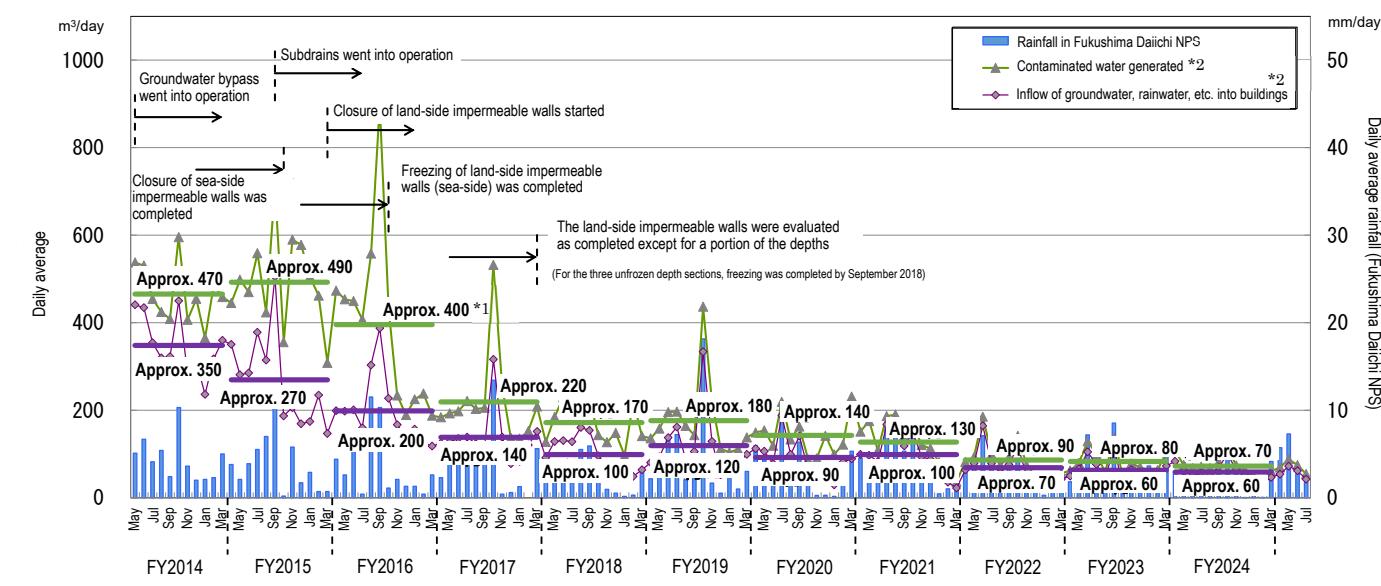
Figure 1: Changes in contaminated water generated and inflow of groundwater and rainwater into buildings

- Multi-layered contaminated water management measures, including land-side impermeable walls and subdrains, have stabilized the groundwater at a low level and the increased contaminated water generated during rainfall is being suppressed by repairing damaged portions of building roofs facing onsite. Through these measures, the generation of contaminated water has been suppressed and reduced from approx. 540 m³/day (in May 2014) before implementing measures to approx. 70 m³/day (in FY2024). It was confirmed that the milestone of “suppressing the amount of contaminated water generated to 100 m³/day or less during average rainfall within FY2025,” which was achieved in FY2023, has been maintained in FY2024.
- Measures will proceed to further reduce the amount of contaminated water generated and suppress to approx. 50-70 m³/day by FY2028.

*1 Values differ from those announced at the 20th Committee on Countermeasures for Contaminated Water Treatment (held on August 25, 2017) because the method of calculating the contaminated water volume generated was reviewed on March 1, 2018. Details of the review are described in the materials for the 50th and 51st meetings of the Secretariat of the Team for Countermeasures for Decommissioning and Contaminated Water Treatment.

*2: The monthly daily average is derived from the daily average from the previous Thursday to the last Wednesday, which is calculated based on the data measured at 7:00 on every Thursday

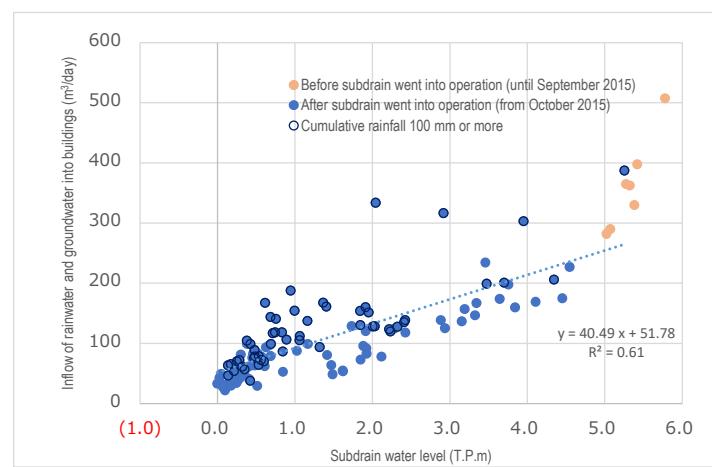
Figure 2: Correlation between inflow such as groundwater and rainwater into buildings and the water level of Units 1-4 subdrains

- At the Water-Treatment Facility Special for Subdrains & Groundwater drains, release started from September 14, 2015, and up until August 19, 2025, 2753 release operations had been conducted.

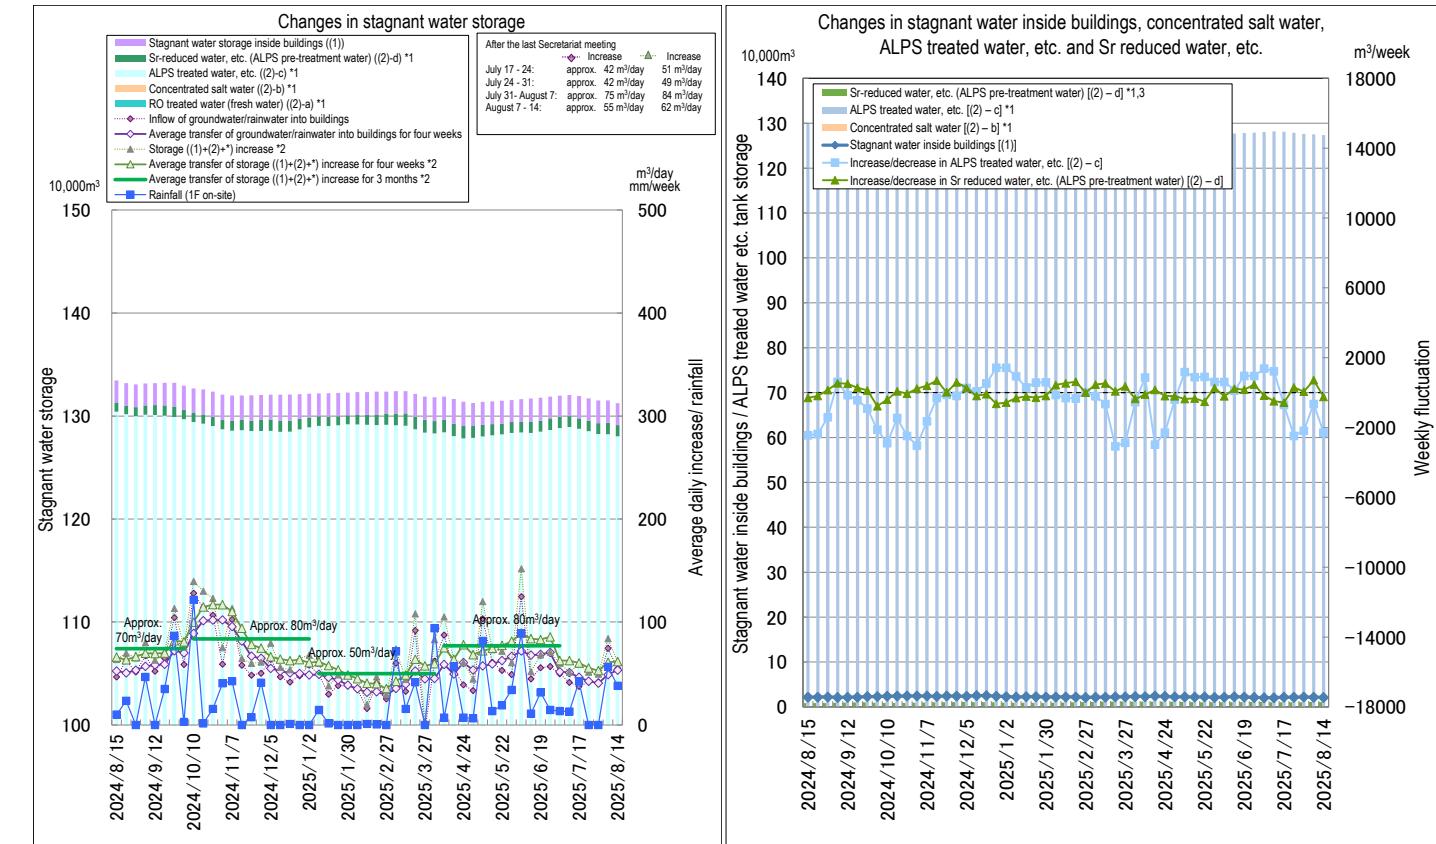
Figure 3: Status of stagnant water storage

- The volume of ALPS treated water, etc. was approx. 1,275,697 m³ as of August 14, 2025.
- The total volume of ALPS treated water discharged into the sea since the discharge commenced on August 24, 2023, was approx. 109,778 m³ as of the completion of the third discharge in FY2025.

(1): Stagnant water storage inside buildings (Units 1-4, Process Main Building, High Temperature Incinerator Building, Waste Liquid Supply Tank, SPT (A), SPT (B), Units 1-3 CST, buffer tank)

(2): Units 1-4 tank storage [(2)-a RO-treated water (fresh water)] + [(2)-b Concentrated salt water] + [(2)-c ALPS treated water, etc.] + [(2)-d Sr-reduced water, etc. (ALPS pre-treatment water)]
 *: Water amount from tank bottom to water-level gauge 0% (DS)
 *1: Water amount for which the water-level gauge indicates 0% or more
 *2: Calculated in the method of contaminated water generated [(Inflow of groundwater/rainwater into buildings) + (other transfer) + (chemical injection into ALPS)], amount of ALPS treated water discharged was not taken into account.
 *3: Amount of Sr-reduced water and others increased and decreased depending on the operation status of facilities due to clog of the cross-flow filter for the multi-nuclide removal system.

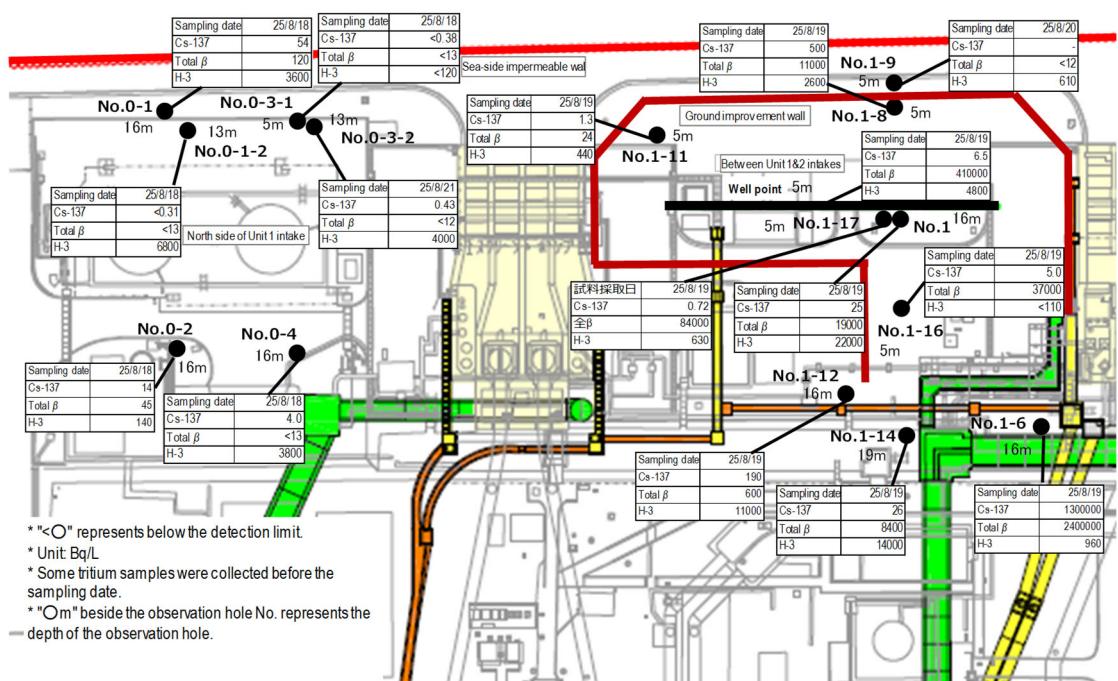
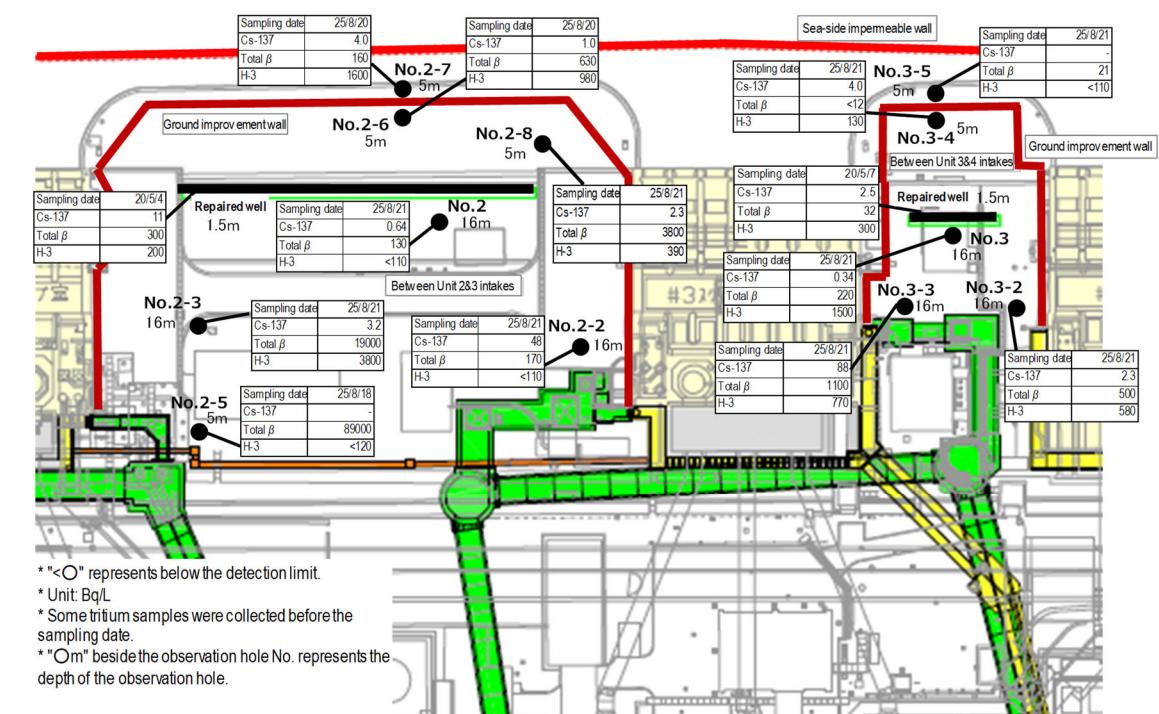
Figure 4: Groundwater concentration on the Turbine Building east side

<Unit 1 intake north side, between Unit 1 and 2 intakes>

<Between Unit 2 and 3 intakes, between Unit 3 and 4 intakes>

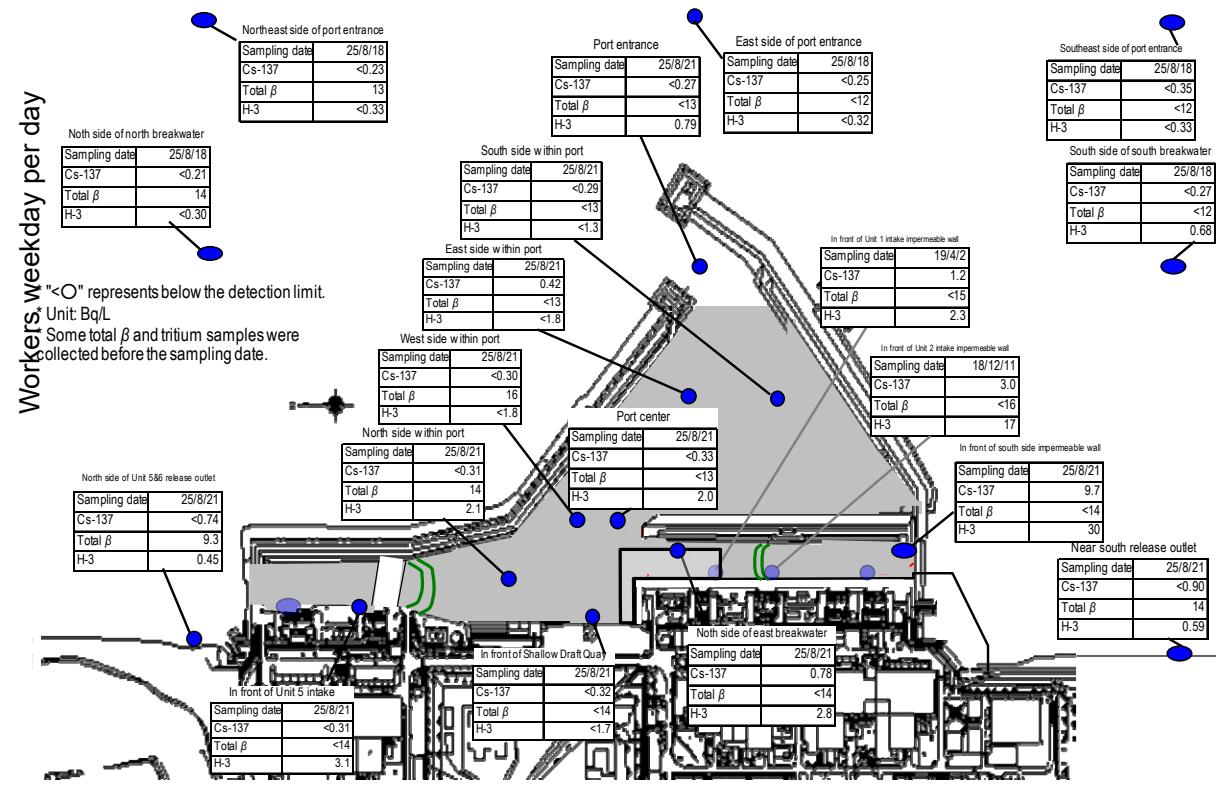
Figure 5: Seawater concentration around the port

- In the open channel area of the seawater intake for Units 1 to 4, the concentration of radioactive materials in seawater has remained below the legal discharge limit and been declining long term, despite the temporary increases in Cs-137 and Sr-90 observed during rainfall. They have also been declining following the completed installation and the connection of steel pipe sheet piles for the sea-side impermeable walls. The concentration of Cs-137 remained slightly higher in front of the south-side impermeable walls and slightly lower on the north side of the east breakwater since March 20, 2019, when the silt fence was transferred to the center of the open channel due to mega float-related construction.

- In the port area, the concentration of radioactive materials in seawater has remained below the legal discharge limit and been declining long term, despite temporary increases in Cs-137 and Sr-90 observed during rainfall. They have remained below the level of those in the Units 1-4 intake open channel area and been declining following the completed installation and connection of steel pipe sheet piles for the sea-side impermeable walls.

- In the area outside the port, regarding the concentration of radioactive materials in seawater, those of Cs-137 and Sr-90 declined and remained low after steel pipe sheet piles for the sea-side impermeable walls were installed and connected. Regarding the concentration of Cs-137, a temporary increase was sometimes observed on the north side of the Units 5 and 6 outlets and near the south outlet due to the influence of weather, marine meteorology and other factors. Regarding the concentration of Sr-90, variation was observed in FY2021 in the area outside the port (north and south outlets). Monitoring of the tendency continues, including the potential influence of weather, marine meteorology and others. During the period for which ALPS treated water was discharged, the tritium concentration increased at the sampling point near the discharge outlet, but this was considered within the assumed range based on the oceanic dispersion simulation results.

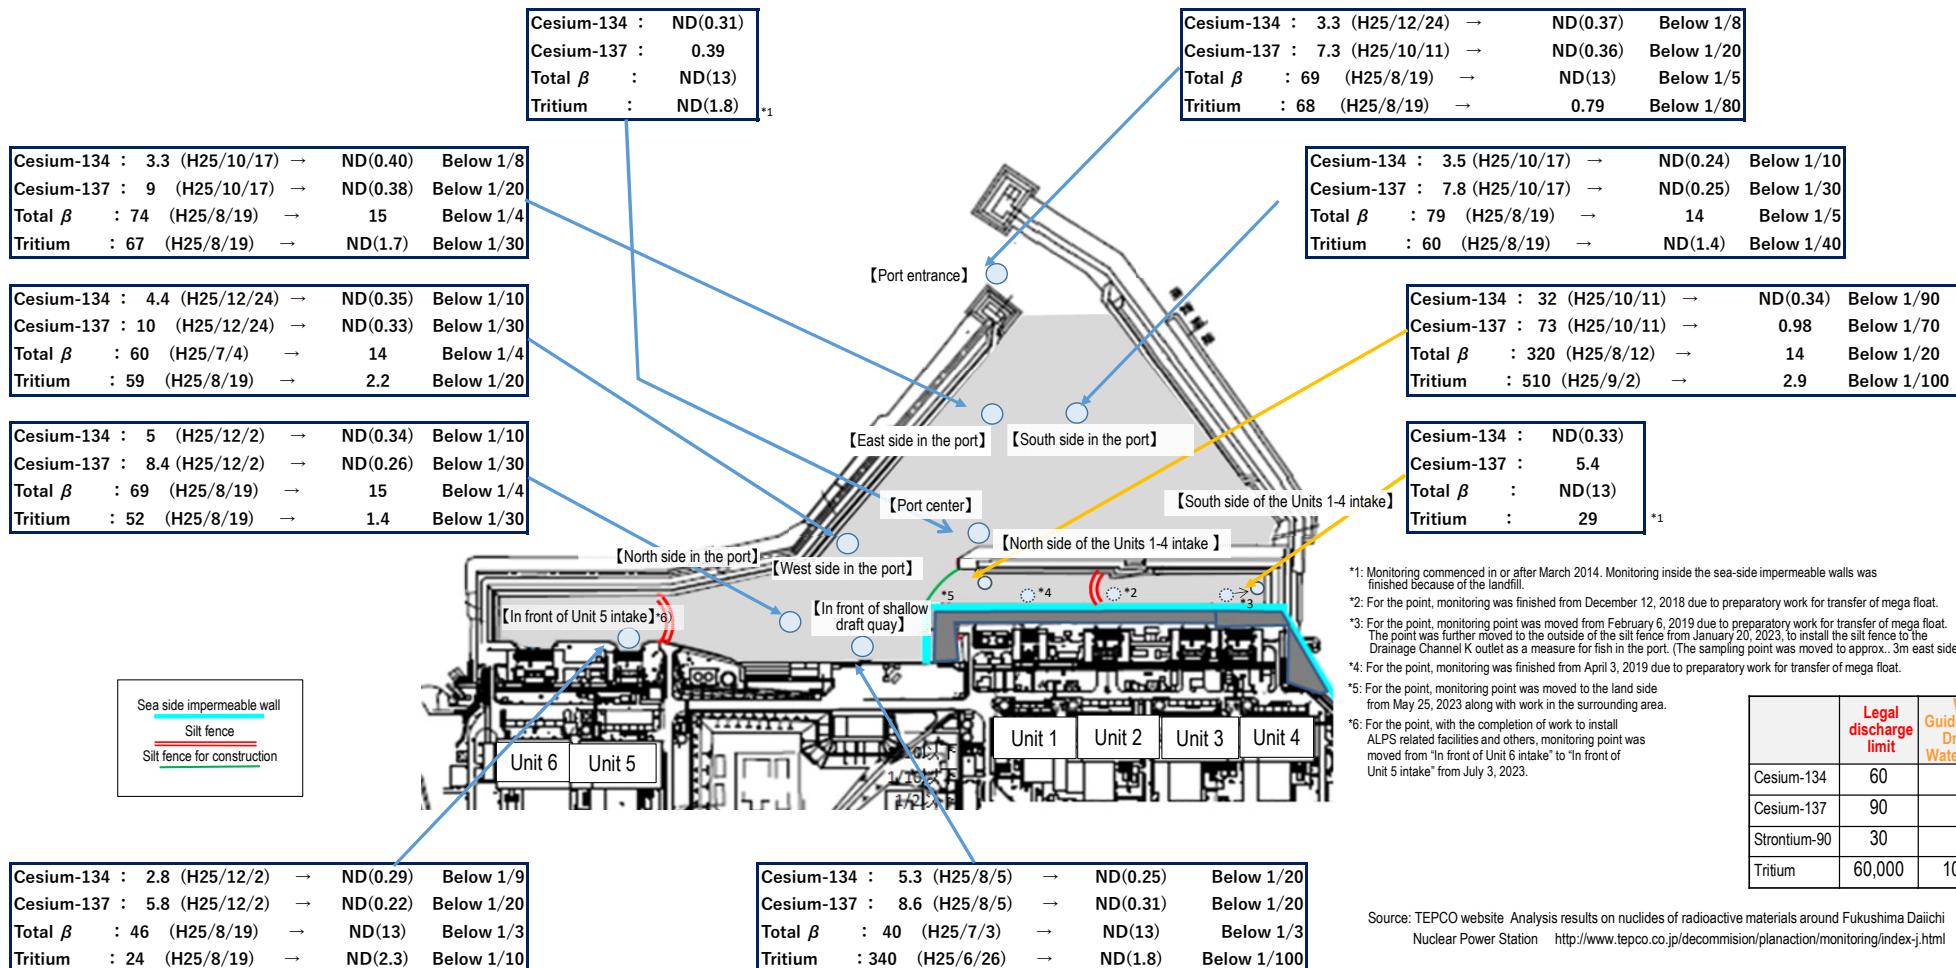
Status of seawater monitoring within the port (comparison between the highest values in 2013 and the latest values)

"The highest value" → "the latest value (sampled during August 4 - 25)"; unit (Bq/L); ND represents a value below the detection limit

Note: The Total β measurement value is the total radioactivity concentration of radioactive materials that emit β -ray (Potassium-40, Cesium-137, Strontium-90, progeny nuclide Yttrium-90, etc.). In general, approx. 12 Bq/L of natural nuclide Potassium-40 is included in seawater.

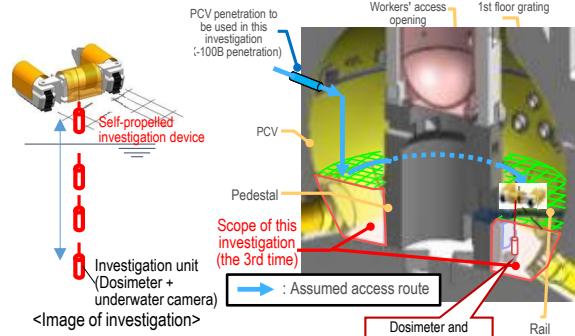
- In April 2015, a device having entered the inside of the PCV via a narrow opening (bore: $\phi 100$ mm) collected information such as images and airborne dose inside the PCV 1st floor.
- In March 2017, an investigation using a self-propelled investigation device was conducted to inspect the spreading of debris to the basement floor outside the pedestal, with images taken of the PCV bottom status for the first time. The conditions inside the PCV will continue to be examined, based on the imagery and dose data obtained.

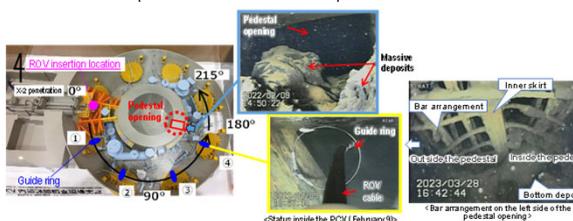
**Unit 1 PCV internal investigation**

In February 2022, "the guide ring" was installed to facilitate the investigation. From March 28, 2023, the investigation inside the pedestal by ROV-A2 started and confirmed that a portion of the bar arrangement was exposed. Regarding the soundness of the pedestal, based on the past earthquake resistant evaluation by the International Research Institute for Nuclear Decommissioning (IRID), it was evaluated that even though a portion of the pedestal was lost, there would be no serious risk. However, as the present information is very limited, the investigation will continue to acquire as much information as possible for continued evaluation.

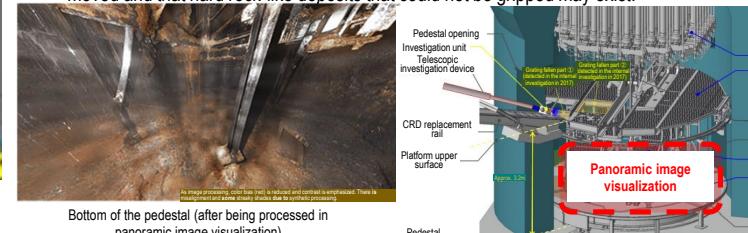
- In January 2017, a camera was inserted from the PCV penetration to inspect the conditions of the rail on which the robot traveled. The results of a series of investigations confirmed some gratings had fallen and deformed as well as a quantity of deposit inside the pedestal.

- In January 2018, the conditions below the platform inside the pedestal were investigated. Based on the analytical results of images obtained in the investigation, deposits, probably including fuel debris, were found at the bottom of the pedestal. Moreover, multiple parts exceeding the surrounding deposits were also detected. We presumed that there were multiple instances of fuel debris falling.

- In February 2019, an investigation touching the deposits at the bottom of the pedestal and on the platform was conducted and confirmed that the pebble-shaped deposits, etc. could be moved and that hard rock-like deposits that could not be gripped may exist.

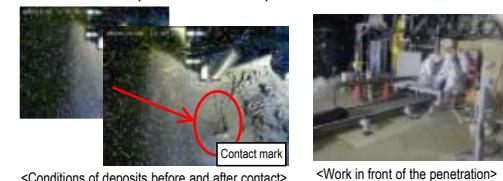
- From September 10, 2024, the end tool of the telescopic equipment passed through the isolation valve, and the trial fuel debris retrieval commenced. On October 30, fuel debris was gripped with the end tool, on November 2, the guide pipe was pulled off, and the telescopic equipment was stored in the enclosure. On November 7, fuel debris was carried out from the hatch on a side of the enclosure, and the trial retrieval was completed.

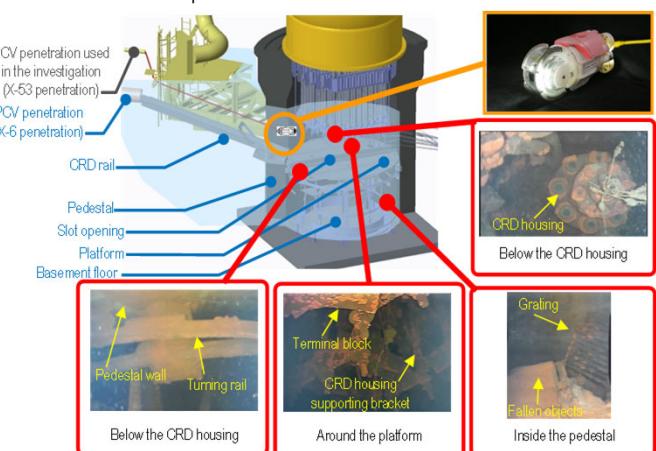
<Conditions inside the pedestal>

- In July 2017, the inside of the PCV was investigated using the underwater ROV (remotely operated underwater vehicle) to inspect the inside of the pedestal. Analysis of the imagery obtained in the investigation identified damage to multiple structures and the supposed core internals.

- Videos obtained in the investigation were reproduced in 3D. Based on the reproduced images, the relative positions of the structures, such as the rotating platform slipping off the rail with a portion buried in deposits, were visually understood.

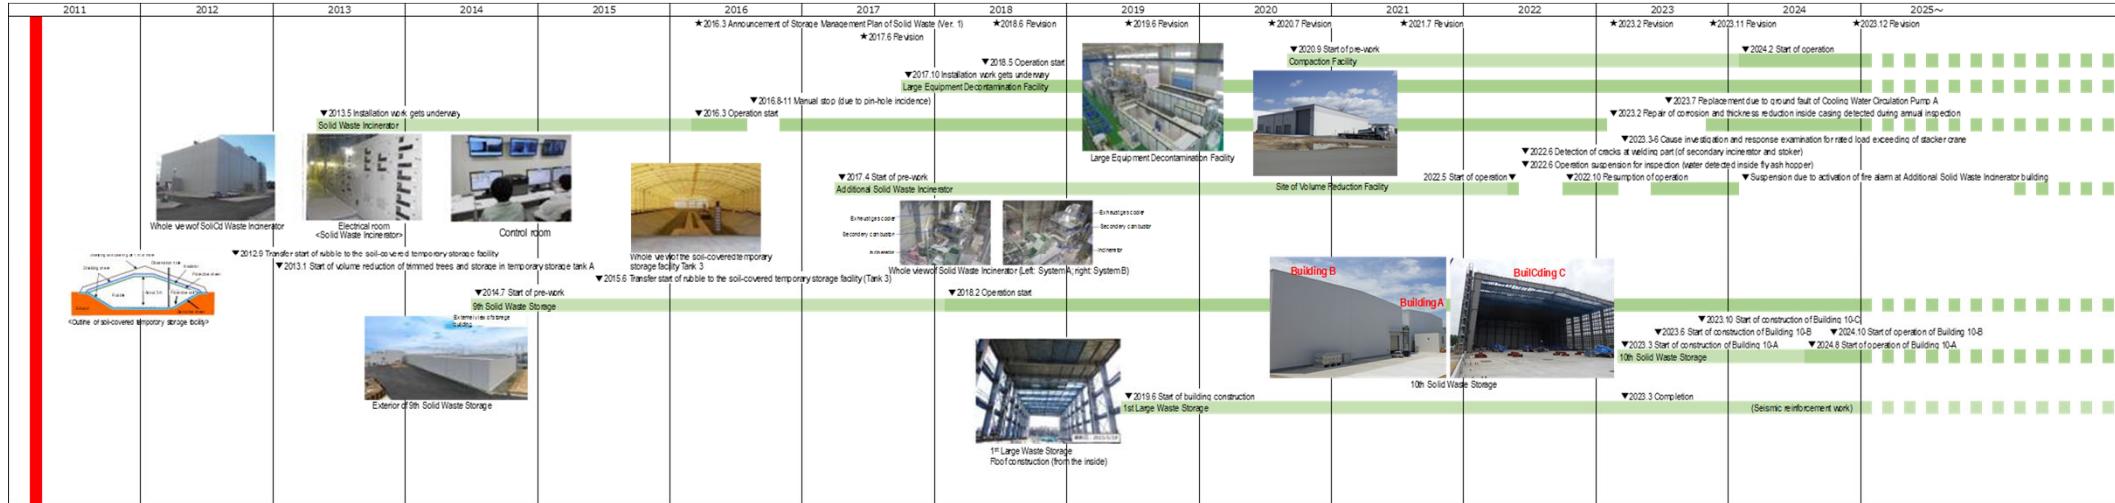
Eliminating temporary outdoor storage of rubble and others * Except for secondary waste of water treatment and materials for reuse or recycling (within FY2028)

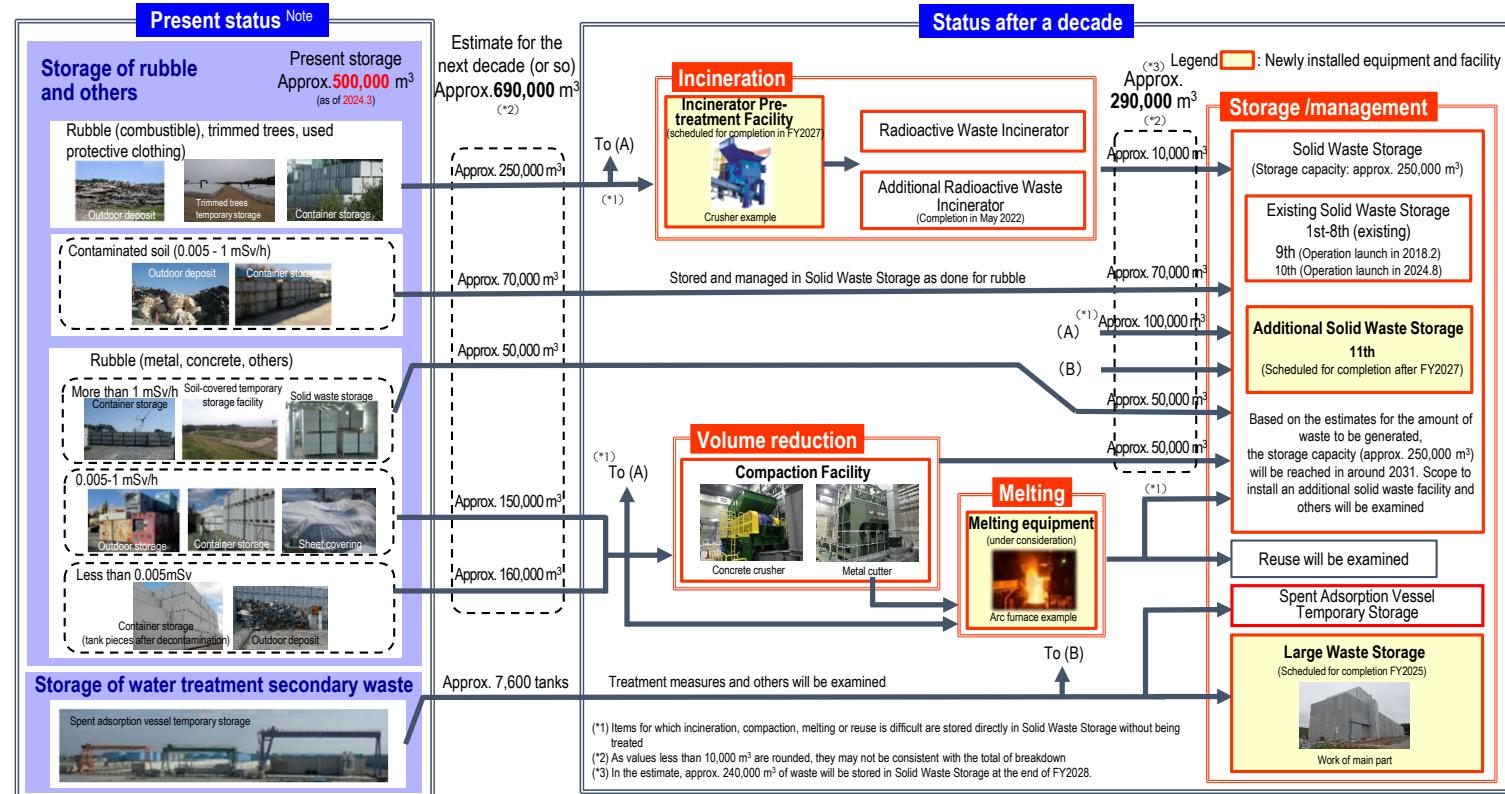
- Solid Waste Storage Management Plan for the Fukushima Daiichi Nuclear Power Station (Revision in December 2024)
