Main decommissioning work and steps

Progress status

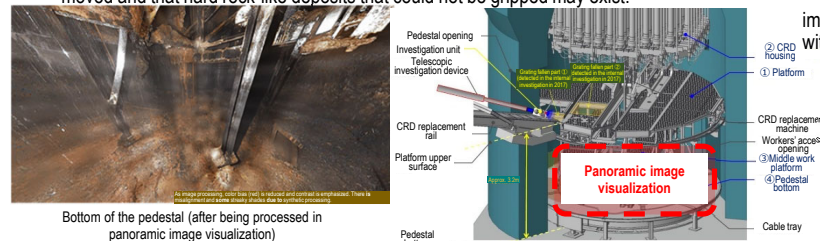
- In January 2017, a camera was inserted from the PCV penetration to inspect the conditions of the rail on which the robot traveled. The results of a series of investigations confirmed some gratings had fallen and deformed as well as a quantity of deposit inside the pedestal.

- In January 2018, the conditions below the platform inside the pedestal were investigated. Based on the analytical results of images obtained in the investigation, deposits, probably including fuel debris, were found at the bottom of the pedestal. Moreover, multiple parts exceeding the surrounding deposits were also detected. We presumed that there were multiple instances of fuel debris falling.

- In February 2019, an investigation touching the deposits at the bottom of the pedestal and on the platform was conducted and confirmed that the pebble-shaped deposits, etc. could be moved and that hard rock-like deposits that could not be gripped may exist.
