Measures pertaining to the fish inside the port at the Fukushima Daiichi Nuclear Power Station

1. Main installation work

for the net to prevent the fish from leaving at the East sea wall

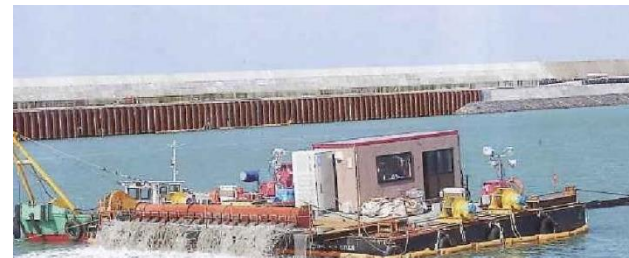
Diagram 2. Covering using a uni-float barge (sand covering/soil covering)

Before covering the seabed soil using cement based material, sand mixed with seawater will be scattered from a uni-float barge to prevent the sand from lifting.

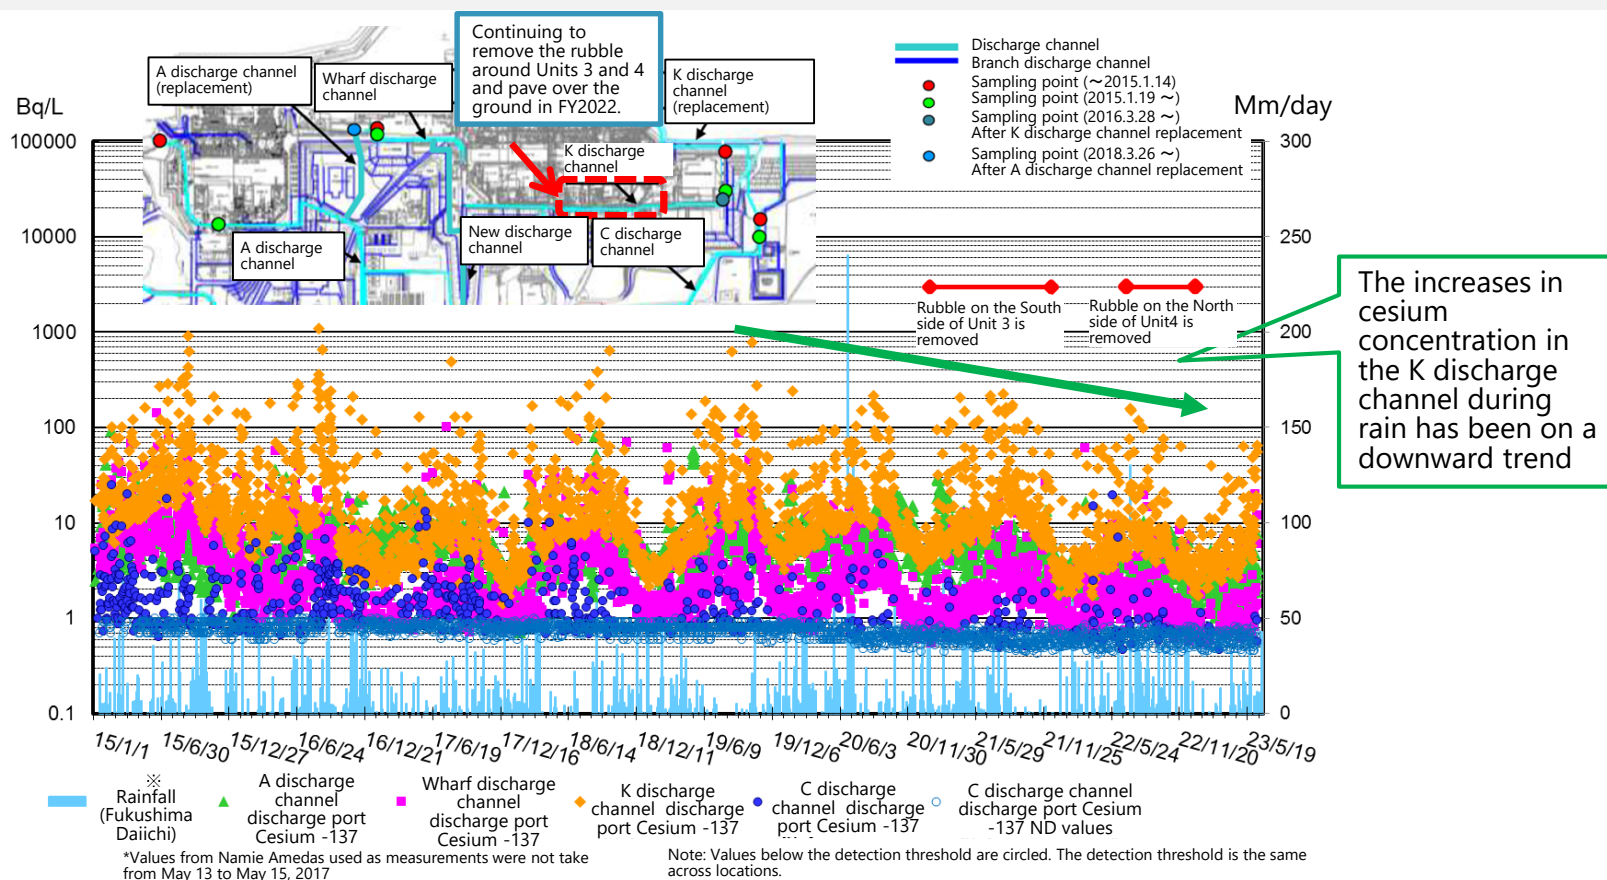
Diagram 1. Cesium 137 concentration in the discharge channel

- Measures to reduce the amount of cesium that flows into the port from the K discharge channel continue to be implemented as part of the environmental improvement in the port measures. As a result, increases in cesium concentration during rain has been on a downward trend.
- Progress continues to be made in these measures in FY2023, for example, through removing the rubble around the Unit 3 turbine building shed and paving over the west side of the Unit 3.
- With the aim of reducing the cesium concentration of seawater in the Units 1-4 intake open channel will be below 1 Bq/L, we will work to reduce the concentration in K discharge channel by considering to move up the schedule for the rubble removal from around Units 1-4 and paving the ground, and implement measures to reduce the outflow of sand.**

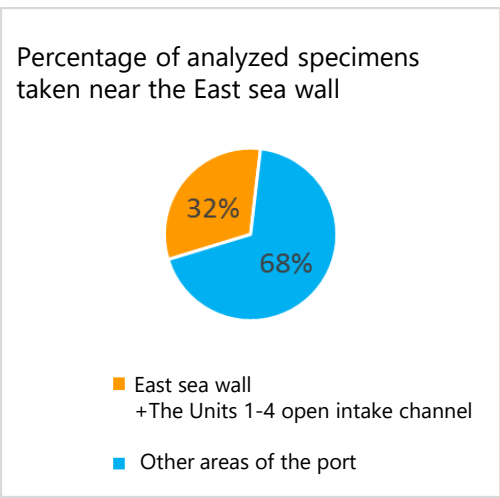
Diagram Percentage of specimens taken and specimens exceeding 100 Bq/L taken around the East sea wall

- Following increased efforts to catch the fish in the port implemented in February 2022 and onward, the number of specimens caught and analyzed has increased significantly from 88 in FY2021 to 415 in FY2022. The number of specimens analyzed with cesium concentrations exceeding 100 Bq/L has also increased accordingly.
- The trend of a higher number of fish with a cesium concentration exceeding 100 Bq/kg coming from near the East sea wall and the Units 1-4 intake open channel continued from FY2021 to FY2022. In particular, the cesium concentration of all of the fish caught inside the Units 1-4 intake open channel exceeded 100 Bq/L.
- We will continue to strengthen our efforts to catch fish by improving upon catching methods and adding nets.
