**Measures pertaining to the fish inside the port at the Fukushima Daiichi Nuclear Power Station (planned commencement of construction for main installation work for the net to prevent the fish from leaving at the East sea wall, etc.)**

<Reference Material>  
July 24, 2023  
TEPCO Holdings  
Fukushima Daiichi  
D&D Engineering Company

## 2. Main installation (replacement) work for the net to prevent the fish from leaving at the East sea wall etc,

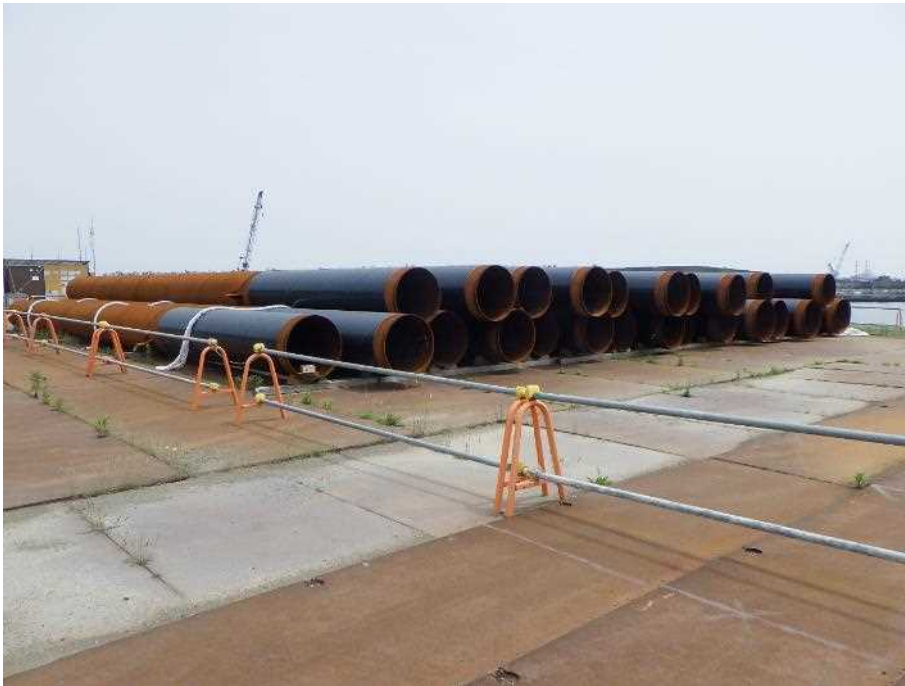
Figure 1. Steel pipe piles (Temporary placement on site)

- May 13: Steel pipe piles brought on to the Fukushima Daiichi site (near the unloading wharf)
- July 18: Construction ship enters the Fukushima Daiichi Port (unloading wharf)

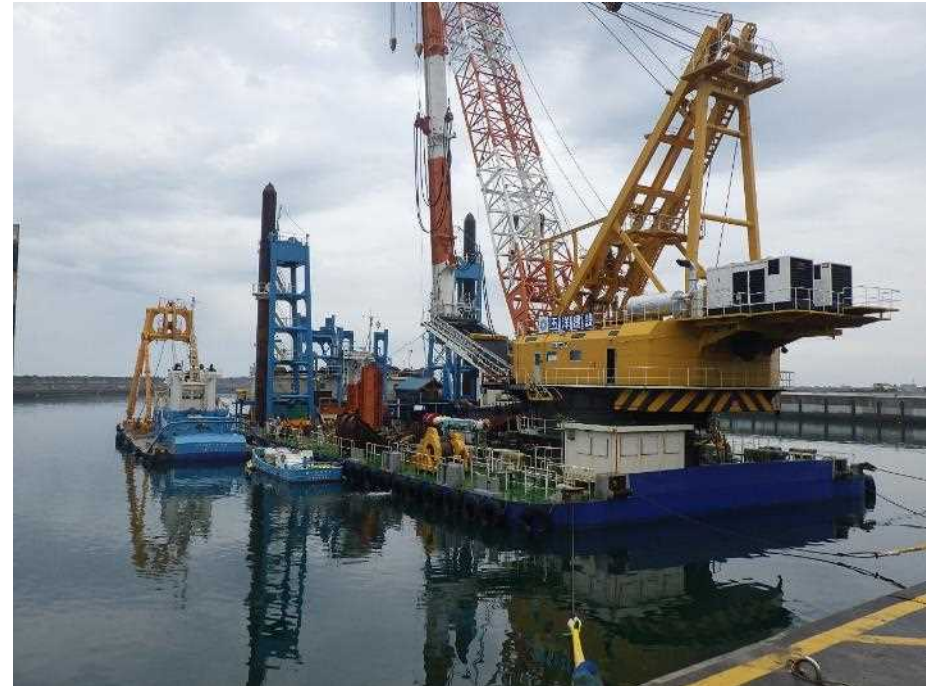
Figure 2. Construction ship (moored at the unloading wharf)

■ Construction ship specifications

L:62m×H:25m

Maximum height of piledriver from sea surface: 63m

Displacement at full capacity: Approx. 3,000 tons

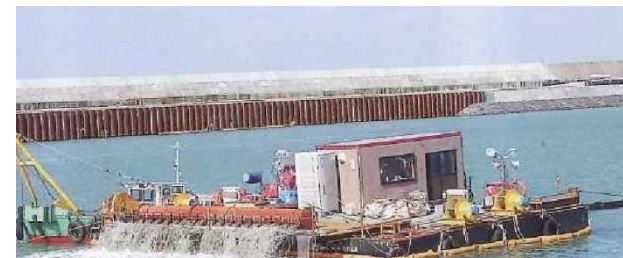
Diagram 2. Covering using a uni-float barge (sand covering/soil covering)

Before covering the seabed soil using cement based material, sand mixed with seawater will be scattered from a uni-float barge to prevent the sand from lifting.

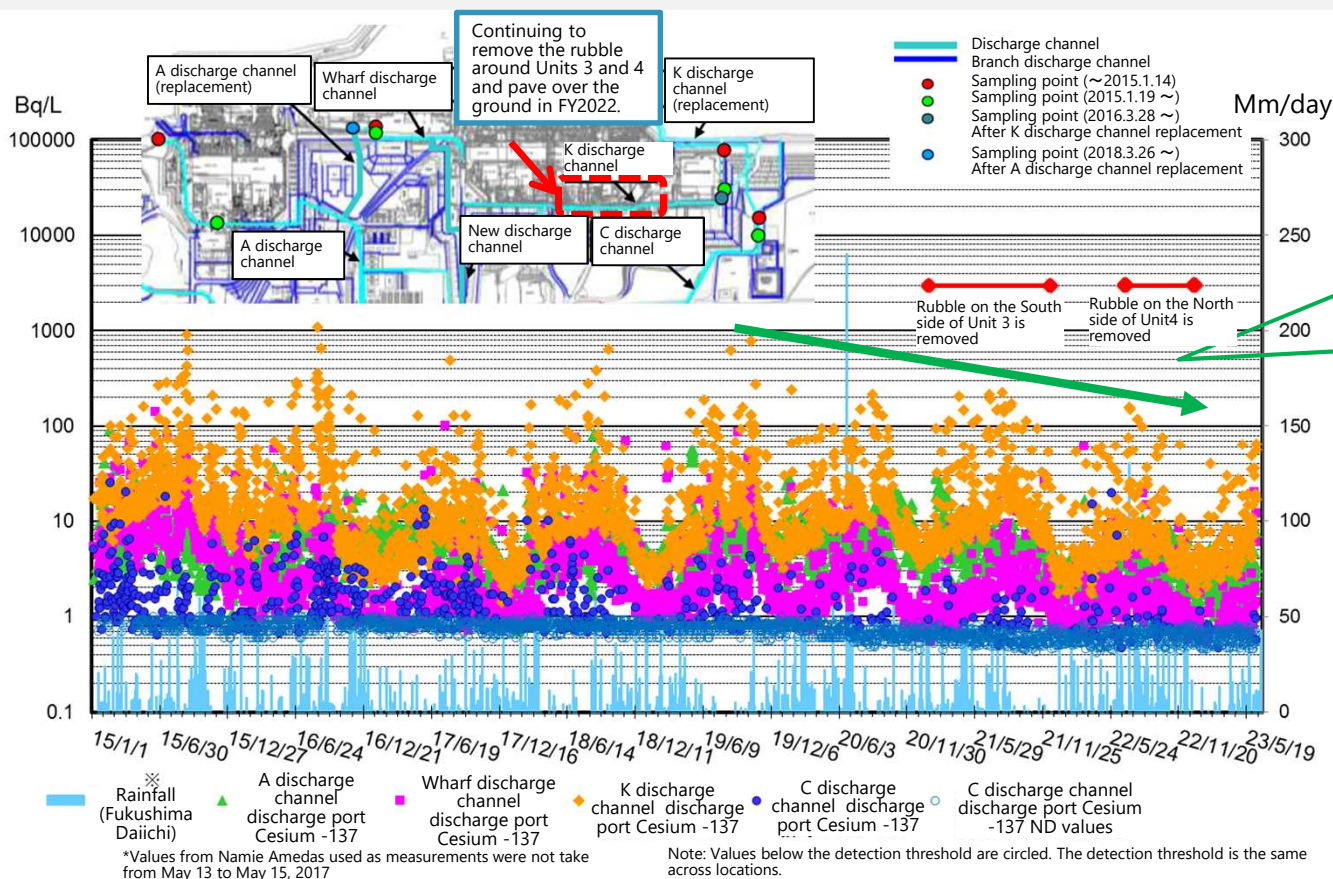
Diagram 1. Cesium 137 concentration in the discharge channel

- Measures to reduce the amount of cesium that flows into the port from the K discharge channel continue to be implemented as part of the environmental improvement in the port measures. As a result, increases in cesium concentration during rain has been on a downward trend.
- Progress continues to be made in these measures in FY2023, for example, through removing the rubble around the Unit 3 turbine building shed and paving over the west side of the Unit 3.
- With the aim of reducing the cesium concentration of seawater in the Units 1-4 intake open channel will be below 1 Bq/L, we will work to reduce the concentration in K discharge channel by considering to move up the schedule for the rubble removal from around Units 1-4 and paving the ground, and implement measures to reduce the outflow of sand.**

The increases in cesium concentration in the K discharge channel during rain has been on a downward trend
