**Measures pertaining to the fish inside the port at the Fukushima Daiichi Nuclear Power Station  
(Progress of construction for main installation work for the net to prevent the fish from leaving at the east sea wall,  
and the commencement of re-cover of the seabed soil in units 1-4 intake open channel, etc. )**

< Reference document >  
October 13, 2023  
Tokyo Electric Power Company Holdings, Inc.  
Fukushima Daiichi Decontamination and  
Decommissioning Engineering Company

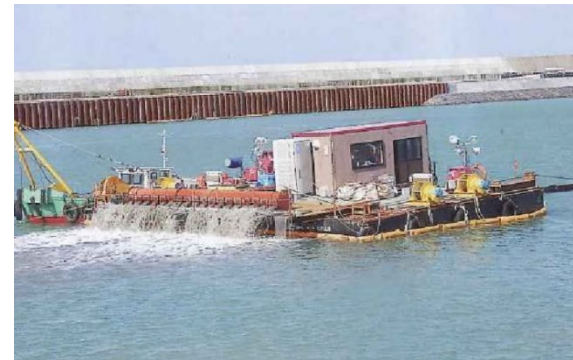
**Figure 3. Using a uni-float barge for sand overlaying work**

The uni-float barge is brought from land and assembled inside the Units 1-4 intake open channel.

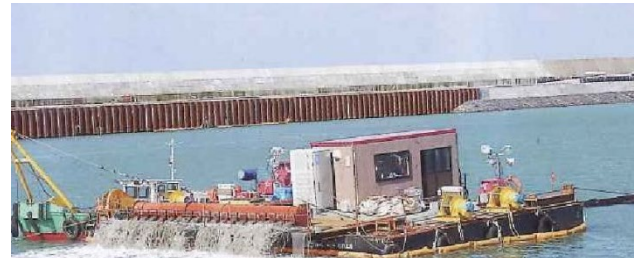
Diagram 2. Covering using a uni-float barge (sand covering/soil covering)

Before covering the seabed soil using cement based material, sand mixed with seawater will be scattered from a uni-float barge to prevent the sand from lifting.

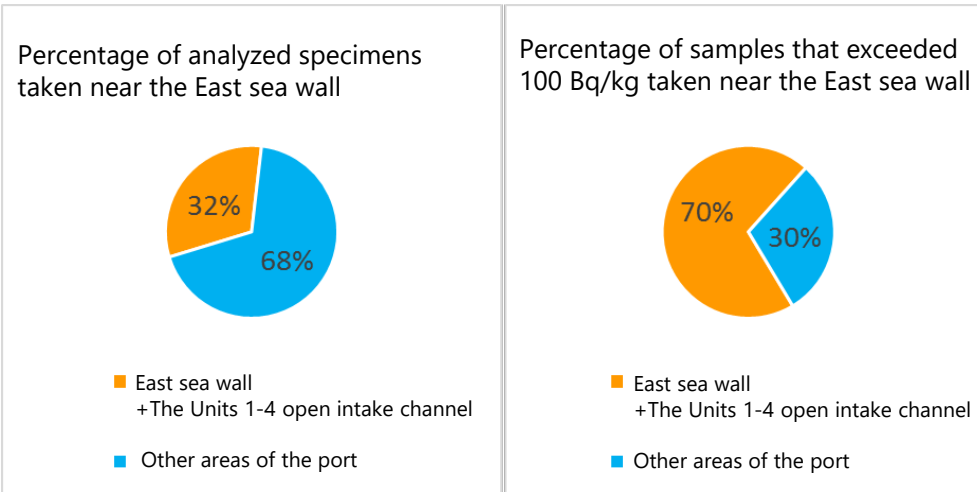
Diagram Percentage of specimens taken and specimens exceeding 100 Bq/L taken around the East sea wall

- Following increased efforts to catch the fish in the port implemented in February 2022 and onward, the number of specimens caught and analyzed has increased significantly from 88 in FY2021 to 415 in FY2022. The number of specimens analyzed with cesium concentrations exceeding 100 Bq/L has also increased accordingly.
- The trend of a higher number of fish with a cesium concentration exceeding 100 Bq/kg coming from near the East sea wall and the Units 1-4 intake open channel continued from FY2021 to FY2022. In particular, the cesium concentration of all of the fish caught inside the Units 1-4 intake open channel exceeded 100 Bq/L.
- We will continue to strengthen our efforts to catch fish by improving upon catching methods and adding nets.
