## Investigation Results of Unit 3 Spent Fuel Pool Utilizing an Tokyo Electric Power Company Underwater Camera at Fukushima Daiichi Nuclear Power Station (Performed on February 14, 15, 16 and 18)

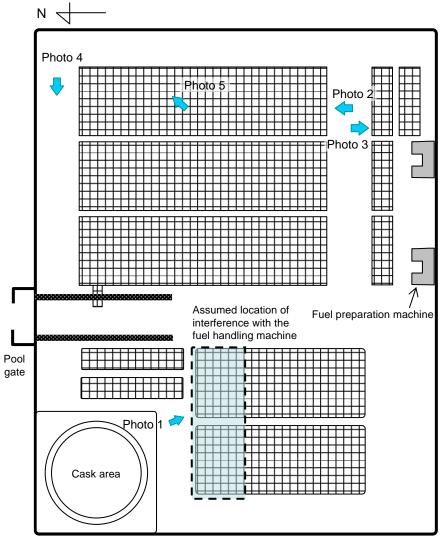
- The fuel handling machine mast which fell into the pool on February 6 had no impact on the fuel storage rack, liner, etc.
- No deformation was found on the fuel rack below the fuel handling machine.
- General distribution condition of the debris in the spent fuel pool was confirmed.

Photo 1: The lower part of the fuel handling machine and the fuel rack
