# Outline of the Facing Works within the Premises of the Fukushima Daiichi NPS

July 14, 2014

Tokyo Electric Power Company

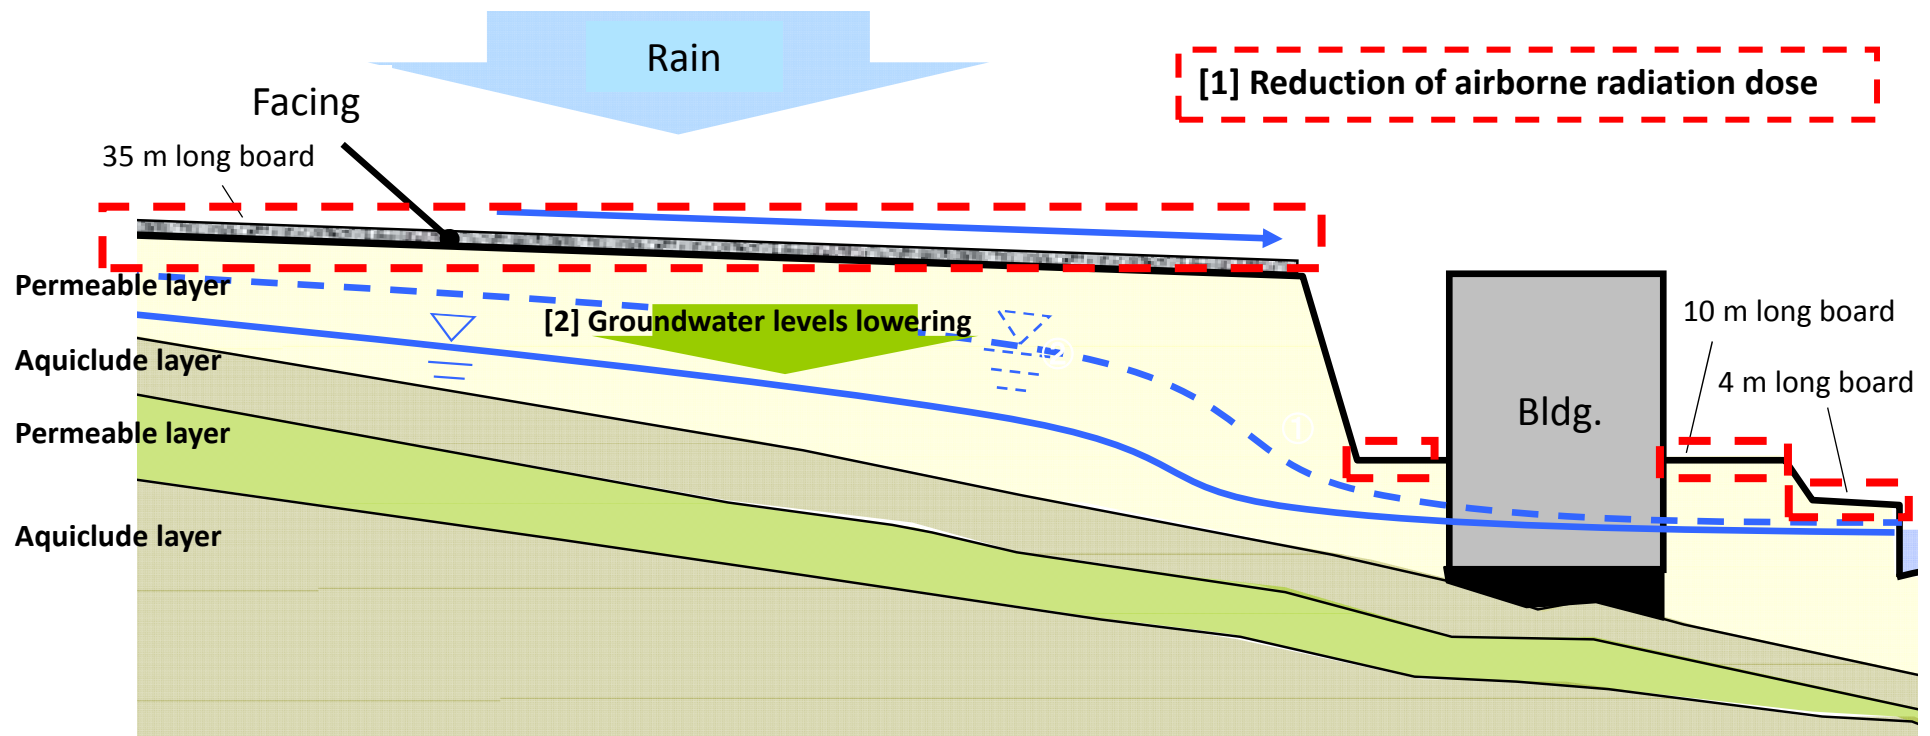
### 3. Image of facing

Effects expected to gain through the facing.

[1] Reduction of radiation dose within the premises.

[2] Reduction of the amount of water flowing into the building due to groundwater levels lowering.

【Overview of measures】

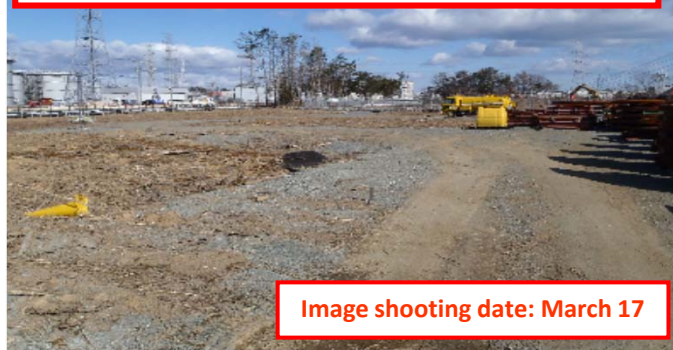
After clearing works completion ( partial)

Image shooting date: March 17

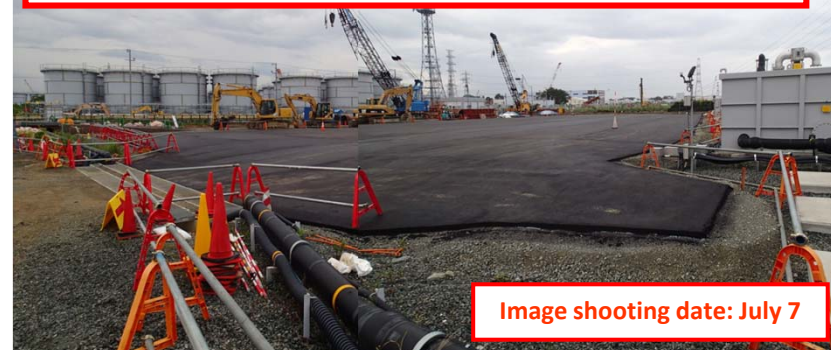
After asphalt pavement works completion (partial)

Image shooting date: July 7
