Main works and steps for decommissioning

Progress status

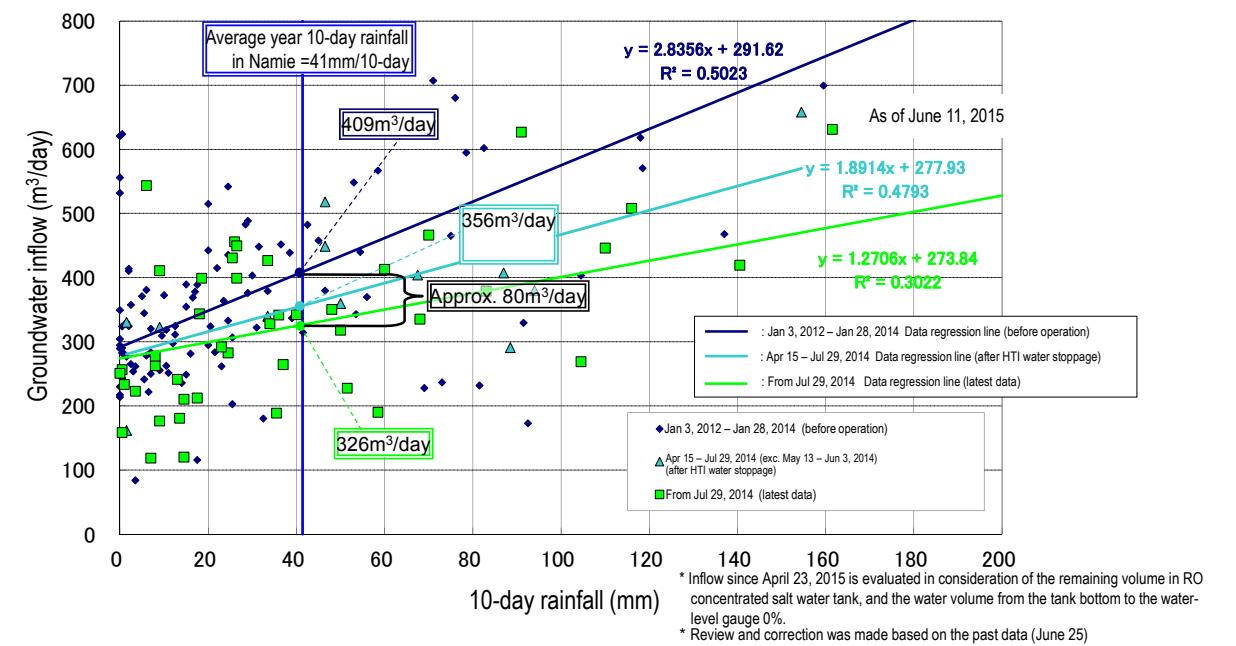
Figure 1: Analytical results of inflow into buildings

- It was confirmed that the groundwater inflow into the buildings had decreased by approx. 80 m³/day, based on the evaluation data to date, through measures such as groundwater bypass and water stoppage of the High Temperature Incinerator Building (HTI) (see Figure 1).

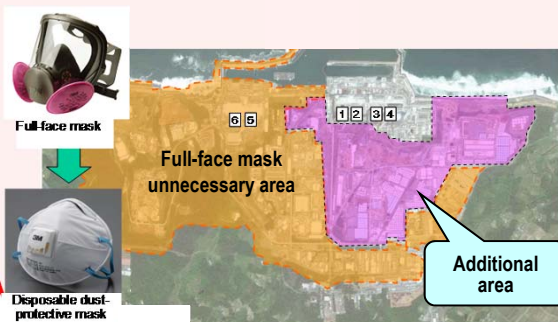
Full-face mask unnecessary area

The number of dust monitors has increased to ten with additional monitors installed in Units 3 and 4 slopes and tank areas, the full-face mask unnecessary area will be expanded to approx. 90% of the site from May 29.

However, wearing full- or half-face mask is required for works exposed to highly concentrated dust; and full-face masks, for works involving a risk of ingesting concentrated salt water, etc.

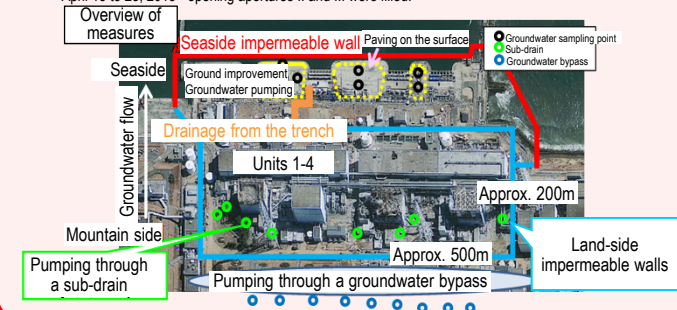
- Unit 2: November 25 to December 18, 2014 - tunnel sections were filled. February 24, 2015 - filling of the Vertical Shafts commenced.
 - Unit 3: February 5 to April 8, 2015 - tunnel sections were filled. May 2, 2015 - filling of Vertical Shafts commenced

- Unit 4: February 14 - March 21, 2015 - tunnel sections were filled. April 15 to 28, 2015 - opening apertures II and III were filled.
