## Main works and steps for decommissioning

Fuel removal from Unit 4 SFP had been completed. Preparatory works to remove fuel from Unit 1-3 SFP and fuel debris (Note 1) removal are ongoing.

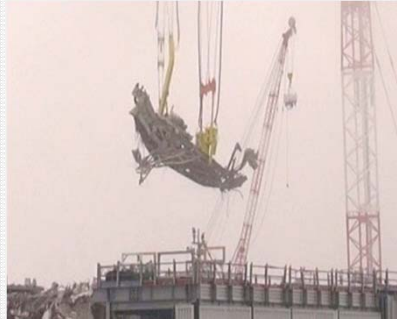
<Removal of the fuel-handling machine>

### Removal of Unit 3 FHM completed

On August 2, the fuel-handling machine (FHM), the largest piece of rubble which fell in the Unit 3 spent fuel pool, was removed safely.

- On August 2, the fuel-handling machine, the largest piece of rubble to have fallen in the spent fuel pool, was removed. On August 4, an inspection on the status of rubble in the spent fuel pool and pool gate identified distortion of fuel handles with four out of eight spent fuel assemblies newly found. As no significant change was identified in the radiation density in pool water, it was confirmed that the distortion of fuel assemblies was not attributable to the removal of the fuel-handling machine. Detailed inspections will be conducted during the process to consider fuel removal. Regarding the pool gate, it was confirmed that gate brackets were hooked on gate hooks.

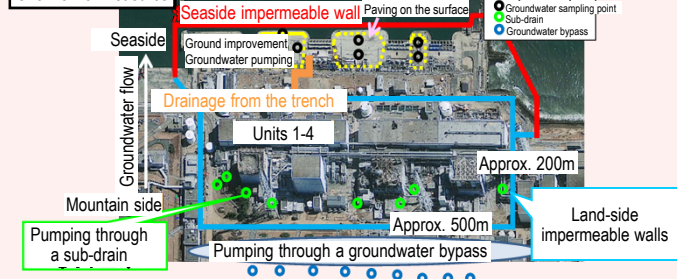
### Overview of measures

- Unit 4: February 14 - March 21, 2015 - tunnel sections were filled. April 15 to 28, 2015 - opening apertures II and III were filled.
