## Main works and steps for decommissioning

Fuel removal from Unit 4 SFP had been completed. Preparatory works to remove fuel from Unit 1-3 SFP and fuel debris (Note 1) removal are ongoing.

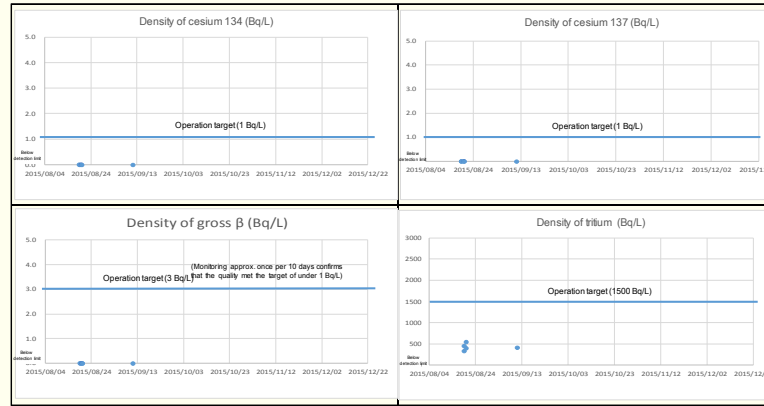
< Analytical results of temporary storage tanks (values of analysis by TEPCO)

Operation target	(Reference 1) Announcement density limit	(Reference 2) WHO Guidelines for Drinking Water Quality
Cesium 134	1	60	10
Cesium 137	1	90	10
Gross β	3 (1) <sup>*1</sup>	30 <sup>*2</sup>	10 <sup>*2</sup>
Tritium	1,500	60,000	10,000

\* Monitoring approx. once per 10 days confirms that the quality met the target of under 1 Bq/L.  
 \* Values against strontium 90.

- To reduce groundwater flowing into the buildings, pumping-up of groundwater from wells (subdrains) around the buildings started on September 3. Pumped-up groundwater was purified at dedicated facilities and released after TEPCO and a third-party organization had confirmed that its quality met operational targets (cesium 134: 1 Bq/L, cesium 137: 1 Bq/L, gross  $\beta^*$ : 3 Bq/L, tritium: 1,500 Bq/L) (see Figure 2). From September 14, a total of 4,025 m<sup>3</sup> was drained in five releases. Groundwater pumped up from groundwater drains since September 3 was also released from September 28 after being purified.

- \* Monitoring around once every 10 days confirms that the quality met the target of under 1 Bq/L.
- The water level of subdrains located on the mountain side of the buildings will be gradually reduced, while avoiding any significant variations in water levels of subdrains located on the sea side (see Figure 3).

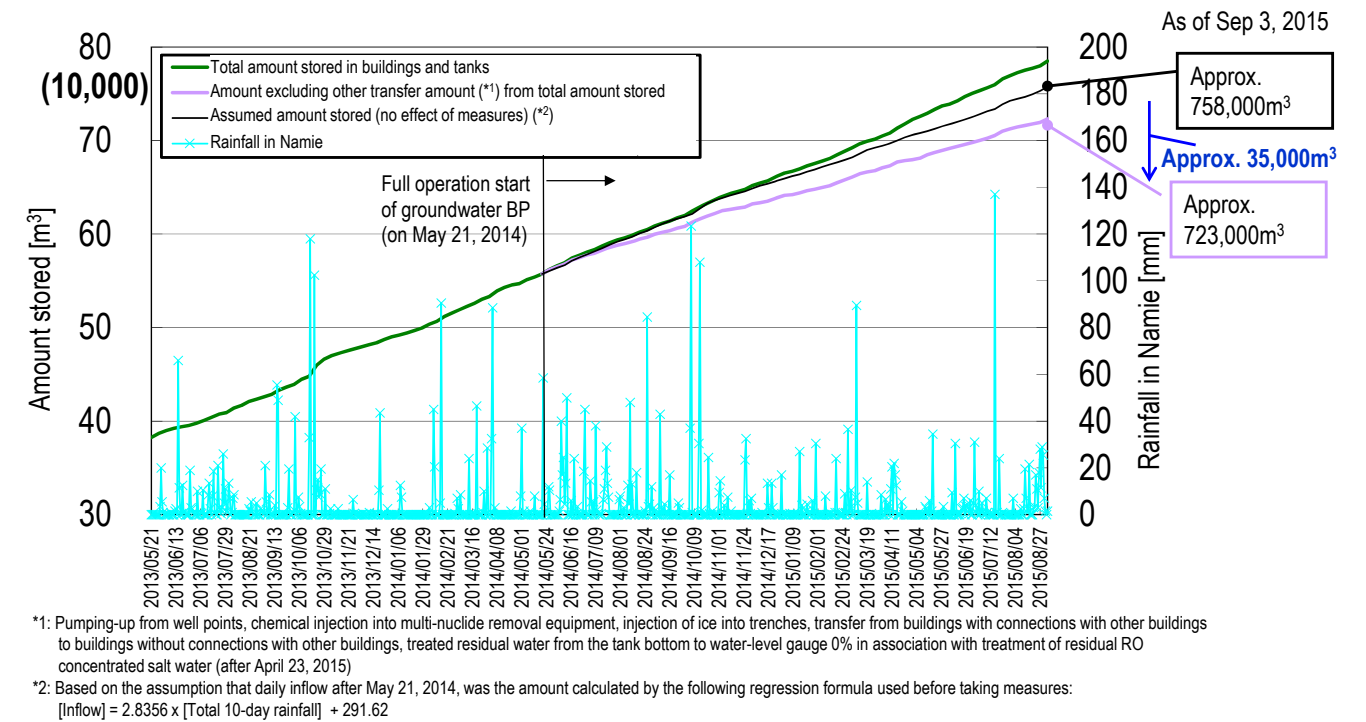
Figure 1: Analytical results of inflow into buildings

- It was evaluated that the groundwater inflow had decreased by approx. 80 m<sup>3</sup>/day and a total of approx. 35,000 m<sup>3</sup> by September 3, 2015 since the full-operation start of the groundwater bypass on May 21, 2014, through measures such as this bypass and water stoppage of the High Temperature Incinerator Building (HTI) (see Figure 1). After operation start of water treatment facilities including subdrains, went into operation (from September 3) given the difficulty in distinguishing between the effect of these facilities and that of previous inflow control measures, evaluation via the ongoing method was terminated.

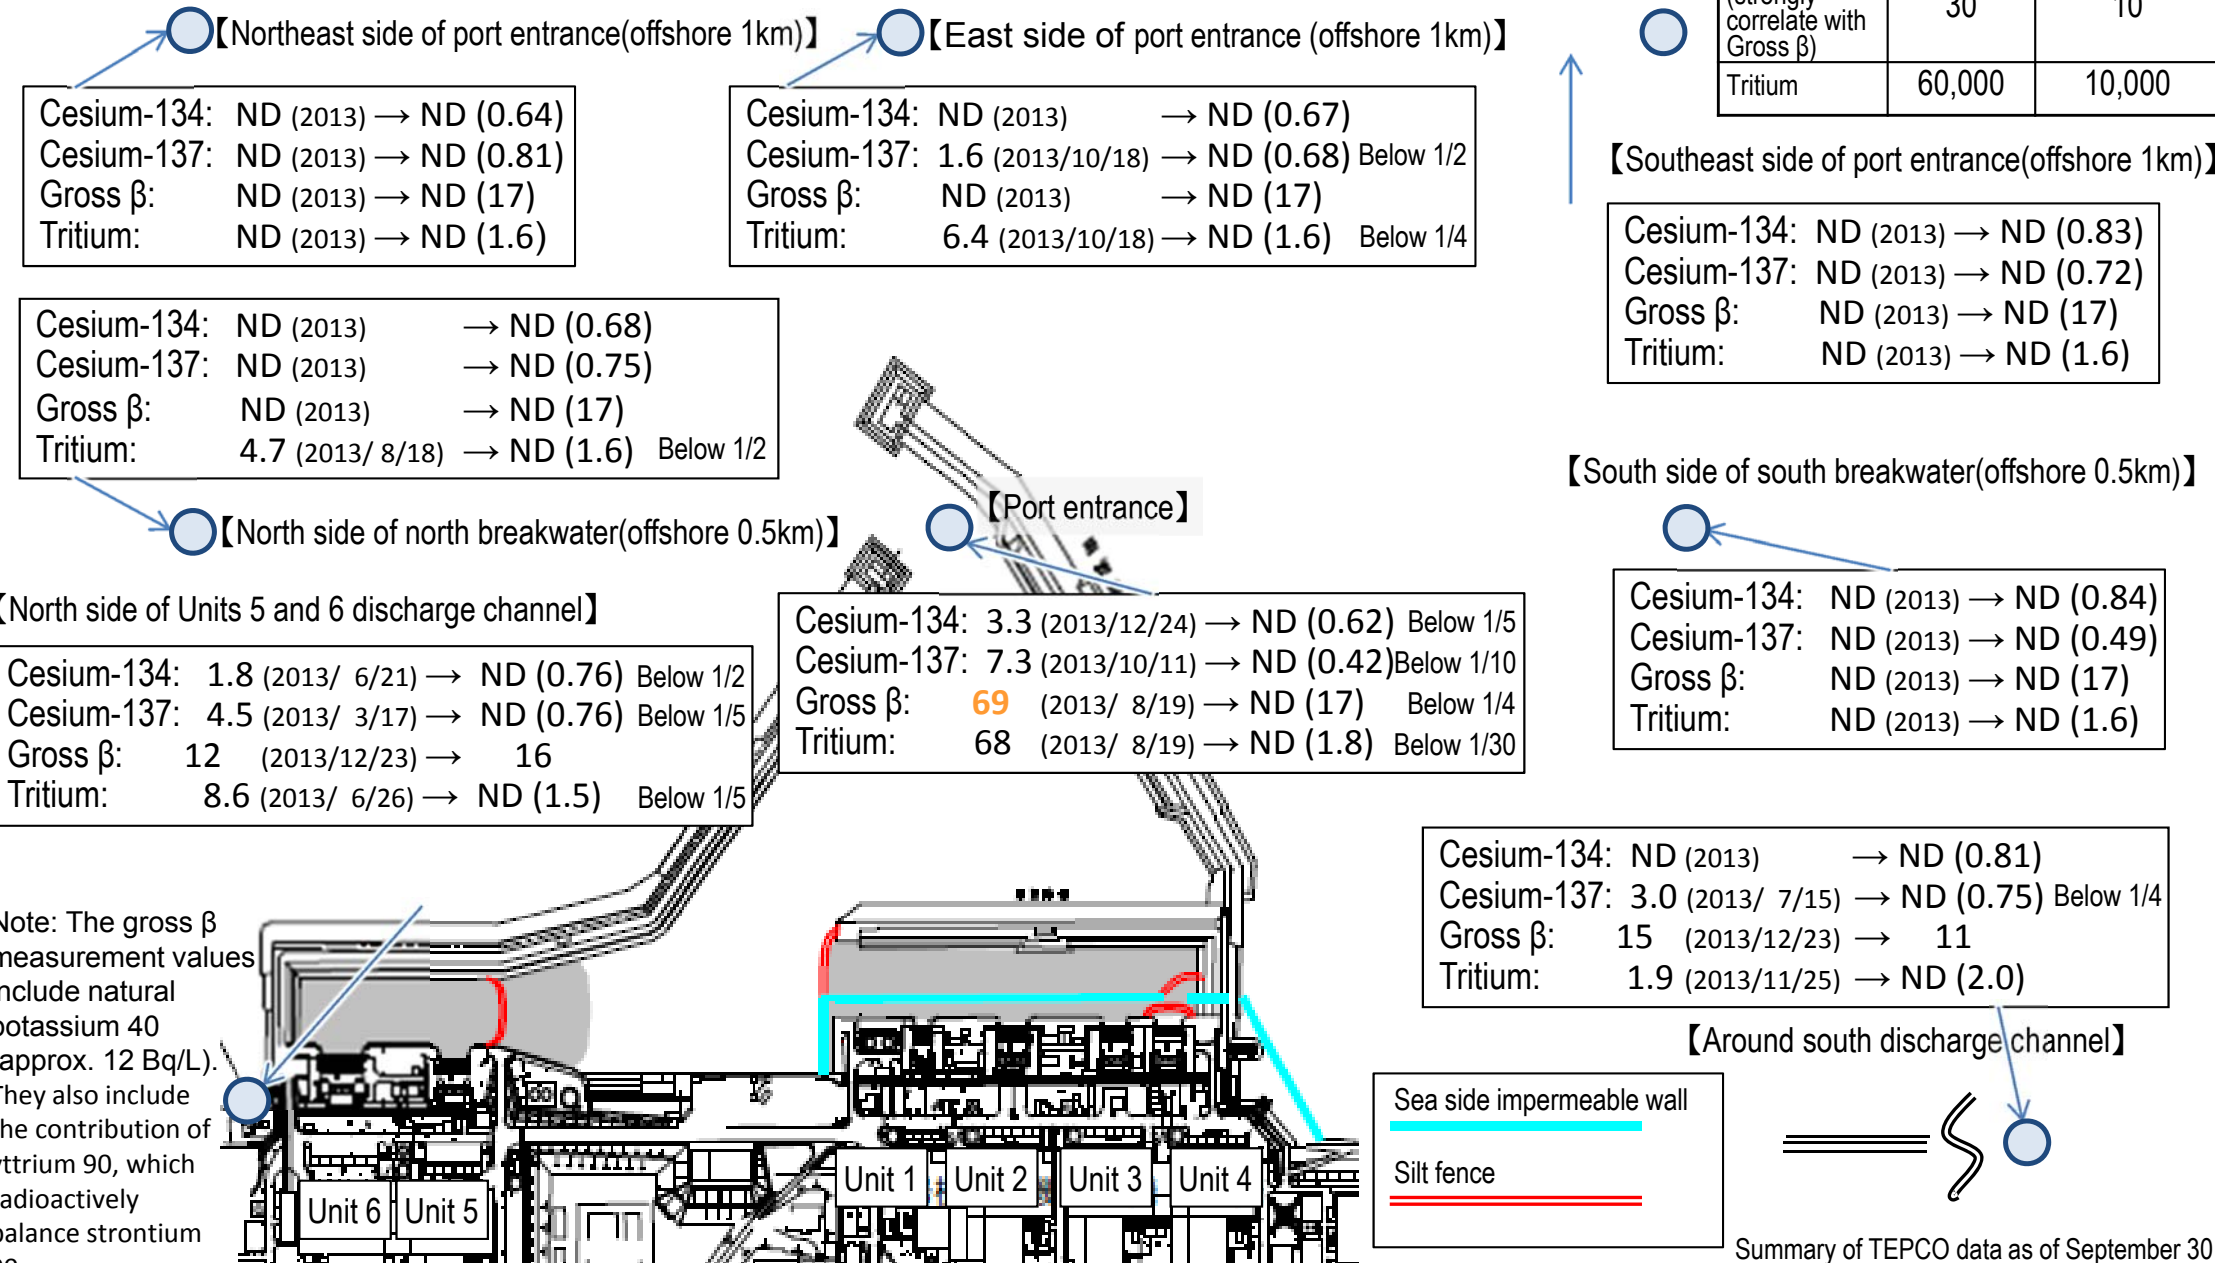
Legal discharge limit	WHO Guidelines for Drinking Water Quality
Cesium-134	60	10
Cesium-137	90	10
Strontium-90 (strongly correlate with Gross β)	30	10
Tritium	60,000	10,000

Unit (Bq/L); ND represents a value below the detection limit; values in ( ) represent the detection limit; ND (2013) represents ND throughout 2013

Note: The gross β measurement values include natural potassium 40 (approx. 12 Bq/L). They also include the contribution of yttrium 90, which radioactively balance strontium 90.

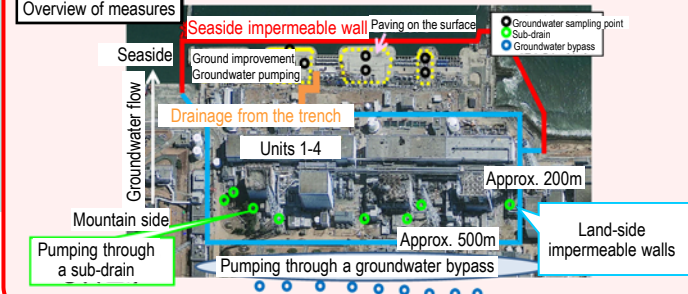
## Overview of measures

- To prevent contamination expansion into the sea, the following measures are being implemented:
  - Prevent leakage of contaminated water
    - Ground improvement behind the bank to prevent the expansion of radioactive materials. (Between Units 1 and 2: completed on August 9, 2013; between Units 2 and 3: from August 29 and completed on December 12, 2013; between Units 3 and 4: from August 23, 2013 and completed on January 23, 2014)
