Main works and steps for decommissioning

Progress status

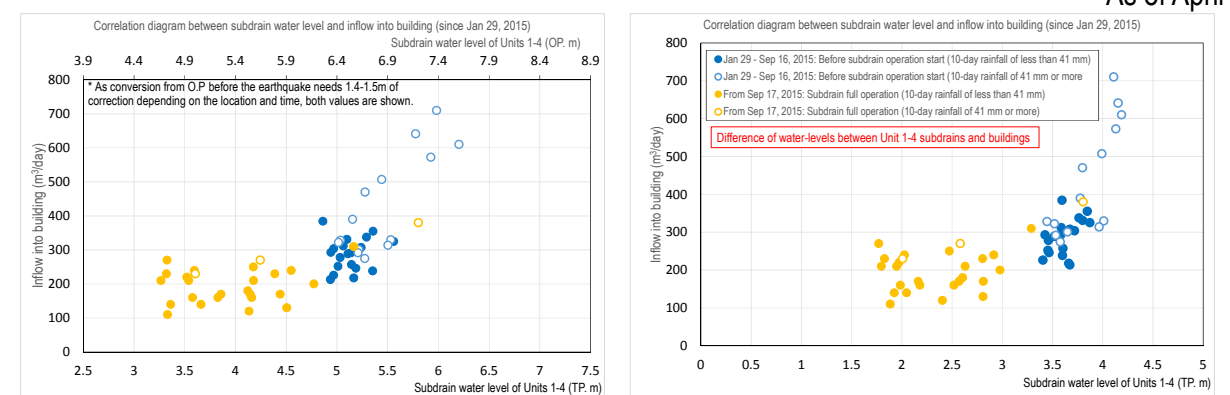
Figure 1: Evaluation of inflow into buildings after the subdrains went into operation

- However, given insufficient data on the effect of rainfall after the subdrains went into operation, the effect of the inflow into buildings will be reviewed as necessary by accumulating data.

- Inflow into buildings declined to approx. 100 - 200 m³/day during times when the subdrain water level decreased to approx. T.P. 3.5 m or when the difference with the water levels in buildings decreased to approx. 2 m after the subdrains went into operation.

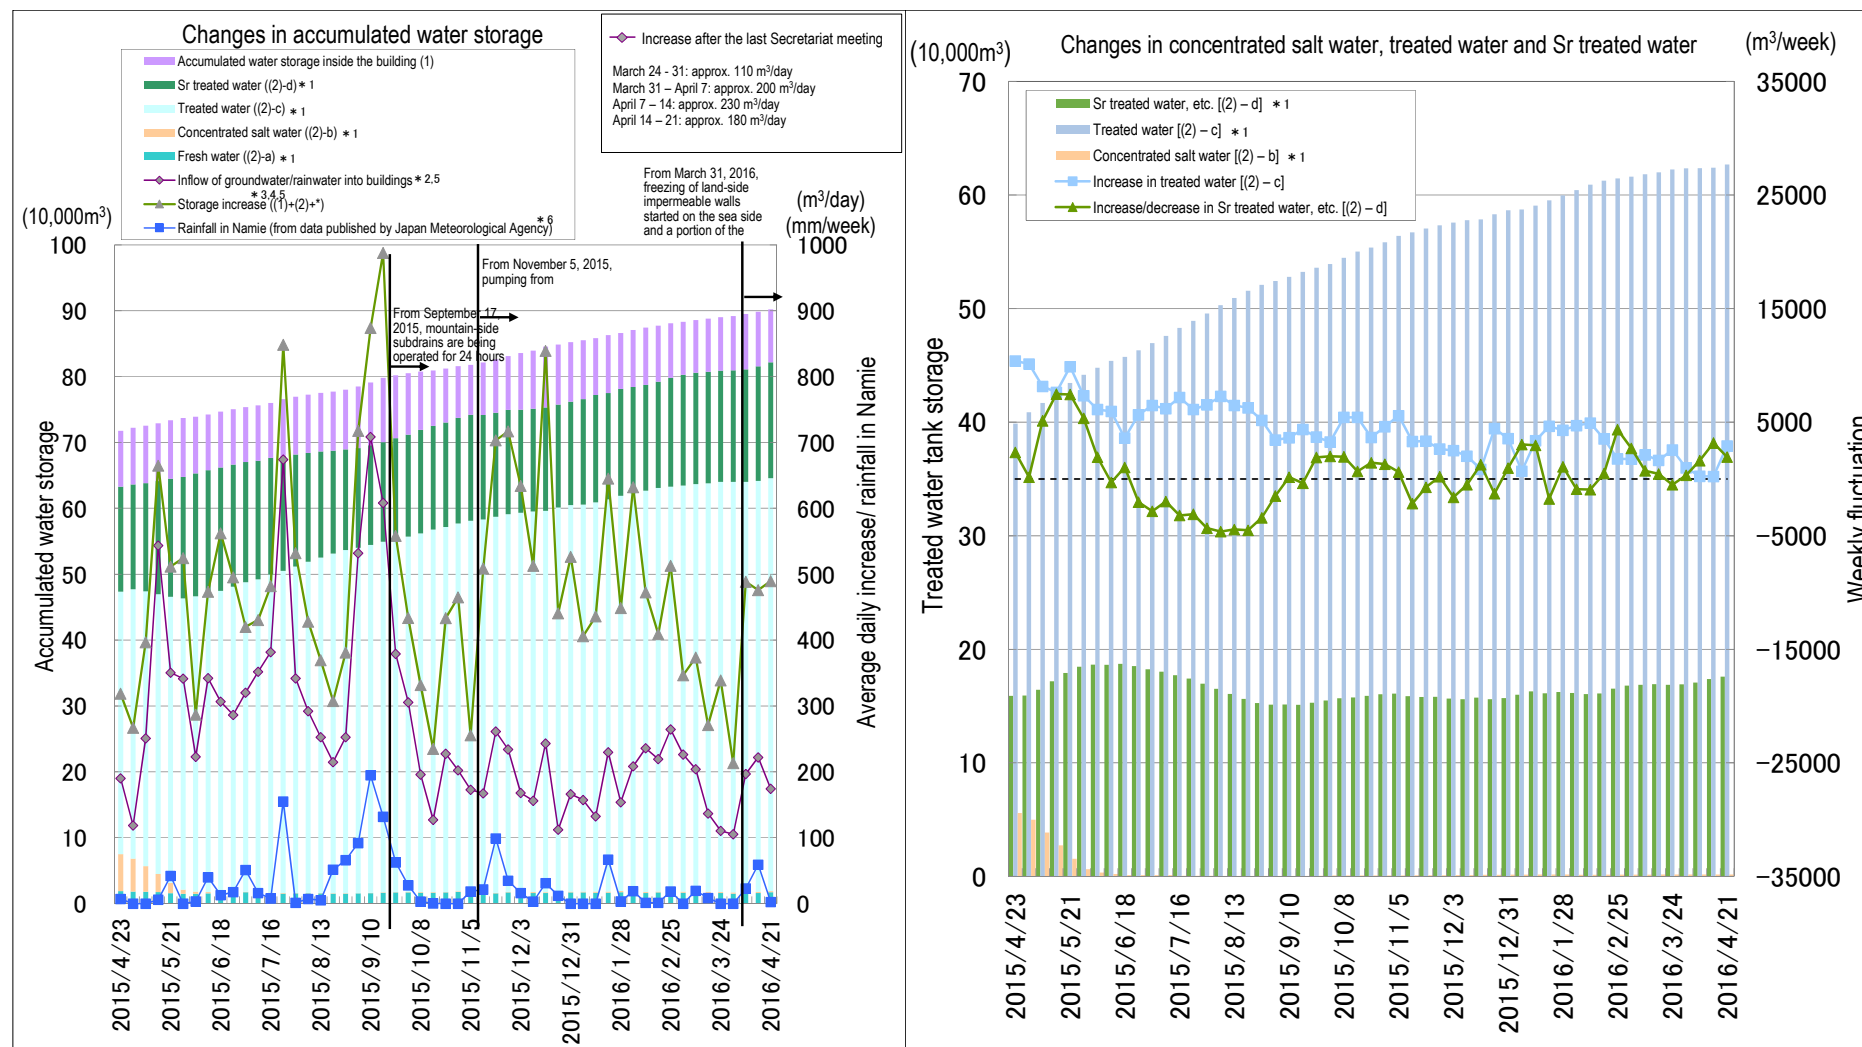
Figure 3: Status of accumulated water storage

As of April 21, 2016

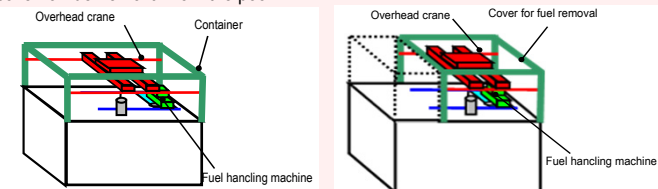
Examination of the following two plans continues: Plan 1 to share a container for removing fuel assemblies and debris from the pool; and Plan 2 to install a dedicated cover for fuel removal from the pool.

Image of Plan 1

Image of Plan 2

To facilitate removal of fuel assemblies and debris in the Unit 2 spent fuel pool, the scope of dismantling and modification of the existing Reactor Building rooftop was examined. From the perspective of ensuring safety during the work, controlling impacts on the outside of the power station, and removing fuel rapidly to reduce risks, we decided to dismantle the whole rooftop above the highest floor of the Reactor Building.

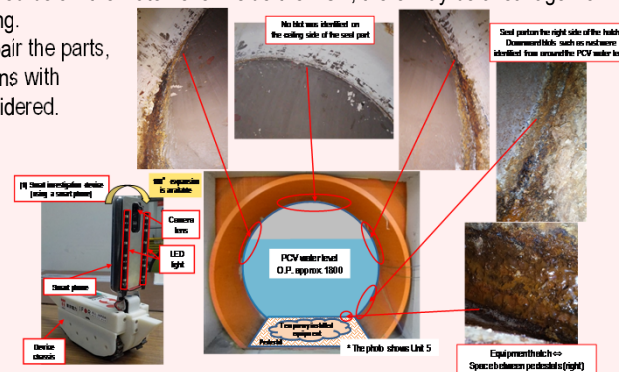
Investigation inside the PCV

As part of the investigation into the PCV to facilitate fuel debris removal, the status around the Unit 3 PCV equipment hatch was investigated using a small self-traveling investigation device on November 26, 2015.

Given blots such as rust identified below the water level inside the PCV, there may be a leakage from the seal to the extent of bleeding. Methods to investigate and repair the parts, including other PCV penetrations with a similar structure, will be considered.

Prior to removing fuel debris, to check the conditions inside the Primary Containment Vessel (PCV) including the location of the fuel debris, investigation inside the PCV was conducted.

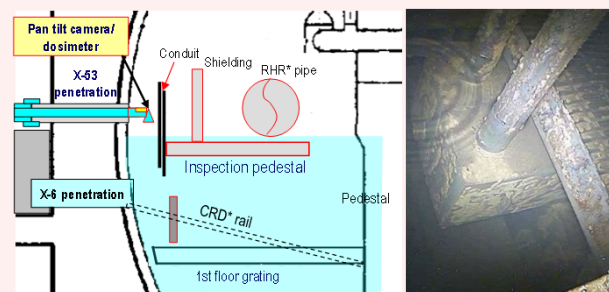
Inspection pedestal and water surface

- From October 22-24, the status of X-53 penetration, which may be under the water and which is scheduled to use to investigate the inside of the PCV, was investigated using remote-controlled ultrasonic test equipment. Results showed that the penetration is not under the water.
- For the purpose of confirming the status inside the PCV, an investigation device was inserted into the PCV from X-53 penetration on October 20 and 22, 2015 to obtain images, data of dose and temperature and sample accumulated water. No damage was identified on the structure and walls inside the PCV and the water level was almost identical with the estimated value. In addition, the dose inside the PCV was confirmed to be lower than in other Units.
- In the next step, the obtained information will be analyzed to be utilized in the consideration about the policy for future fuel debris removal.

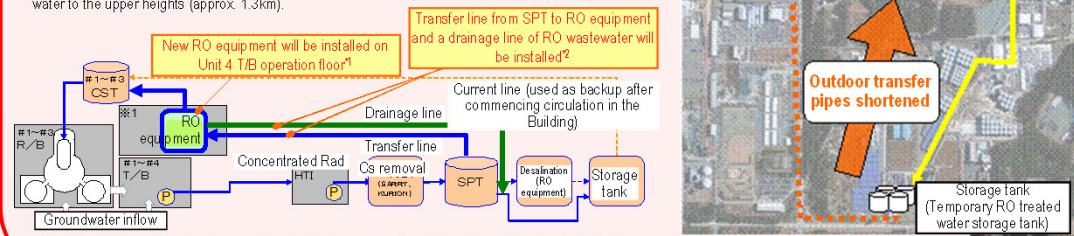
- Operation of the reactor water injection system using Unit 3 CST as a water source commenced (from July 5, 2013). Compared to the previous systems, in addition to the shortened outdoor line, the reliability of the reactor water injection system was enhanced, e.g. by increasing the amount of water-source storage and enhancing durability.
- By newly installing RO equipment inside the Reactor Building, the reactor water injection loop (circulation loop) will be shortened from approx. 3km to approx. 0.8km*.
- * The entire length of contaminated water transfer pipes is approx. 2.1km, including the transfer line of surplus water to the upper heights (approx. 1.3km).

*1 Unit 4 T/B operation floor is one of the installation proposals, which will be determined after further examination based on the work environment
 *2 A detailed line configuration will be determined after further examination

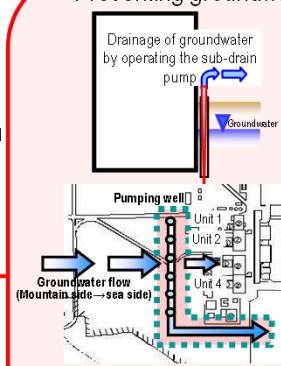
Measures to pump up groundwater flowing from the mountain side upstream of the Building to reduce the groundwater inflow (groundwater bypass) have been implemented. The pumped up groundwater is temporarily stored in tanks and released after TEPCO and a third-party organization have confirmed that its quality meets operational targets. Through periodical monitoring, pumping of wells and tanks is operated appropriately. At the observation holes installed at a height equivalent to the buildings, the trend showing a decline in groundwater levels is checked. The analytical results on groundwater inflow into the buildings based on existing data showed a declining trend.

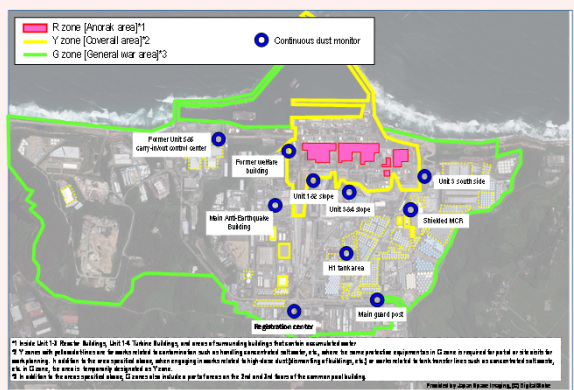
Optimization of radioactive protective equipment
 Based on the progress of measures to reduce environmental dosage on site, the site is categorized into two zones: highly contaminated area around Unit 1-4 buildings, etc. and other areas to optimize protective equipment according to each category aiming at improving safety and productivity by reducing load during work.
 From March 8, 2016, limited operation started in consideration of workers' load.

R zone (Anorak area)	Y zone (Coverall area)	G zone (General wear)
Full-face mask 	Full-face or half-face masks *1, *2 	Disposable disposable mask
Anorak on coverall Or double coveralls 	Coverall 	General*3 Dedicated on-site wear

*1 For works in buildings including water treatment facilities (multi-nuclide removal equipment, etc.) (excluding site visits), wear a full-face mask.
 *2 For works in tank areas containing concentrated salt water or Sr-treated water (excluding works not handling concentrated salt water, etc.), patrol, on-site investigation for work planning, and site visits) and works related to tank transfer lines, wear a full-face mask.
 *3 Specified light works (patrol, monitoring, delivery of goods brought from outside, etc.)
