## Main decommissioning works and steps

# TEPCO Holdings Fukushima Daiichi Nuclear Power Station Site

Appendix 2  
March 30, 2017

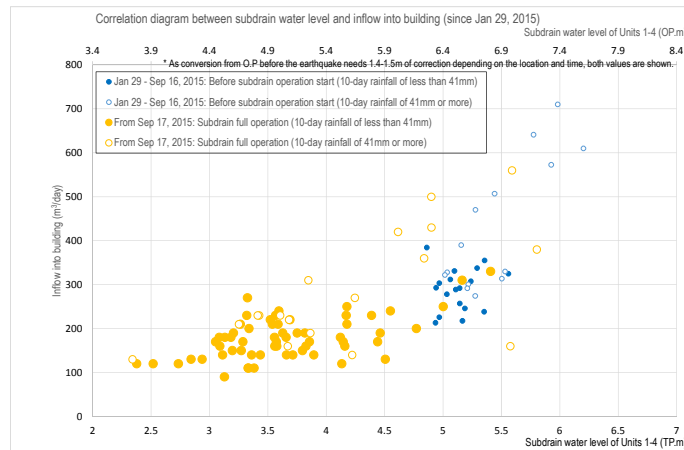
Figure 1: Correlation between inflow such as groundwater and rainwater into buildings and the water level of Unit 1-4 subdrains

“Inflow such as groundwater and rainwater into buildings” correlates highly with the average water level of subdrains around the Unit 1-4 buildings.

Since January 2017, in particular, the average subdrain water level has declined due to the progress of measures for subdrains, closure of unfrozen sections of the land-side impermeable walls (on the mountain side) and other construction in addition to the low-rainfall climate. “Inflow such as groundwater and rainwater into buildings” has also declined correspondingly.

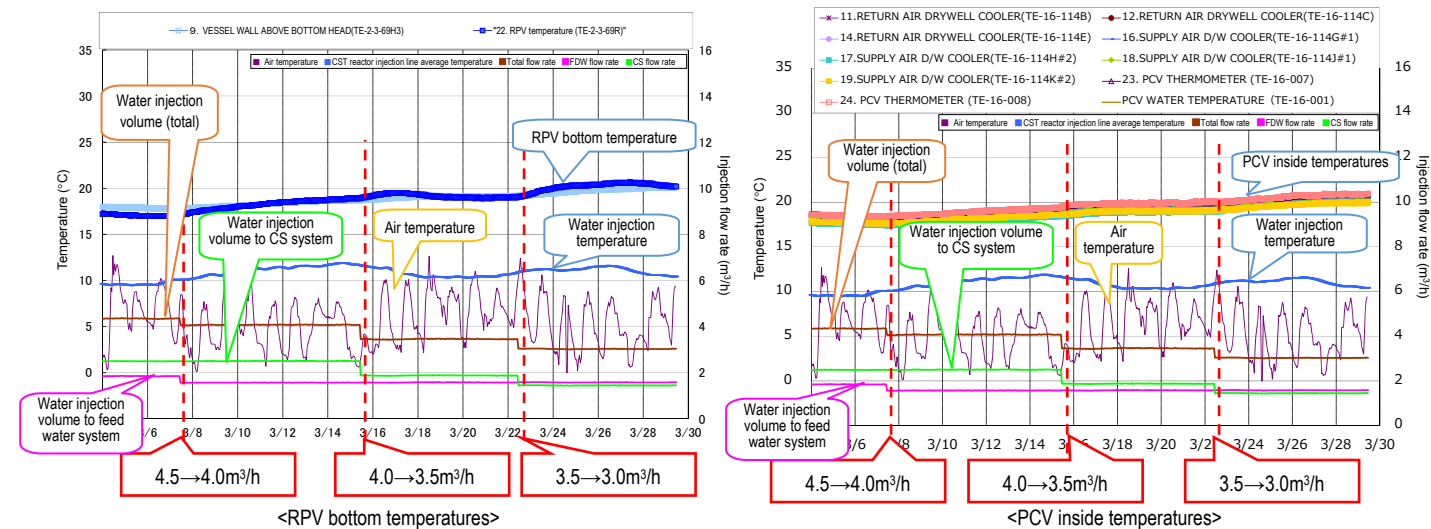
Figure 4: Change in temperatures in the Unit 2 reactor after reducing the water injection volume

- The volume of water injected into the Unit 2 reactor was reduced from 4.5 to 4.0 m<sup>3</sup>/h from March 7, from 4.0 to 3.5 m<sup>3</sup>/h from March 15 and 3.5 to 3.0 m<sup>3</sup>/h from March 22. No abnormality attributable to the reduction was detected under the cold shutdown condition.

To facilitate the purification of contaminated water in buildings, the volume of water injected into the Unit 2 reactor was reduced to 3.0 m<sup>3</sup>/h on March 22 as was done for Units 1 and 3. Cooling conditions of fuel debris and influence of accumulated water treatment in buildings will be checked based on data such as temperatures and radioactive densities in accumulated water in the buildings, which were changed by reducing the volume of water injected into Units 1-3.
