Main decommissioning works and steps

All fuel has been removed from Unit 4 SFP and preparatory work to fuel removal from Unit 1-3 SFP and fuel debris (Note 1) retrieval is ongoing.

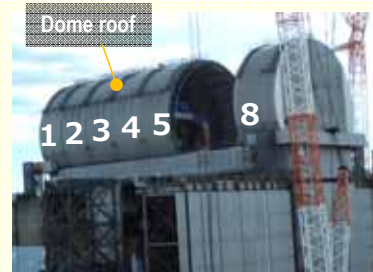
Installation of the fuel removal cover (December 19, 2017)

Installation of the Unit 3 fuel removal cover

As preparatory work for fuel removal from Unit 3, the fuel removal cover is being installed. Installation of the eighth Dome Roof (consists of eight) was completed on December 12. Following hanging of the slide trestle, the sixth and seventh Dome Roofs will be installed in February.

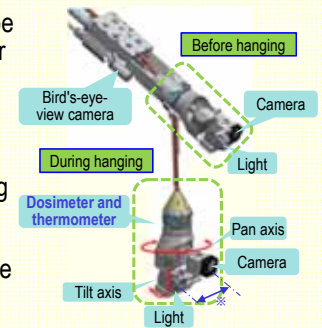
Overview of the investigative device edge

The inside of the Unit 2 PCV will be investigated from January 2018. For this investigation, the investigative device was upgraded based on the experience of the previous investigation (January – February 2017) to improve visibility. A hanging mechanism was added and a thermometer and dosimeter were mounted on the device to investigate the bottom of the pedestal. The investigation will proceed carefully not to affect the surrounding environment.

* A mechanism capable of keeping a distance between the camera and the light was added to improve visibility

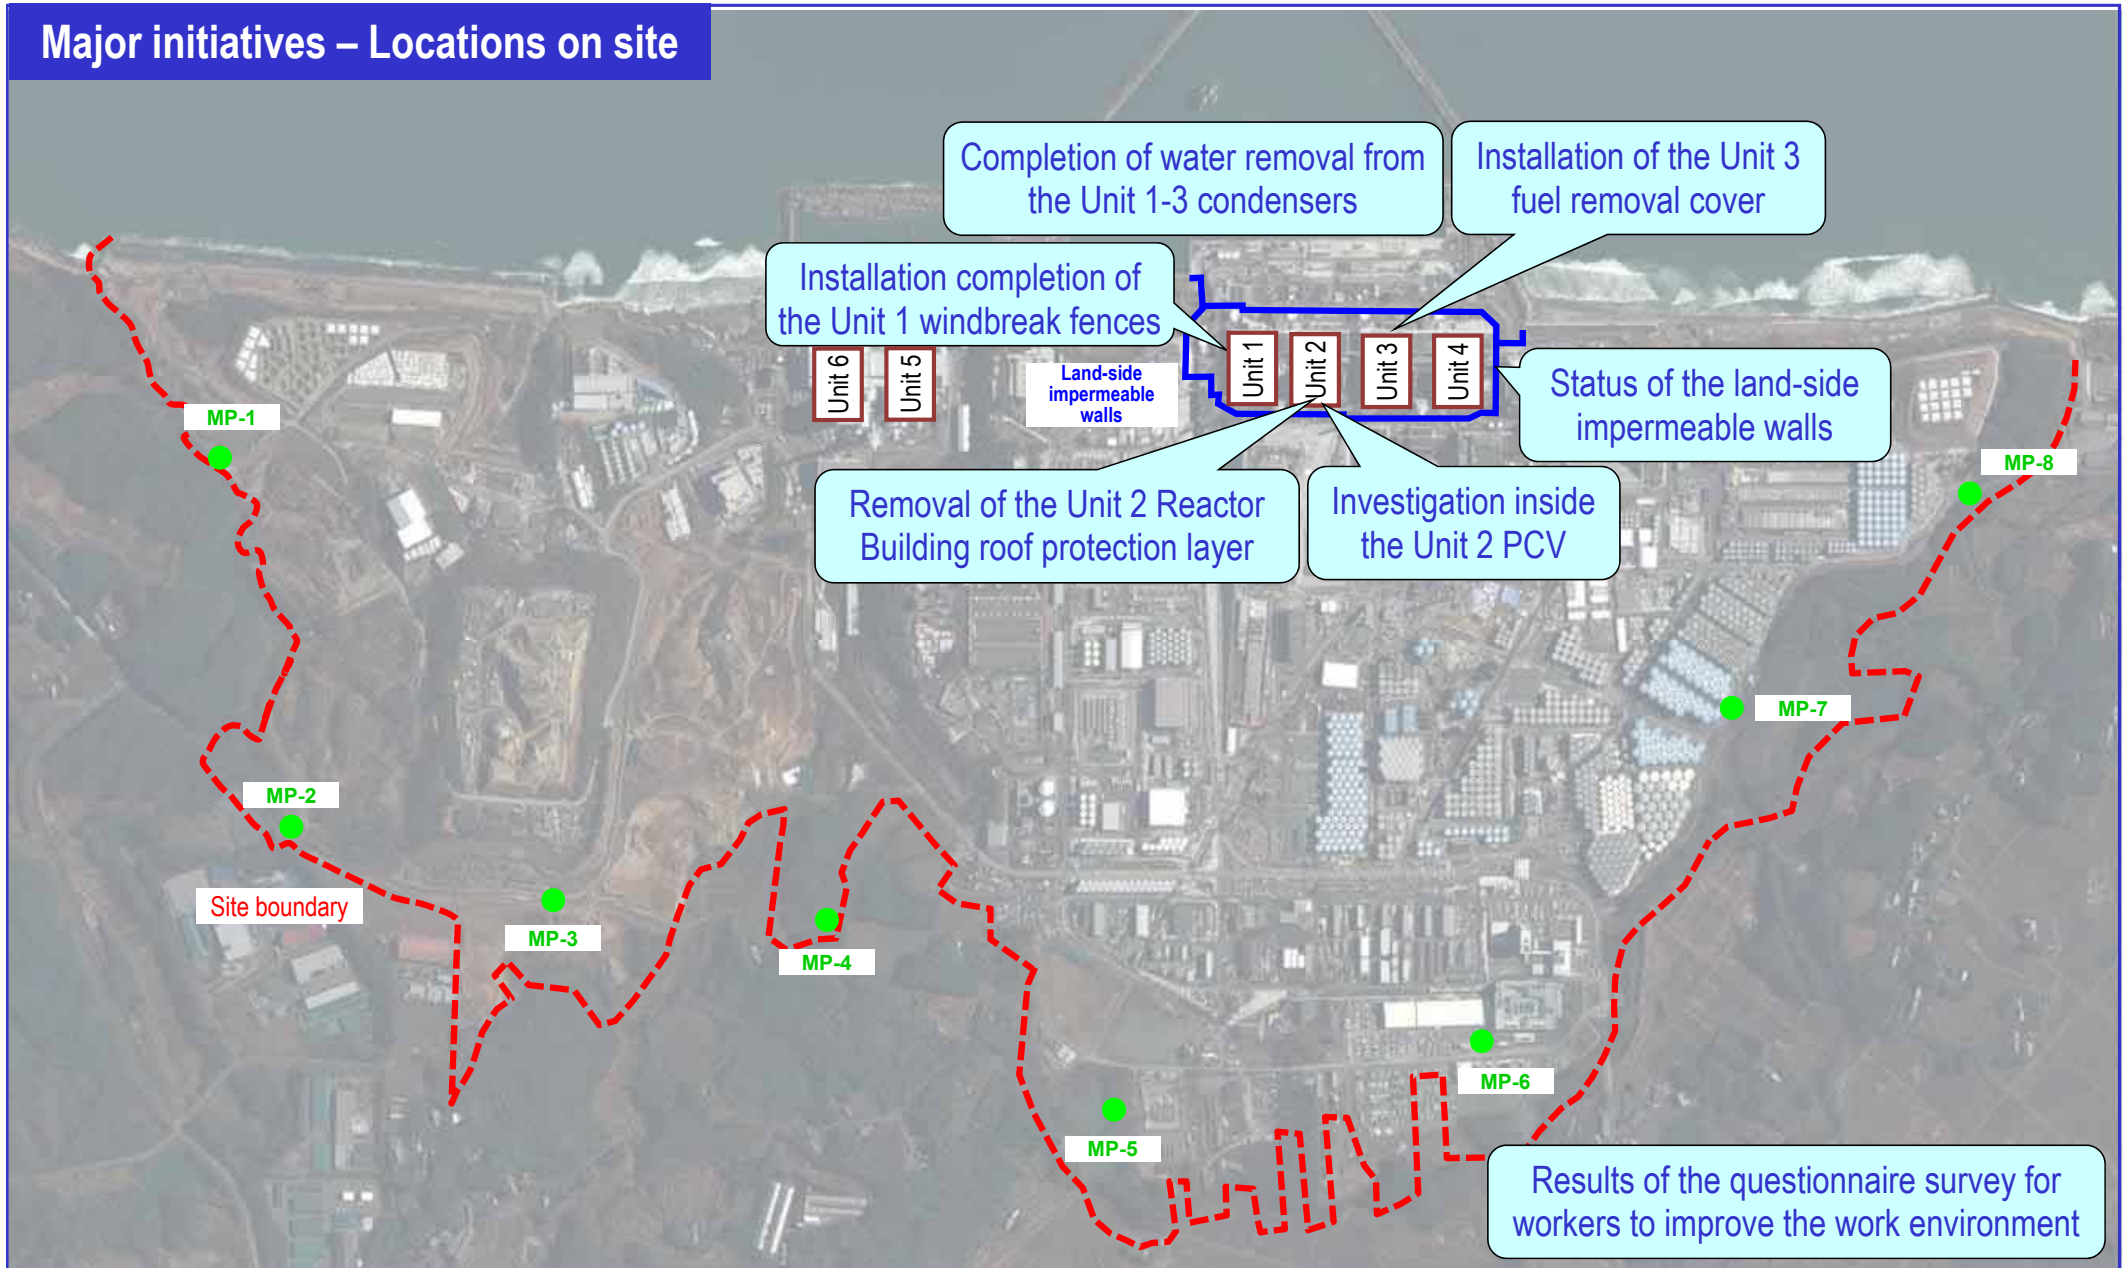
* Data of Monitoring Posts (MP1-MP8.)

Data (10-minute values) of Monitoring Posts (MPs) measuring the airborne radiation rate around site boundaries show 0.483 – 1.784 $\mu\text{Sv/h}$ (November 29 – December 19, 2017).

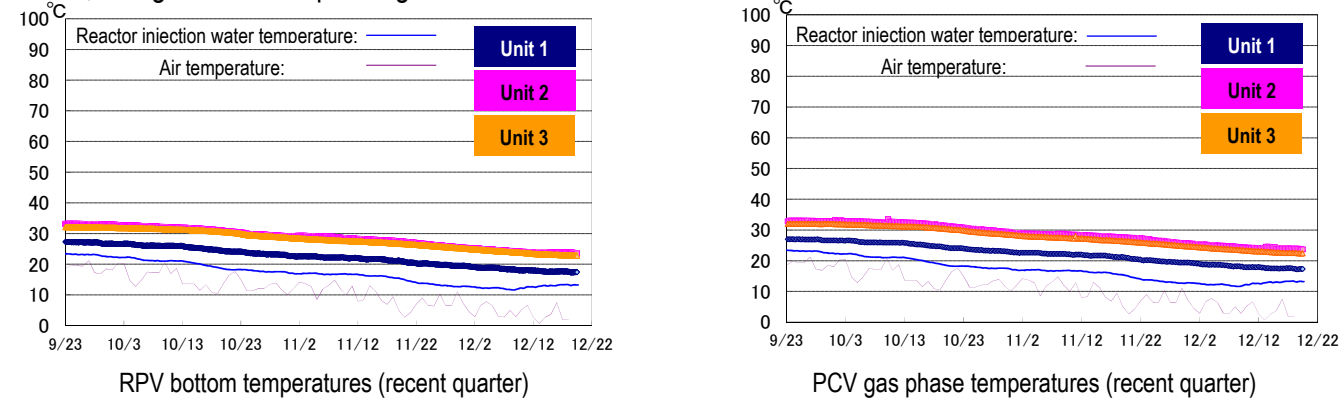
Through continuous reactor cooling by water injection, the temperatures of the Reactor Pressure Vessel (RPV) bottom and the Primary Containment Vessel (PCV) gas phase were maintained within the range of approx. 15 to 30°C for the past month, though it varied depending on the unit and location of the thermometer.

* The trend graphs show part of the temperature data measured at multiple points.

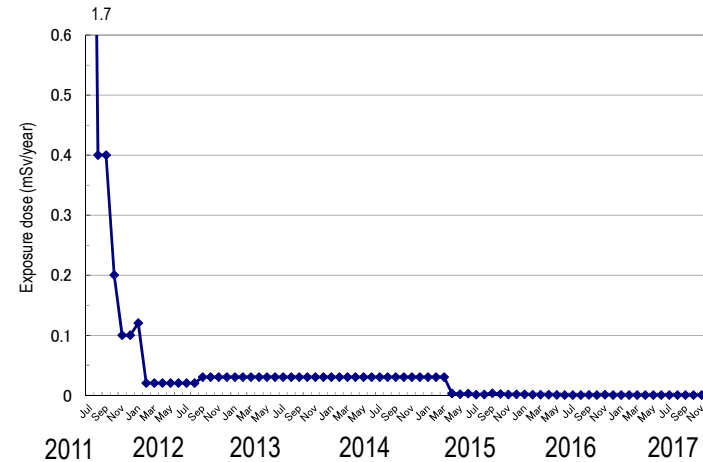
As of November 2017, the density of radioactive materials newly released from Reactor Building Units 1-4 in the air and measured at the site boundary was evaluated at approx. 1.5×10^{-12} Bq/cm³ for Cs-134 and 4.1×10^{-12} Bq/cm³ for Cs-137, while the radiation exposure dose due to the release of radioactive materials there was less than 0.00022 mSv/year.

Annual radiation dose at site boundaries by radioactive materials (cesium) released from Reactor Building Units 1-4

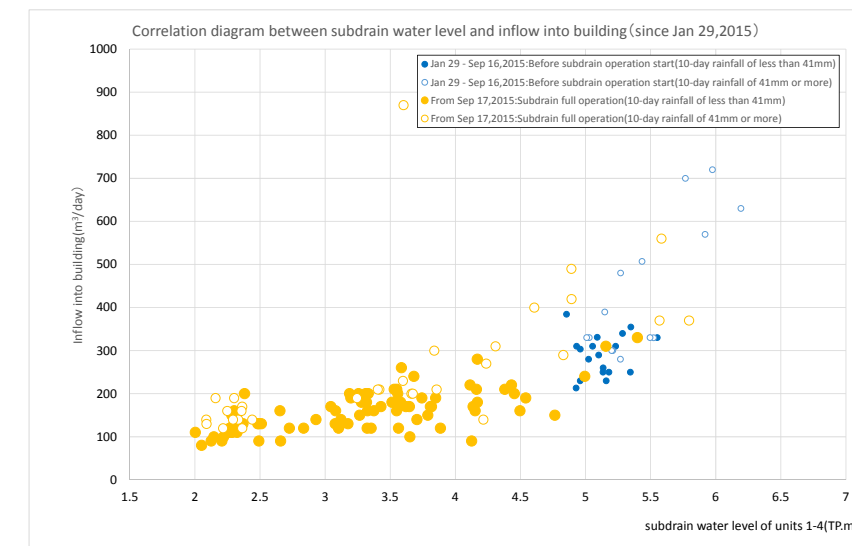
- Since the subdrains went into operation, the inflow into buildings tended to decline to less than 150 m³/day when the subdrain water level declined below T.P. 3.0 m, while the inflow increased during rainfall.

Figure 1: Correlation between inflow such as groundwater and rainwater into buildings and the water level of Unit 1-4 subdrains

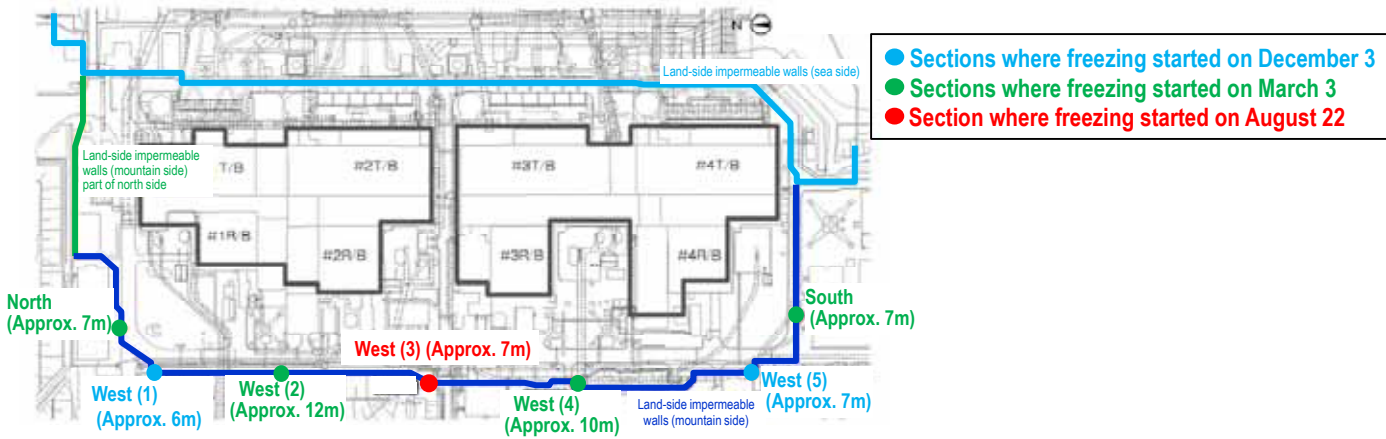
- For West (3) of the land-side impermeable walls (on the mountain side), a supplementary method was implemented (July 31 – September 15). Freezing started from August 22 and the underground temperature has been declining steadily. The difference between the inside and outside of the land-side impermeable walls near the same section increased.
- In the land-side impermeable walls, a maintenance operation to control the frozen soil from getting any thicker continues from May 22 on the north and south sides and started from November 13 on the east side where a sufficient thickness of frozen soil was identified.
- The underground temperature, water levels and pumped-up groundwater volume will continue to be monitored to confirm the effect of the land-side impermeable walls.

Figure 2: Closure of part of the land-side impermeable walls (on the mountain side)

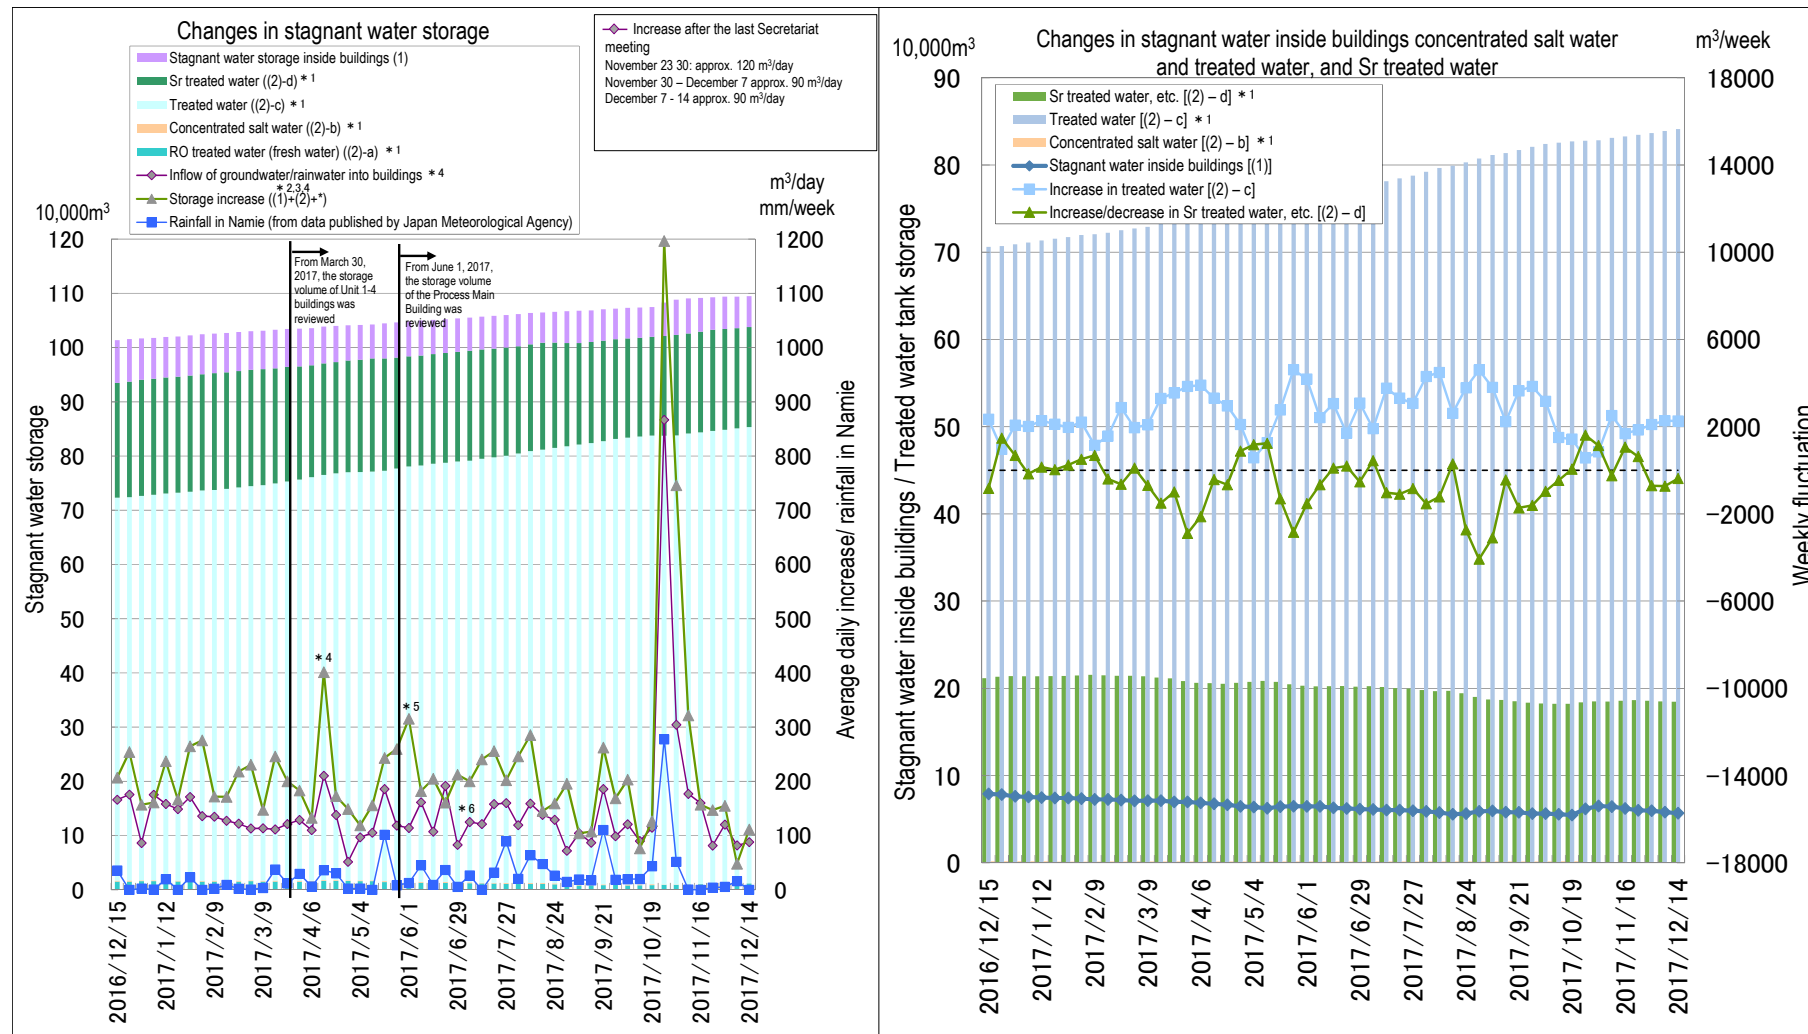
As of December 14, 2017

Figure 3: Status of stagnant water storage

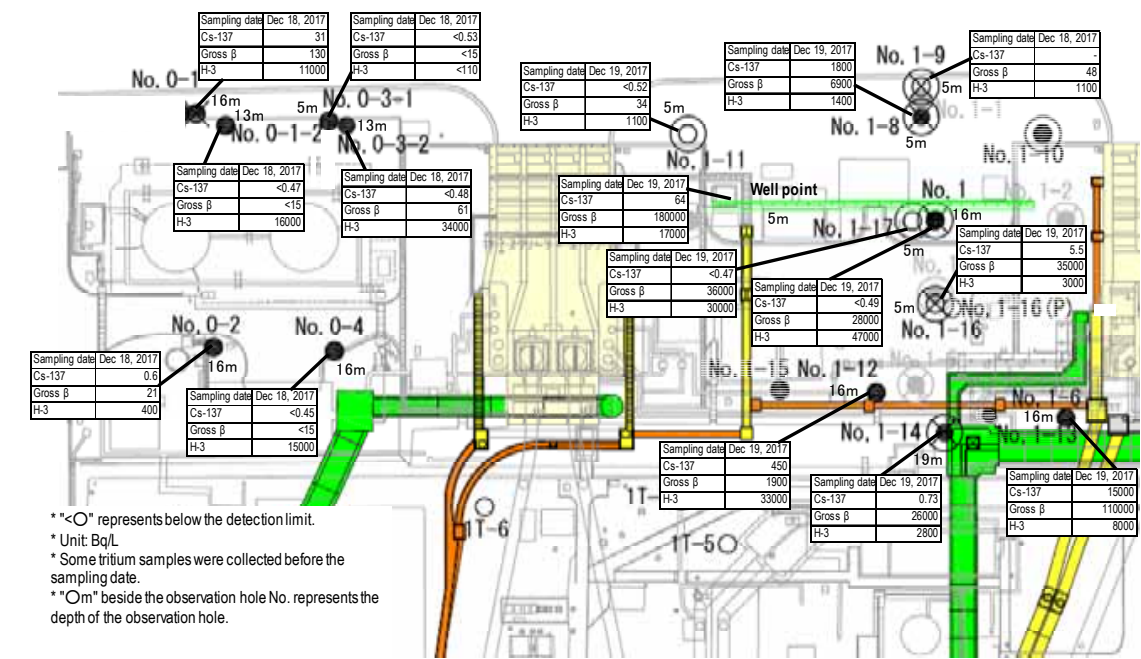
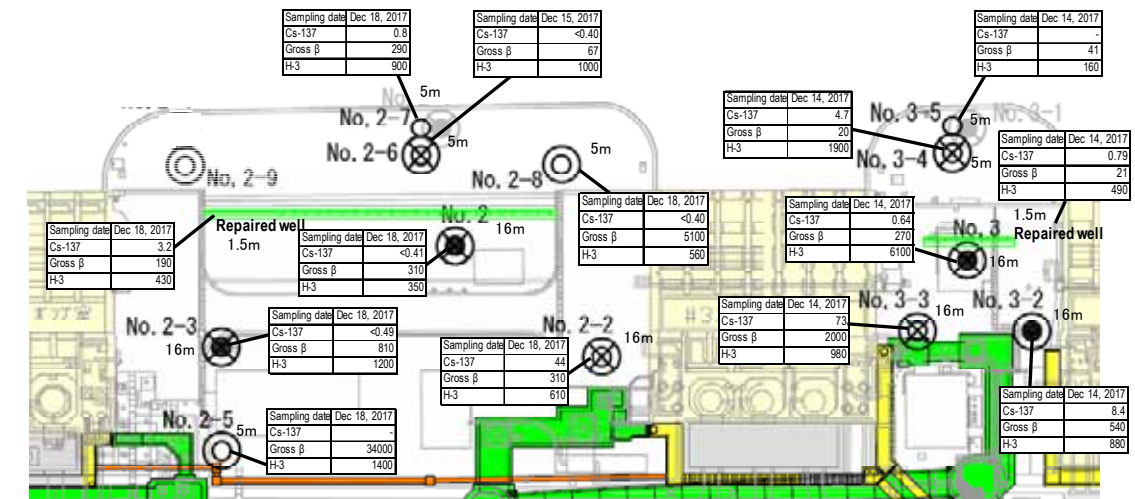
<Unit 1 intake north side, between Unit 1 and 2 intakes>

<Between Unit 2 and 3 intakes, between Unit 3 and 4 intakes>

Figure 4: Groundwater density on the Turbine Building east side

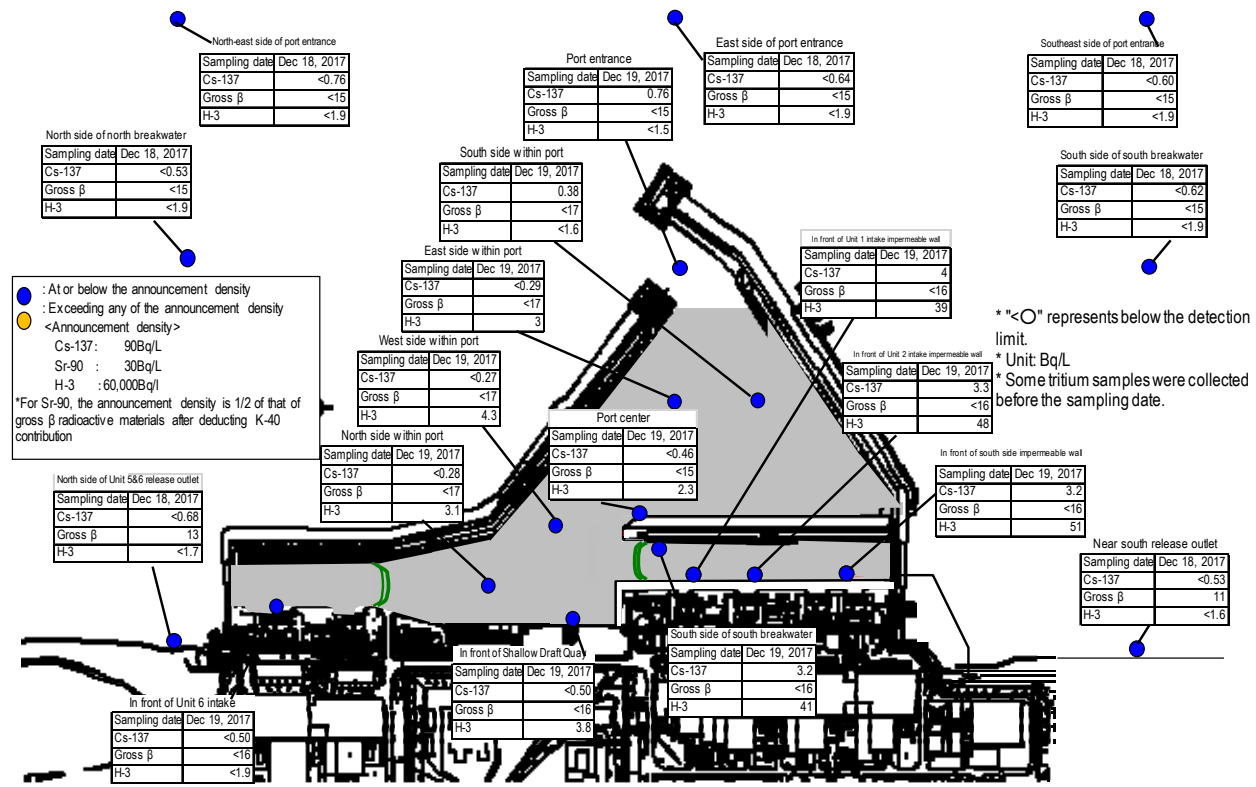
Figure 5: Seawater density around the port

- Regarding the radioactive materials in seawater in the area within the port, densities have remained low except for the increase in cesium 137 and strontium 90 during heavy rain. They have been declining following the completed installation and the connection of steel pipe sheet piles for the sea-side impermeable walls.

- Regarding the radioactive materials in seawater in the area outside the port, densities of cesium 137 and strontium 90 have been declining and remained low following the completed installation and the connection of steel pipe sheet piles for the sea-side impermeable walls.

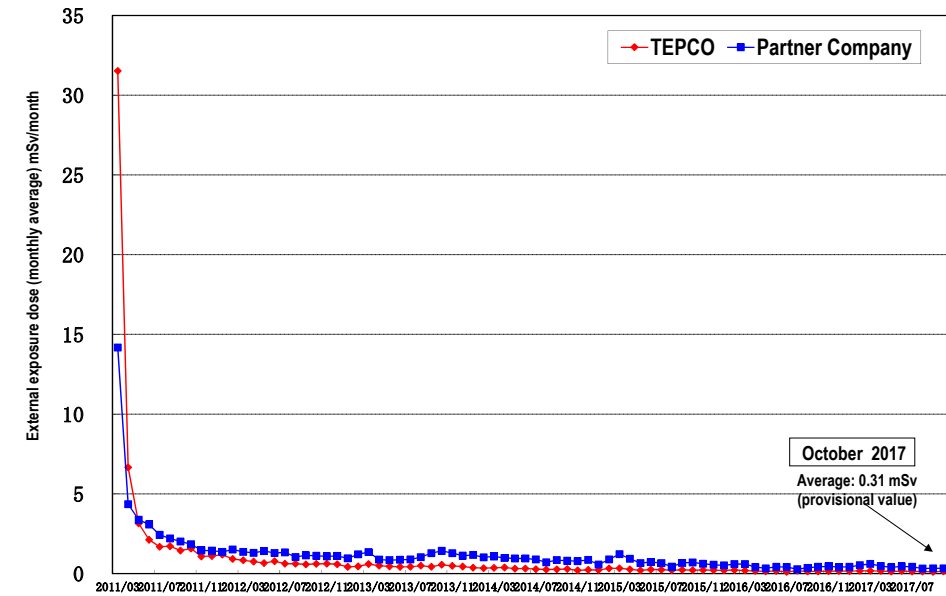
Figure 7: Changes in monthly individual worker exposure dose (monthly average exposure dose since March 2011)

- The monthly average exposure dose of workers remained at approx. 0.81 mSv/month during FY2014, approx. 0.59 mSv/month during FY2015 and approx. 0.39 mSv/month during FY2016. (Reference: Annual average exposure dose 20 mSv/year \doteq 1.7 mSv/month)

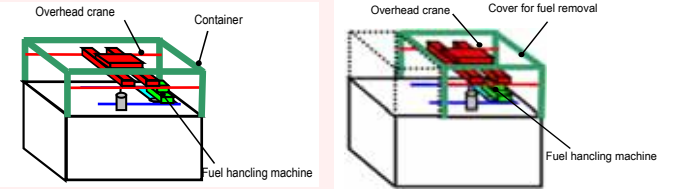
To facilitate removal of fuel assemblies and retrieval of debris in the Unit 2 spent fuel pool, the scope of dismantling and modification of the existing Reactor Building rooftop was examined. From the perspective of ensuring safety during the work, controlling impacts on the outside of the power station, and removing fuel rapidly to reduce risks, we decided to dismantle the whole rooftop above the highest floor of the Reactor Building. Examination of the following two plans continues: Plan 1 to share a container for removing fuel assemblies from the pool and retrieving fuel debris; and Plan 2 to install a dedicated cover for fuel removal from the pool.

Image of Plan 1

Image of Plan 2

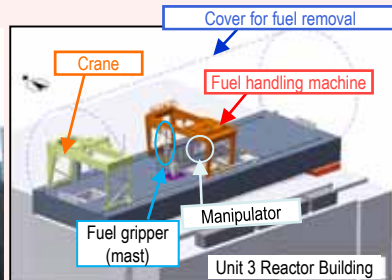
Image of entire fuel handling facility inside the cover

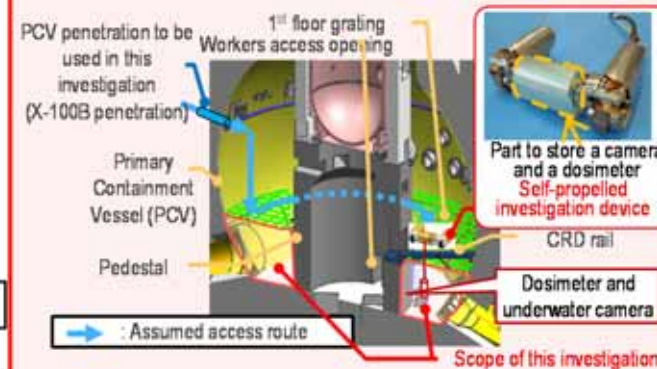
- In April 2015, a device, which entered the inside of the PCV through a narrow access opening (bore: ϕ 100 mm), collected information such as images and airborne dose inside the PCV 1st floor.
- In March 2017, the investigation using a self-propelled investigation device, conducted to inspect the spreading of debris to the basement floor outside the pedestal, took images of the PCV bottom status for the first time. The status inside the PCV will continue to be examined based on the collected image and dose data.

Image of hanging of dosimeter and camera

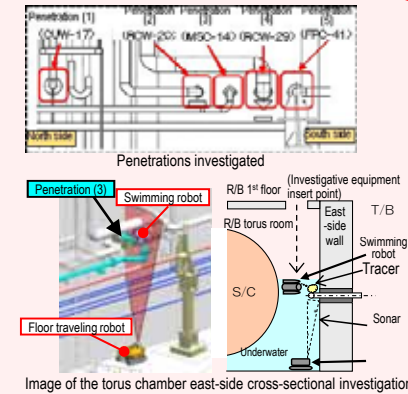
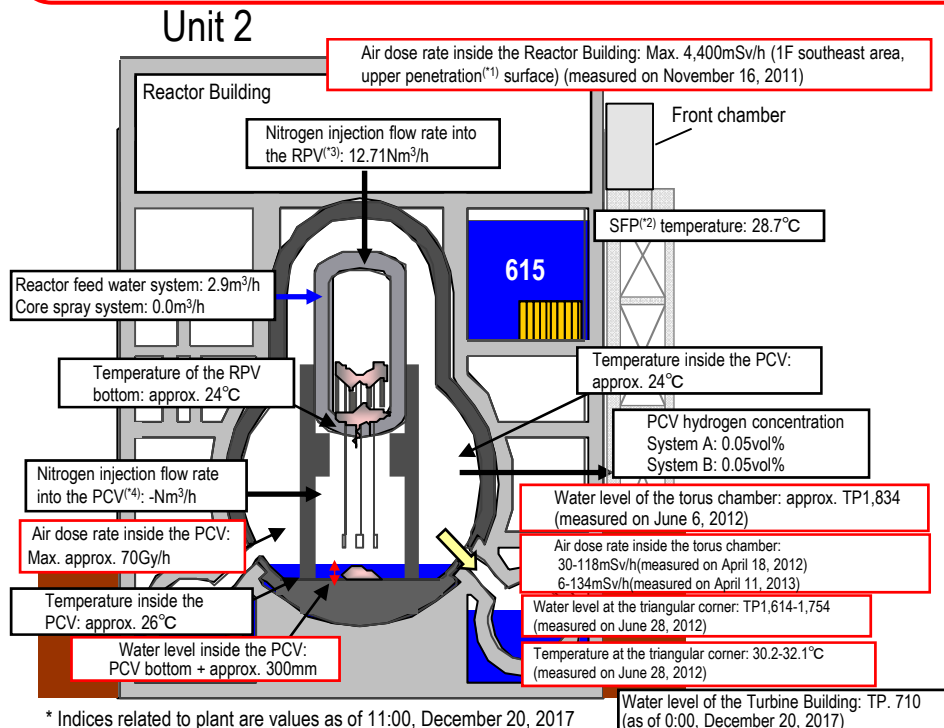
Investigative results on torus chamber walls

- The torus chamber walls were investigated (on the north side of the east-side walls) using equipment specially developed for that purpose (a swimming robot and a floor traveling robot).
- At the east-side wall pipe penetrations (five points), "the status" and "existence of flow" were checked.
- A demonstration using the above two types of underwater wall investigative equipment showed how the equipment could check the status of penetration.
- Regarding Penetrations 1 - 5, the results of checking the sprayed tracer (*) by camera showed no flow around the penetrations. (investigation by the swimming robot)
- Regarding Penetration 3, a sonar check showed no flow around the penetrations. (investigation by the floor traveling robot)

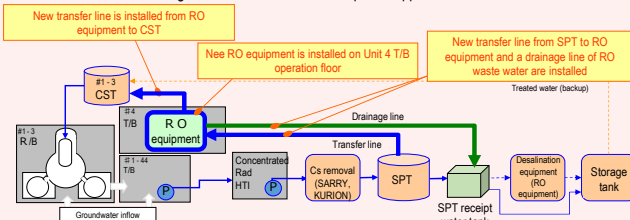
Work to improve the reliability of the circulation water injection cooling system and pipes to transfer stagnant water.

- Operation of the reactor water injection system using Unit 3 Condensate Storage Tank (CST) as a water source commenced (from July 5, 2013). Compared to the previous systems, the reliability of the reactor water injection system was enhanced, e.g. by increasing the amount of water-source storage and enhancing durability.
- To reduce the risk of contaminated-water leakage, the circulation loop was shortened by installing a reverse osmosis (RO) device in the Unit 4 Turbine Building within the circulation loop, comprising the transfer of contaminated water, water treatment and injection into the reactors. Operation of the installed RO device started from October 7 and 24-hour operation started from October 20. Installation of the new RO device inside the building shortened the circulation loop from approx. 3 to 0.8 km.

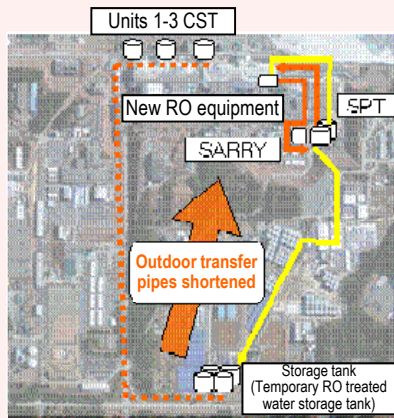
* The entire length of contaminated water transfer pipes is approx. 2.1km, including the transfer line of surplus water to the upper heights (approx. 1.3km).

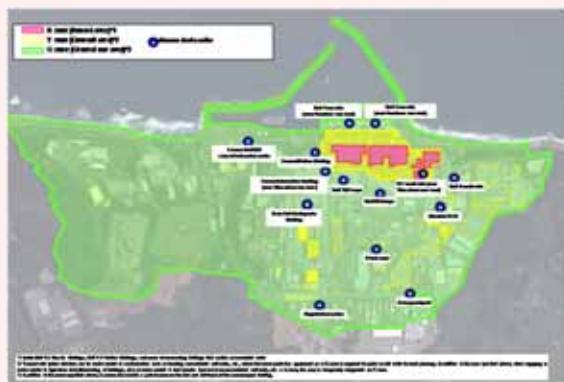
Based on the progress of measures to reduce environmental dosage on site, the site is categorized into two zones: highly contaminated area around Unit 1-4 buildings, etc. and other areas to optimize protective equipment according to each category aiming at improving safety and productivity by reducing load during work.

R zone (Anorak area)	Y zone (Coverall area)	G zone (General wear)
Full face mask  	Full face or half face masks  	Disposable disposable mask  
Anorak on coverall Or double coveralls  	Coverall  	General ¹⁾ Dedicated on-site wear

¹⁾ For works in buildings including water treatment facilities (small-scale removal equipment, etc.) (excluding site visits), wear a full face mask.
²⁾ For works in both or more contaminating concentrated full water or de-treated water (including works and handling concentrated full water, etc., grab-in, on-site investigation for work planning, and site visits) and works related to tank transfer lines, wear a full face mask.
³⁾ Specified light works (grab-in, monitoring, delivery of goods brought from outside, etc.)

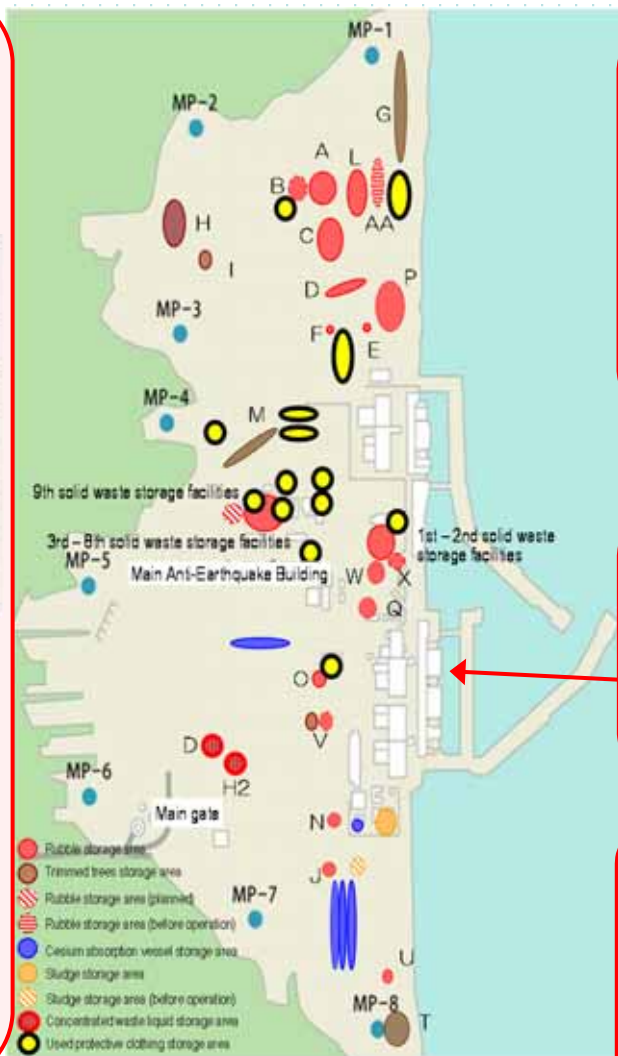
Installation of dose-rate monitors

To help workers in the Fukushima Daiichi Nuclear Power Station precisely understand the conditions of their workplaces, a total of 86 dose-rate monitors were installed by January 4, 2016.
