Main decommissioning works and steps

All fuel had been removed from Unit 4 SFP by December 22, 2014. Work continues toward fuel removal and debris (Note 1) retrieval from Unit 1-3.

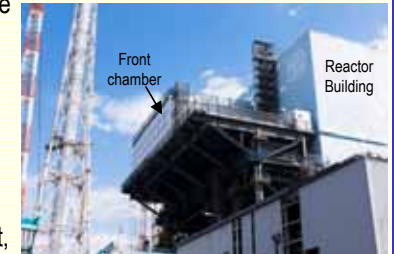
Status on the Reactor Building west side

For Unit 2, toward fuel removal from the spent fuel pool, the dose and dust density, etc. on the operating floor will be measured before examining measures, etc. to prevent any influence on the surrounding environment. Following the completion of preparation, installation of an opening to access the inside of the operating floor will start from April. Dust scattering during the installation work will be suppressed by purifying the room air spraying anti-scattering agent, etc. Work will continue with safety first.

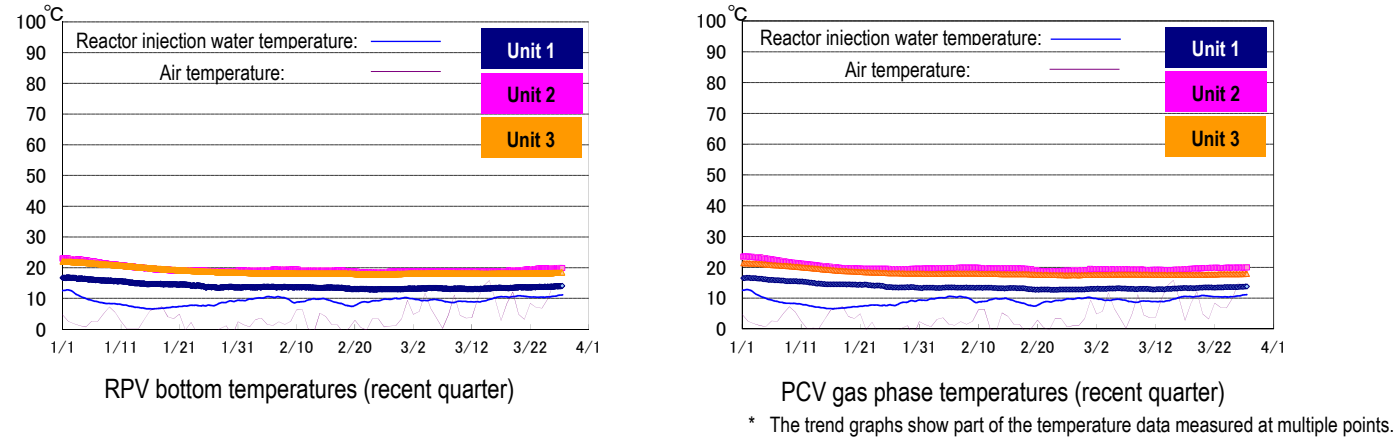
Through continuous reactor cooling by water injection, the temperatures of the Reactor Pressure Vessel (RPV) bottom and the Primary Containment Vessel (PCV) gas phase were maintained within the range of approx. 10 to 20°C for the past month, though it varied depending on the unit and location of the thermometer.

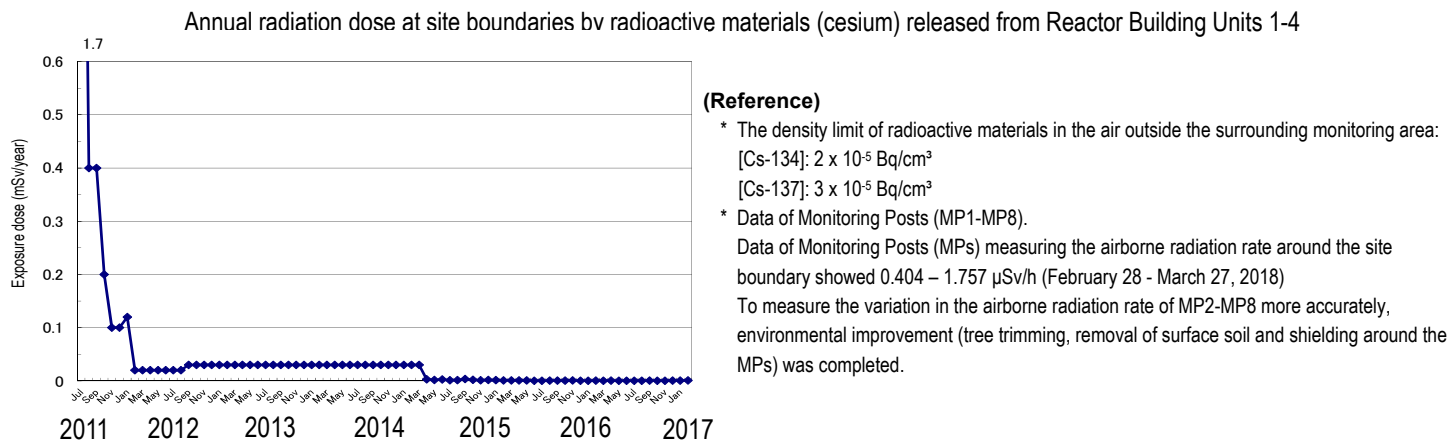
As of February 2018, the density of radioactive materials newly released from Reactor Building Units 1-4 in the air and measured at the site boundary was evaluated at approx. 8.4×10^{-12} Bq/cm³ for Cs-134 and 6.1×10^{-11} Bq/cm³ for Cs-137, while the radiation exposure dose due to the release of radioactive materials there was less than 0.00069 mSv/year.

Note: Different formulas and coefficients were used to evaluate the radiation dose in the facility operation plan and monthly report. The evaluation methods were integrated in September 2012. As the fuel removal from the spent fuel pool (SFP) commenced for Unit 4, the radiation exposure dose from Unit 4 was added to the items subject to evaluation since November 2013. The evaluation has been changed to a method considering the values of continuous dust monitors since FY2015, with data to be evaluated monthly and announced the following month.

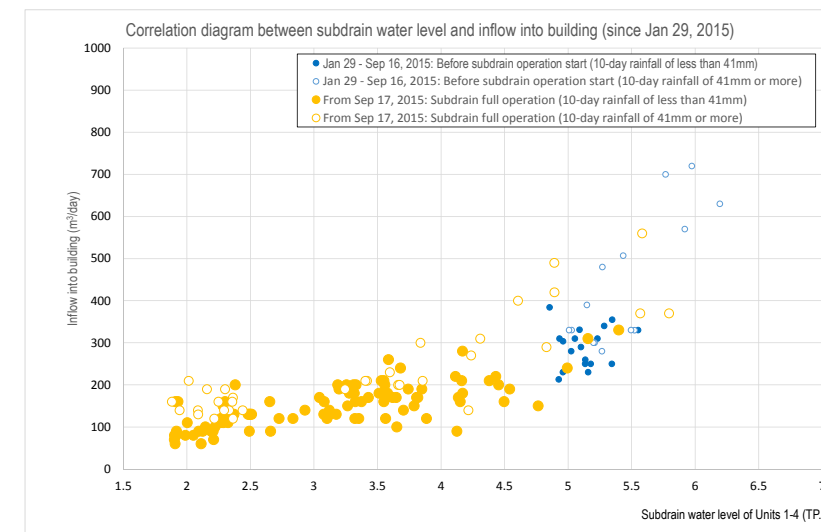
Figure 1: Correlation between inflow such as groundwater and rainwater into buildings and the water level of Unit 1-4 subdrains

- Since the subdrains went into operation, the inflow into buildings tended to decline to less than 150 m³/day when the subdrain water level declined below T.P. 3.0 m, while the inflow increased during rainfall.

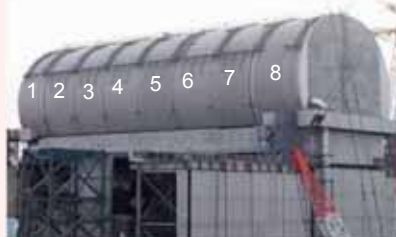
Installation of dome roof (February 21)

Installation of the fuel removal cover was completed on February 23, 2018. Work will continue with safety first toward fuel removal around mid-FY2018.

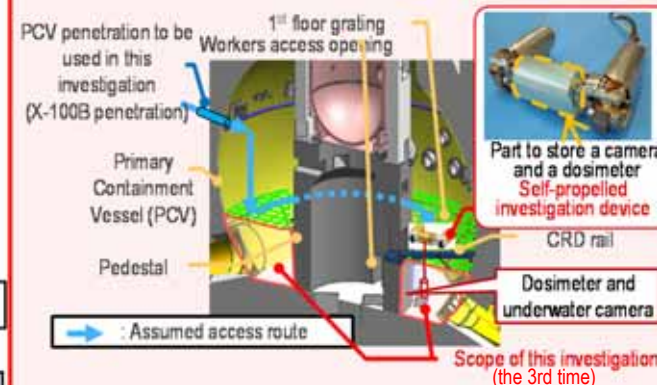
Image of hanging of dosimeter and camera

- In April 2015, a device, which entered the inside of the PCV through a narrow access opening (bore: φ 100 mm), collected information such as images and airborne dose inside the PCV 1st floor.
- In March 2017, the investigation using a self-propelled investigation device, conducted to inspect the spreading of debris to the basement floor outside the pedestal, took images of the PCV bottom status for the first time. The status inside the PCV will continue to be examined based on the collected image and dose data.

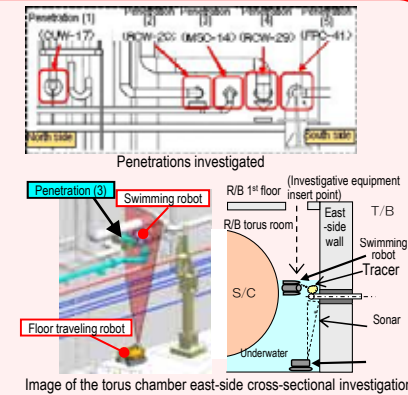
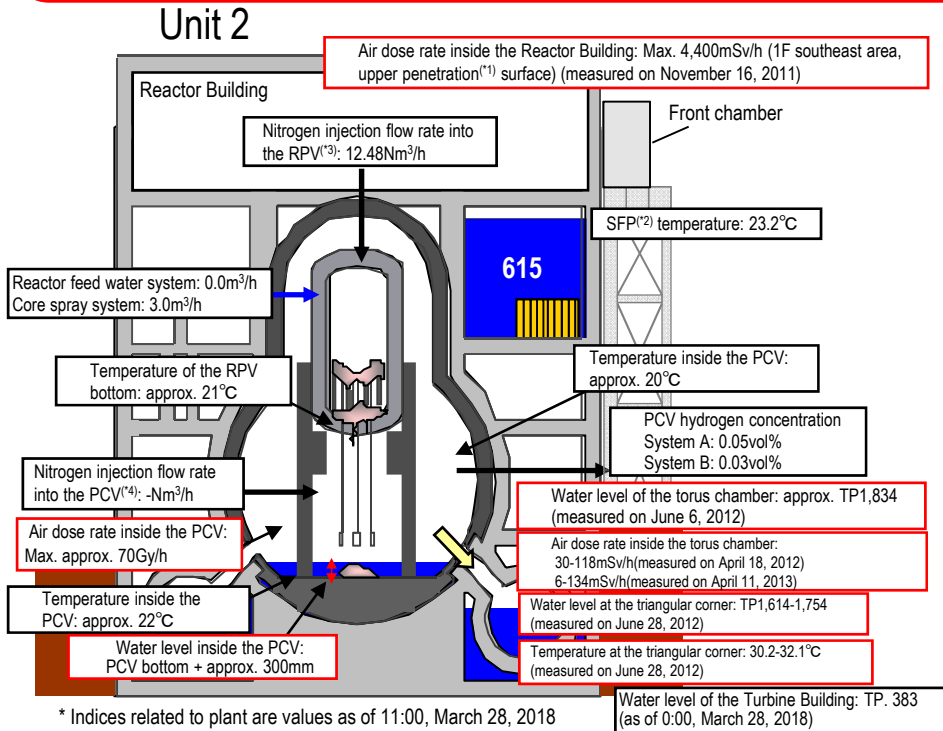
Investigative results on torus chamber walls

- The torus chamber walls were investigated (on the north side of the east-side walls) using equipment specially developed for that purpose (a swimming robot and a floor traveling robot).
- At the east-side wall pipe penetrations (five points), "the status" and "existence of flow" were checked.
- A demonstration using the above two types of underwater wall investigative equipment showed how the equipment could check the status of penetration.
- Regarding Penetrations 1 - 5, the results of checking the sprayed tracer (*) by camera showed no flow around the penetrations. (investigation by the swimming robot)
- Regarding Penetration 3, a sonar check showed no flow around the penetrations. (investigation by the floor traveling robot)

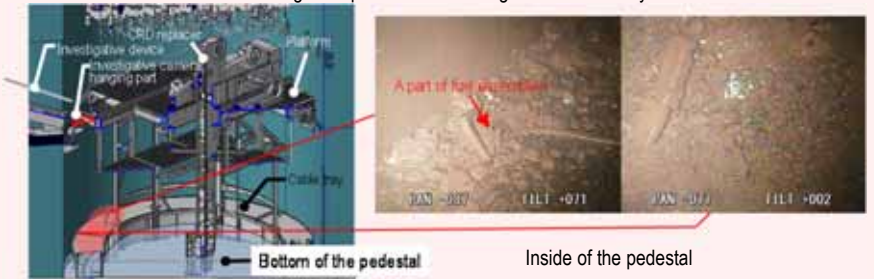
- The results of this series of investigations confirmed fallen and deformed gratings and a quantity of deposit inside the pedestal.
- On January 19, 2018, the inside of the Unit 2 PCV was investigated. During this investigation, the status under the platform was inspected by the improved telescopic-type investigative device which was used in the previous investigation (January - February 2017). From the investigative results, part of the fuel assemblies having fallen to the bottom of the pedestal was found. Deposits identified around the fuel assemblies were considered to be fuel debris. The images acquired in this investigation will be analyzed.

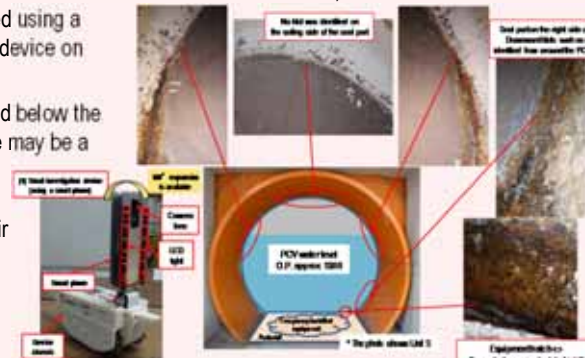
Investigative results into the Unit 3 PCV equipment hatch using a small investigation device

- As part of the investigation into the PCV to facilitate fuel debris retrieval, the status around the Unit 3 PCV equipment hatch was investigated using a small self-traveling investigation device on November 26, 2015.

- Given blots such as rust identified below the water level inside the PCV, there may be a leakage from the seal to the extent of bleeding. Methods to investigate and repair the parts, including other PCV penetrations with a similar structure, will be considered.

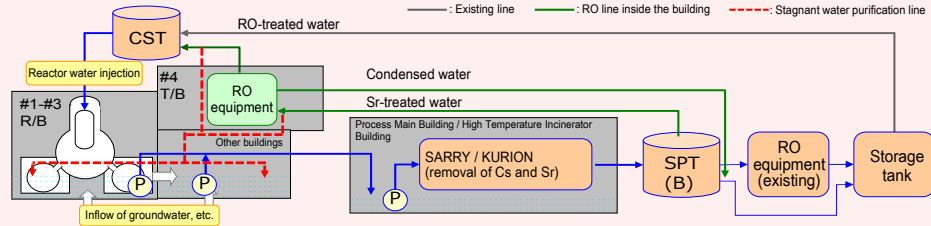
- The risks of stagnant water inside the buildings will continue to be reduced in addition to reduction of its storage.
- The circulating purification on the Unit 1 and 2 side will go into operation in April.

* The entire length of contaminated water transfer pipes is approx. 2.1km, including the transfer line of surplus water to the upper heights (approx. 1.3km).

- To reduce the risk of contaminated-water leakage, the circulation loop was shortened by installing a reverse osmosis (RO) device in the Unit 4 Turbine Building within the circulation loop, comprising the transfer of contaminated water, water treatment and injection into the reactors. Operation of the installed RO device started from October 7 and 24-hour operation started from October 20. Installation of the new RO device inside the building shortened the circulation loop from approx. 3 to 0.8 km.

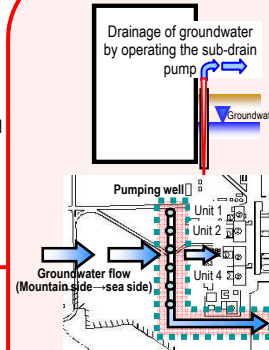
To prevent the inflow of groundwater into the buildings, installation of impermeable walls on the land side is planned. Freezing started on the sea side and at a part of the mountain side from March 2016 and at 95% of the mountain side from June 2016. Freezing of the remaining unfrozen sections advanced with a phased approach and freezing of all sections started in August 2017. In March 2018, the land-side impermeable walls were considered completed except for a portion of the depths based on a monitoring result showing that the underground temperature had declined below 0°C in almost all areas and on the mountain side, the difference between the inside and outside increased to approx. 4-5 m. The multi-layered contaminated water management measures, including subdrains and facing, have stably controlled the groundwater level. Consequently, a water-level management system to isolate the buildings from groundwater was considered to have been established. The Committee on Countermeasures for Contaminated Water Treatment held on March 7 confirmed the effect of the land-side impermeable walls based on these evaluation results.

Freezing plant
Land-side impermeable walls
-Length: approx. 1,500m

Installing land-side impermeable walls with frozen soil around Units 1-4 to prevent the inflow of groundwater into the building
