## Main decommissioning works and steps

All fuel had been removed from Unit 4 SFP by December 22, 2014. Work continues toward fuel removal and debris (Note 1) retrieval from Unit 1-3.

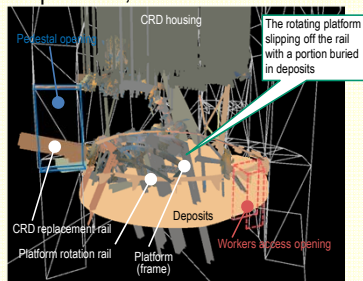
3D reproduced image

To understand the overall picture inside the pedestal, videos obtained while investigating inside the Unit 3 PCV in July 2017 were reproduced in 3D. Based on the reproduced images, the relative positions of the structures, such as the rotating platform slipping off the rail with a portion buried in deposits, were visually understood. Consideration toward fuel removal, such as utilizing these results in the equipment design, continues.

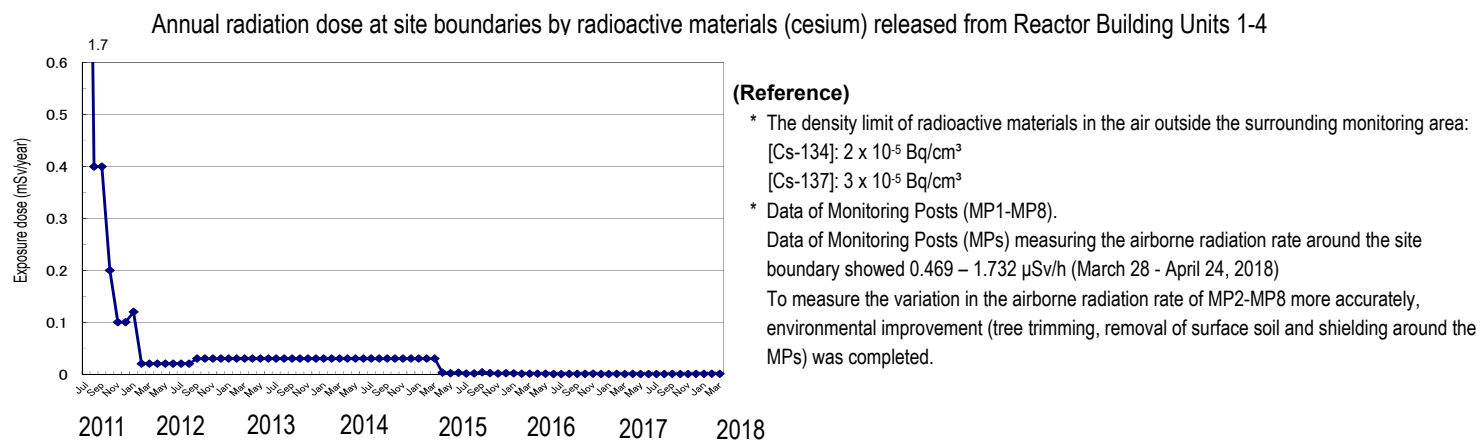
As of March 2018, the density of radioactive materials newly released from Reactor Building Units 1-4 in the air and measured at the site boundary was evaluated at approx.  $3.7 \times 10^{-12}$  Bq/cm<sup>3</sup> for Cs-134 and  $2.1 \times 10^{-11}$  Bq/cm<sup>3</sup> for Cs-137, while the radiation exposure dose due to the release of radioactive materials there was less than 0.00036 mSv/year.
