Main decommissioning works and steps

All fuel had been removed from Unit 4 SFP by December 22, 2014. Work continues toward fuel removal and debris (Note 1) retrieval from Unit 1-3.

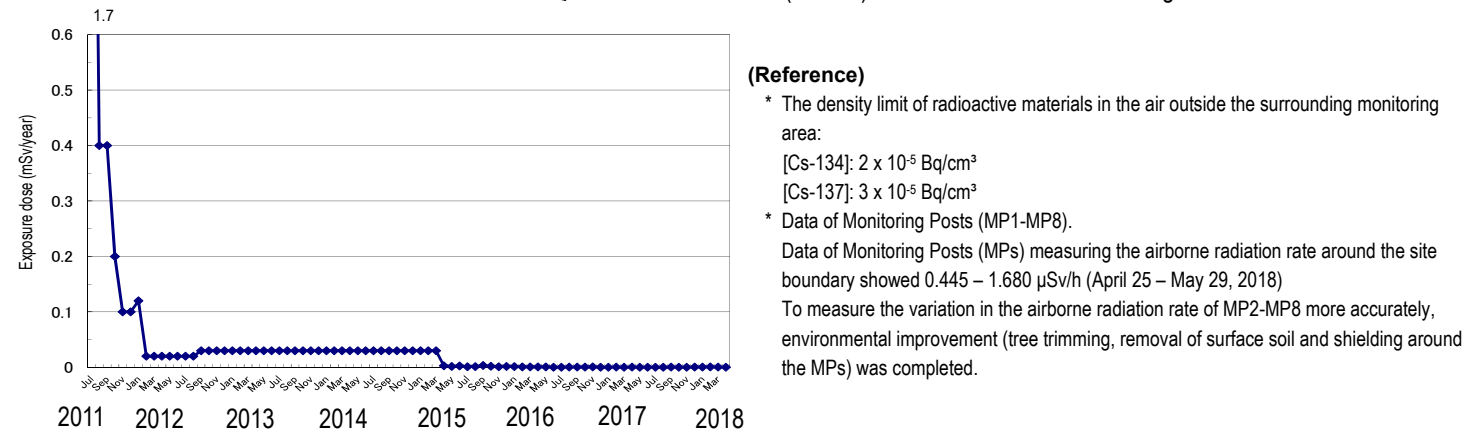
Annual radiation dose at site boundaries by radioactive materials (cesium) released from Reactor Building Units 1-4

Note: Different formulas and coefficients were used to evaluate the radiation dose in the facility operation plan and monthly report. The evaluation methods were integrated in September 2012. As the fuel removal from the spent fuel pool (SFP) commenced for Unit 4, the radiation exposure dose from Unit 4 was added to the items subject to evaluation since November 2013. The evaluation has been changed to a method considering the values of continuous dust monitors since FY2015, with data to be evaluated monthly and announced the following month.

As of April 2018, the density of radioactive materials newly released from Reactor Building Units 1-4 in the air and measured at the site boundary was evaluated at approx. 1.6×10^{-12} Bq/cm³ for Cs-134 and 6.4×10^{-12} Bq/cm³ for Cs-137, while the radiation exposure dose due to the release of radioactive materials there was less than 0.00023 mSv/year.

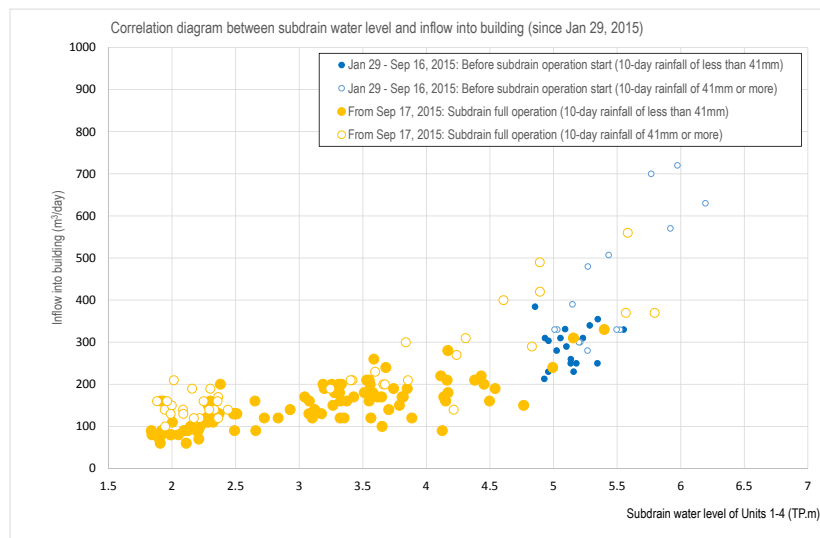
Figure 1: Correlation between inflow such as groundwater and rainwater into buildings and the water level of Unit 1-4 subdrains

- For water levels of subdrains installed around the Unit 1-4 buildings, monitoring from the Main Anti-Earthquake Building was suspended due to communication cables failing on May 18. After investigating the status of the location and replacing them with spare cables the same day, monitoring of water levels from the Main Anti-Earthquake Building resumed.
- An onsite inspection confirmed that subdrain water levels necessary to prevent stagnant water leaking had been maintained and no abnormality was detected during the monitoring suspension.

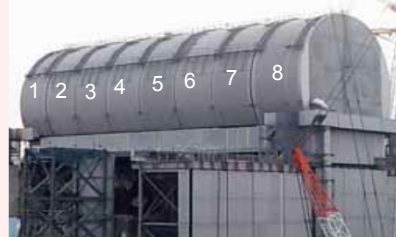
Installation of dome roof (February 21)

Installation of the fuel removal cover was completed on February 23, 2018. Work will continue with safety first toward fuel removal around mid-FY2018.
