Inspection of protection equipments of transmission lines
at substations, etc.
(Report)

June 8, 2011
Tokyo Electric Power Company

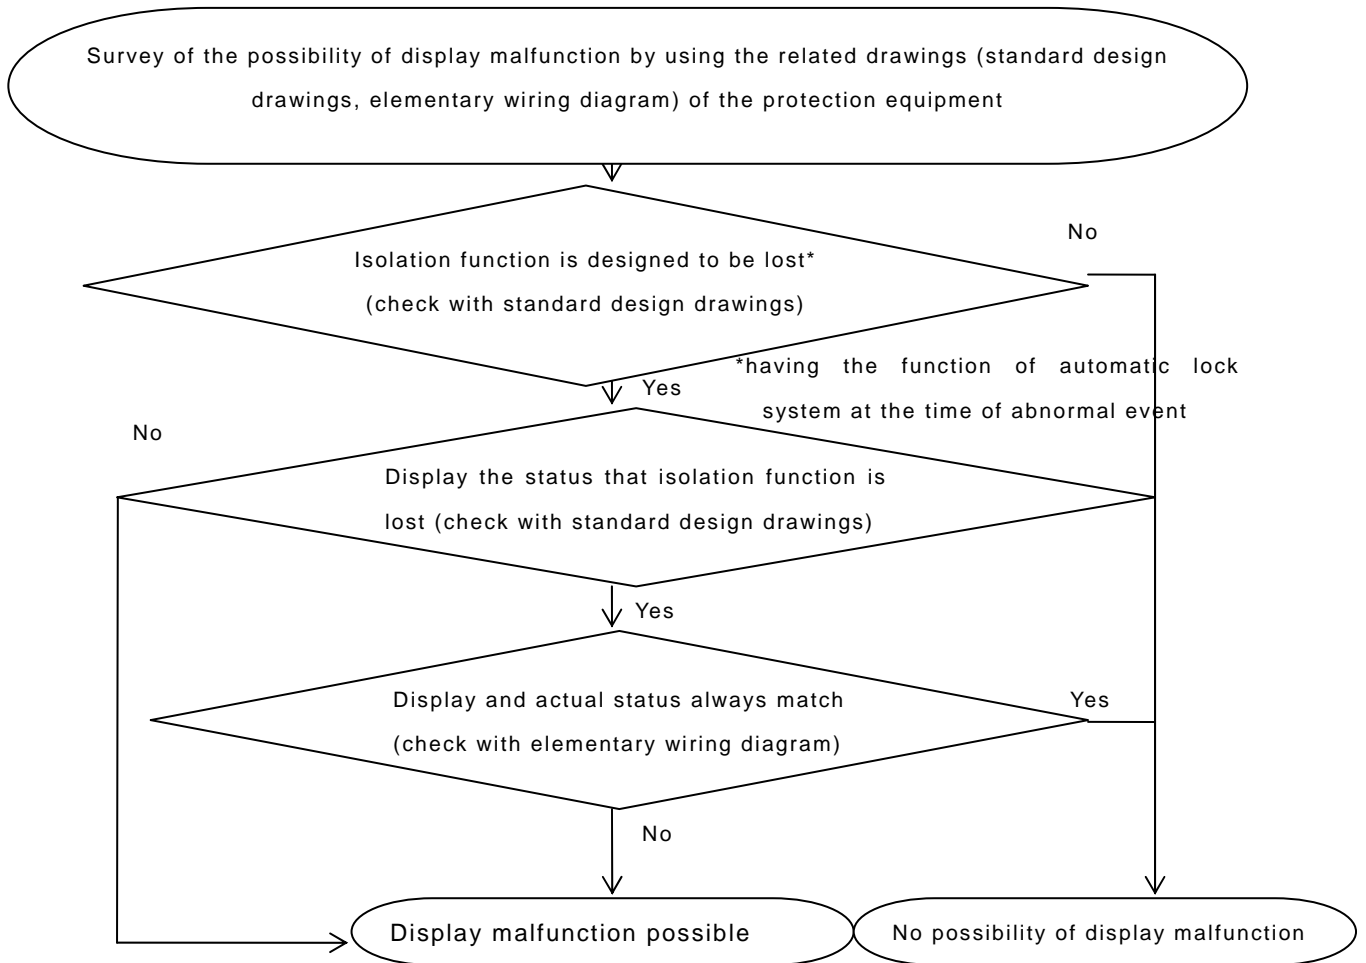
Chart 1: Survey result flow chart

Using the related drawings (standard design drawings, elementary wiring diagram) of the protection equipment, the possibility of display malfunction was checked based on the following decision chart.
