Progress Status and Future Challenges of the Mid-and-Long-Term Roadmap towards the Decommissioning of TEPCO's Fukushima Daiichi Nuclear Power Station Units 1-4 (Outline)

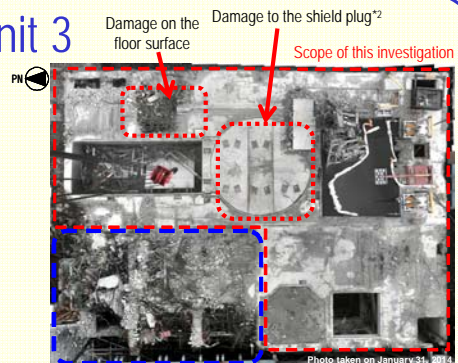
Prior to installing the fuel removal cover, structure of the reactor building was investigated with using a camera mounted on the crane. The investigation found some partial damages on the operating floor surface^{*1} but no significant damage. For the next step, seismic assessment of the reactor building will be implemented based on the investigation result.

Confirmed by the status investigation immediately after the earthquake
* Full view produced by integrated photos of investigation
<Investigative result of operation floor>

- Before installing a fuel-removal cover, the structure of the Reactor Building was investigated (from December 19 and completed on January 31) following the removal of rubble from the operating floor. Though damage was detected to some parts of the operating floor surface and shield plug, no significant damage was detected elsewhere. The next step will involve the scheduled seismic safety evaluation based on these circumstances.

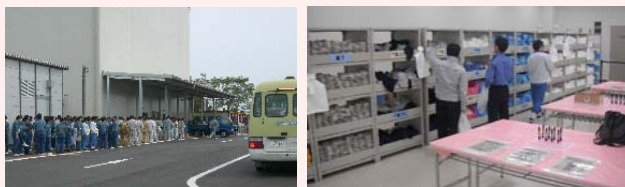
An entry control facility near the main gate of the Fukushima Daiichi Nuclear Power Station commenced operation from June 30, 2013, where contamination tests, decontamination, switching on and off of protective equipment, and distribution/ collection of dosimeters are being conducted.

External view of the entrance control facility Inside the entrance control facility
