## Main works and steps for decommissioning

Fuel removal from Unit 4 SFP is underway. Preparatory works to remove fuel from Unit 1-3 SFP and fuel debris (Note 1) removal are ongoing.

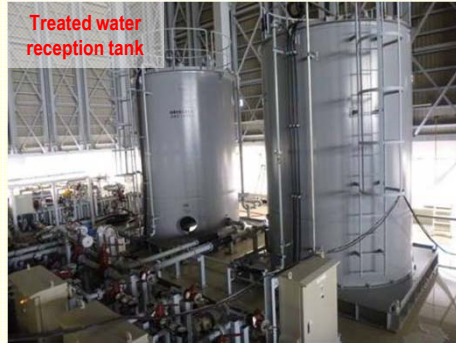
<Installation status of additional multi-nuclide removal equipment>

Regarding the additional multi-nuclide removal equipment (ALPS) having been installed, test operation is proceeding steadily with treatment of contaminated water beginning by one of three systems on September 17. Regarding the remaining two systems, treatment will begin sequentially once preparation is completed.

- Regarding the additional multi-nuclide removal equipment, hot tests using radioactive water are underway (System A: from September 17, System B: scheduled for commencement on September 27, System C: scheduled for commencement in early October) (see Figure 4).

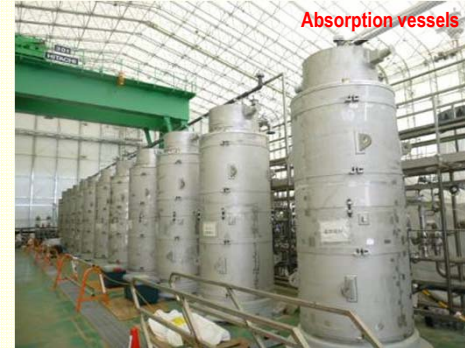
<Installation status of high-performance multi-nuclide removal equipment>

Installation of high-performance multi-nuclide removal equipment, which will significantly reduce waste generation compared to the multi-nuclide removal equipment (ALPS), is steadily underway. Treatment will begin in mid-October once preparation is completed.

- Regarding the high-performance multi-nuclide removal equipment, a subsidy project of the Ministry of Economy, Trade and Industry, foundation construction (from May 10) and installation of equipment (from July 14) are underway. Hot tests will begin in mid-October (see Figure 5).

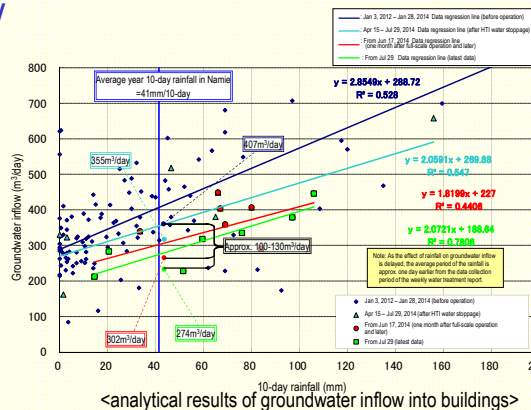
To reduce inflow of groundwater into the buildings and control the increase of contaminated water, groundwater is pumped up on the mountain side of the buildings and released after confirming that the water meets the operation target, which is stricter than the announcement density. The analysis on the groundwater inflow into the buildings based on the existing data showed that the inflow had decreased by approx. 100-130 tons/day (approx. 50-80 tons at the groundwater bypass if the estimated effect of the water stoppage of the HTI building is approx. 50 tons) by combined effect of the inflow control measures.

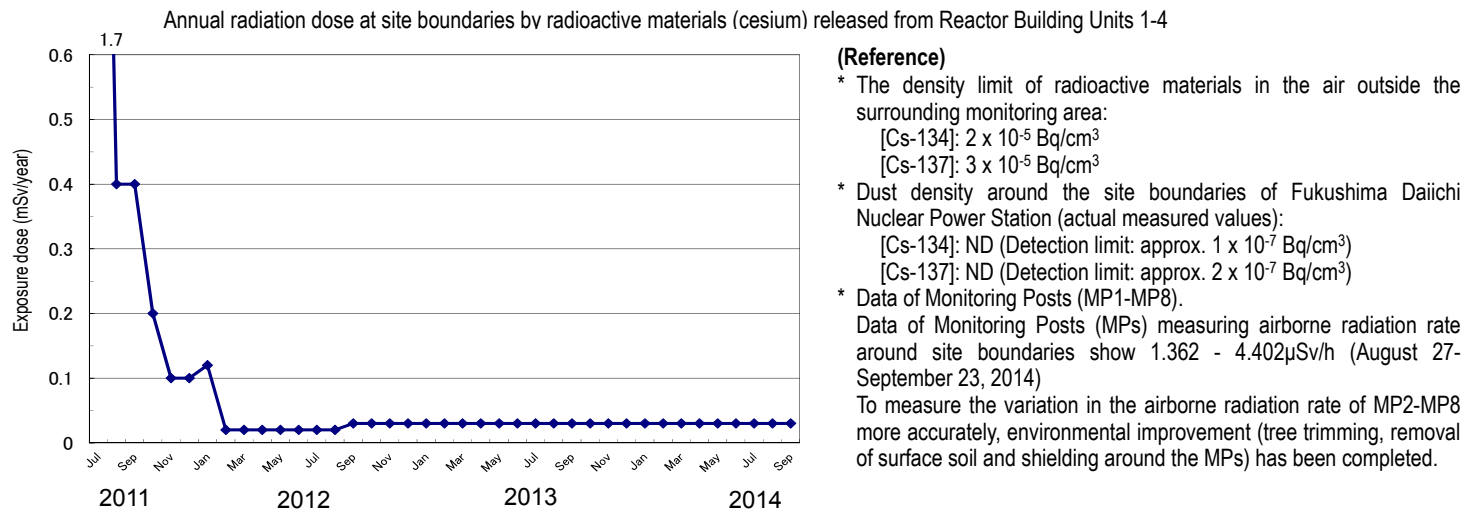
The density of radioactive materials newly released from Reactor Building Units 1-4 in the air measured at site boundaries was evaluated at approx.  $1.4 \times 10^{-9}$  Bq/cm<sup>3</sup> for both Cs-134 and -137. The radiation exposure dose due to the release of radioactive materials was 0.03 mSv/year (equivalent to approx. 1/70 of the annual radiation dose by natural radiation (annual average in Japan: approx. 2.1 mSv/year)) at the site boundaries.

Note: Different formulas and coefficients were used to evaluate the radiation dose in the facility operation plan and monthly report. The evaluation methods were integrated in September 2012. As the fuel removal from the spent fuel pool (SFP) commenced for Unit 4, the radiation exposure dose from Unit 4 was added to the items subject to evaluation since November 2013.

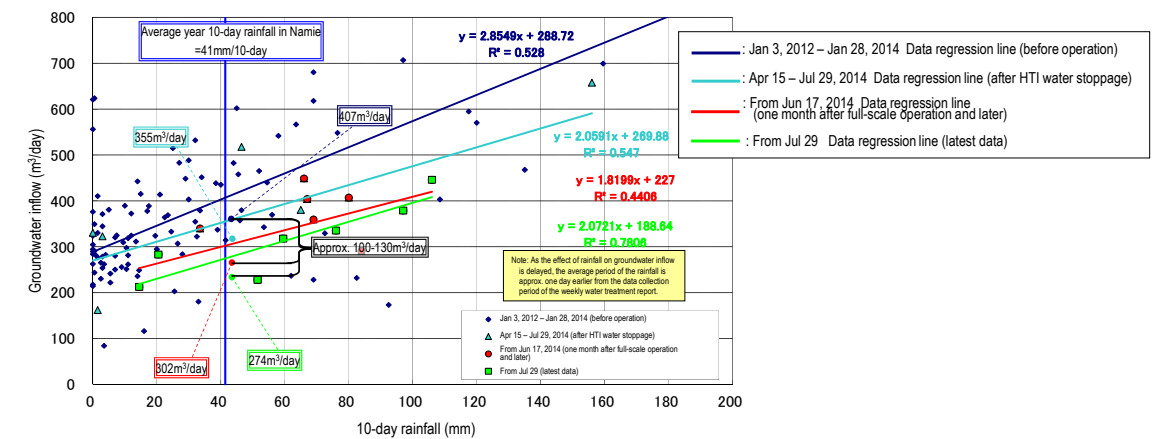
Figure 1: Analysis results of inflow into buildings

- It was confirmed that the groundwater inflow into the buildings had decreased by 100-130m<sup>3</sup>/day through measures such as the groundwater bypass and water-stoppage of the High Temperature Incinerator Building (HTI) (see Figure 1).

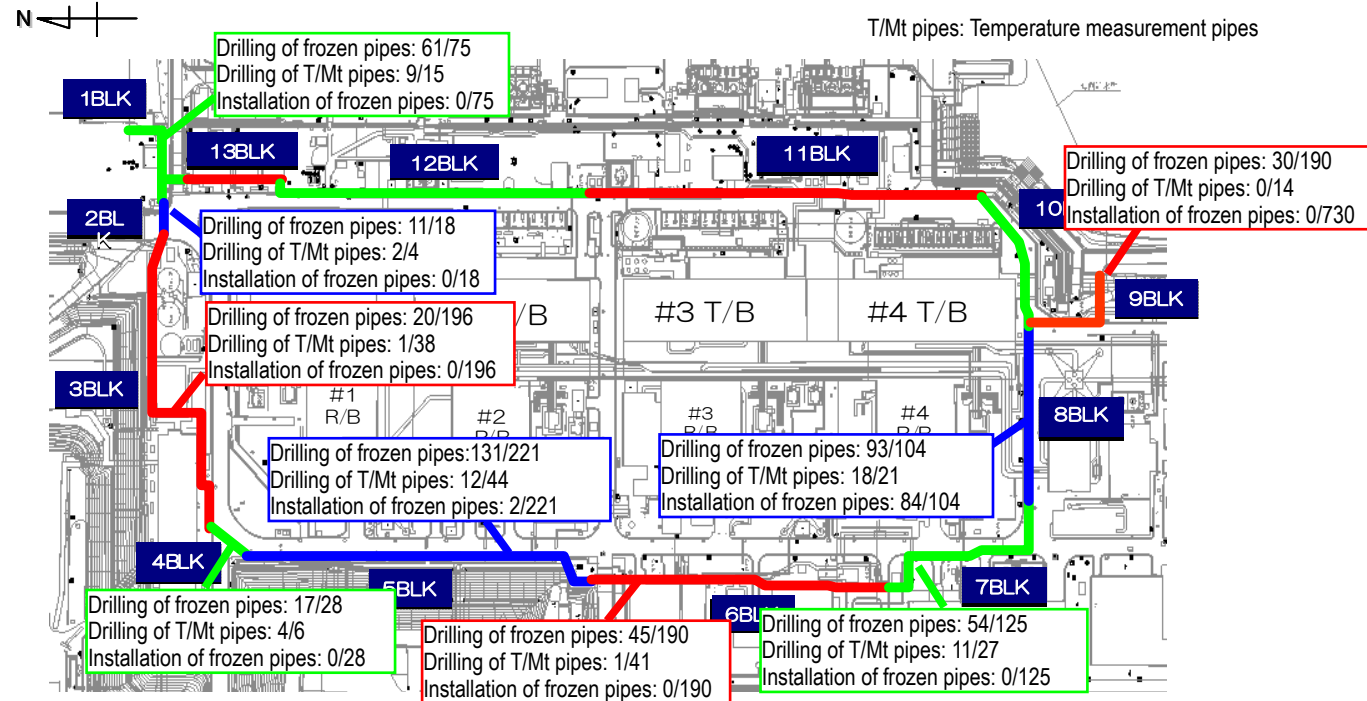
Figure 3: Status of drilling for frozen-soil impermeable walls and installation of frozen pipes

- To facilitate the installation of frozen-soil impermeable walls surrounding Units 1-4 (a subsidy project of the Ministry of Economy, Trade and Industry), drilling to place frozen pipes commenced (from June 2). As of September 23, drilling at 521 points (for frozen pipes: 462 of 1,545 points, for temperature-measurement pipes: 59 of 315 points) and installation of frozen pipes at 103 of 1,545 points had been completed (see Figure 3).
- Installation of chillers for freezing is underway (from August and scheduled for completion on November 22, installation of 13/30 units had been completed).
- Regarding construction for pipe penetration on the mountain side of the Unit 1-4 buildings, the implementation plan was approved (September 17).

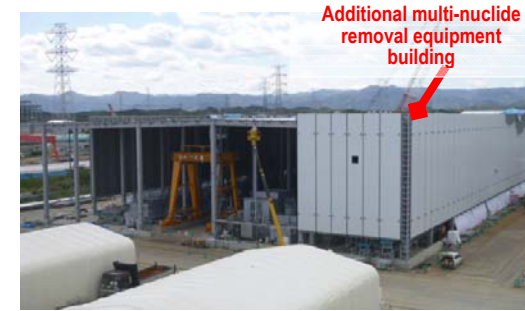
Figure 4: Overview of additional multi-nuclide removal equipment

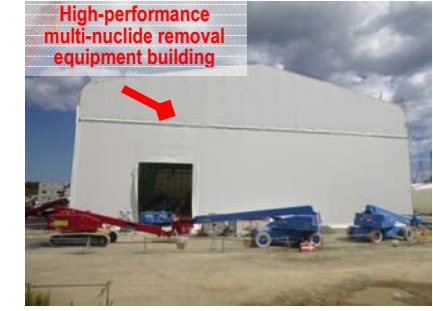
Figure 5: Overview of high-performance multi-nuclide removal equipment

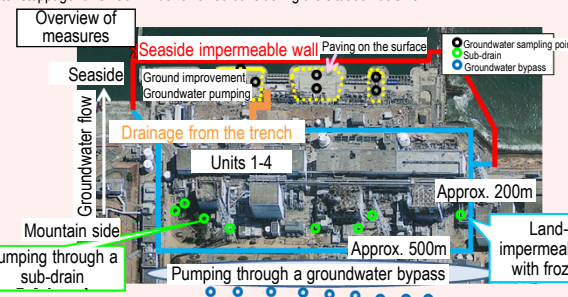
- Removing contaminated water in branch trenches and closing them (completed on September 19, 2013)
    - Treatment and removal of contaminated water in the seawater pipe trench

- Freezing toward water stoppage commenced on April 2.
- Unit 3: November 15, 2013 – July 28, 2014, treatment of cesium. Water stoppage for Unit 3 will be reviewed considering the situation at Unit 2.
