Main works and steps for decommissioning

Progress status

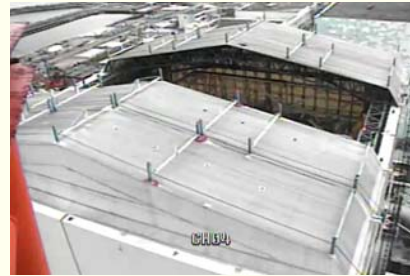
<Status of building cover roof panels>

Two roof panels of the Unit 1 Reactor Building (R/B) were removed to facilitate investigation of the rubble status and monitoring of the dust concentration trend on the R/B top floor (operating floor).

The removed roof panels will be temporarily returned to the roof by early December. Subsequently, after completing the "construction of impermeable walls with frozen soil", which is conducted in the same area, dismantling of R/B cover will commence from around March, 2015.

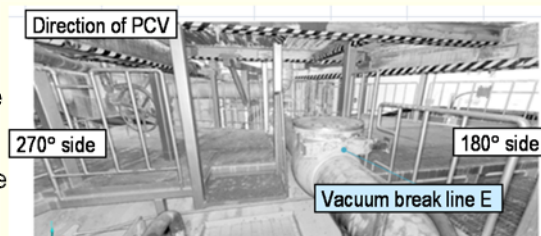
<Image of 3D data>

The upper part of the underground floor (torus room) of Unit 1 R/B was investigated with a laser scan using a remote-controlled robot, and 3D data was collected.

The collected 3D scan data will subsequently be used when considering a plan to repair the PCV in future.

- For use in evaluating obstacles as required for works, including water stoppage at the PCV, inside the Unit 1 Reactor Building torus room, which will be conducted as a future step, 3D data inside the torus room was collected using remote-controlled equipment and with mounted 3D laser-measurement equipment (from October 31 to November 7). The collected 3D scan data will be used in the plan to repair the PCV and vacuum break line.

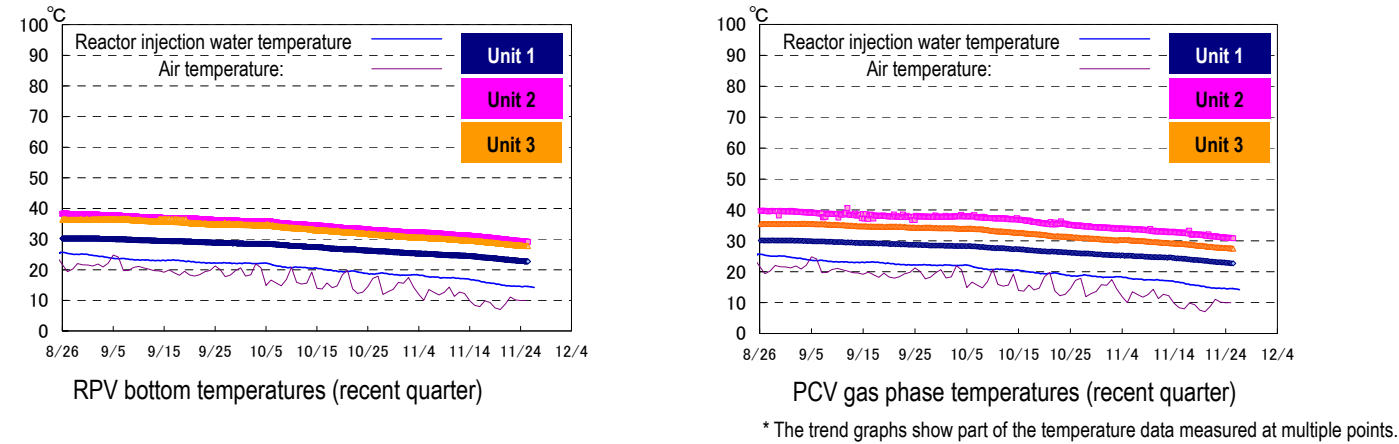
Through continuous reactor cooling by water injection, the temperatures of the Reactor Pressure Vessel (RPV) bottom and the Primary Containment Vessel (PCV) gas phase have been maintained within the range of approx. 20 to 45°C for the past month, though they vary depending on the unit and location of the thermometer.

◆ The temperatures of the Reactor Pressure Vessel (RPV) and the Primary Containment Vessel (PCV) of Units 1-3 have been maintained within the range of approx. 20-45°C^{*1} for the past month. There was no significant change in the density of radioactive materials newly released from Reactor Buildings in the air^{*2}. It was evaluated that the comprehensive cold shutdown condition had been maintained.

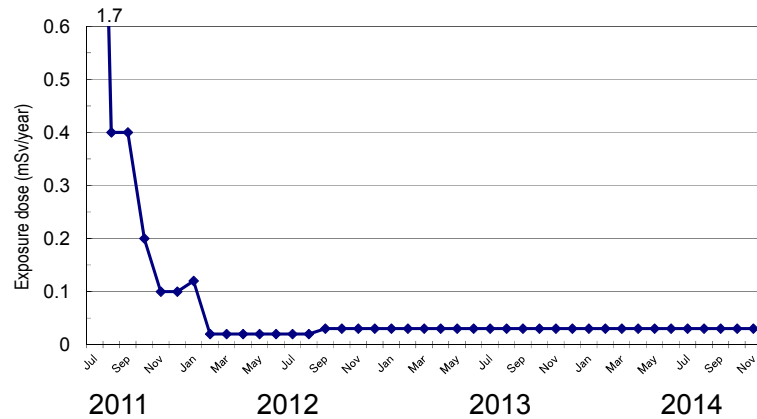
Annual radiation dose at site boundaries by radioactive materials (cesium) released from Reactor Building Units

The density of radioactive materials newly released from Reactor Building Units 1-4 in the air measured at site boundaries was evaluated at approx. 1.8×10^{-9} Bq/cm³ for both Cs-134 and -137. The radiation exposure dose due to the release of radioactive materials was 0.03 mSv/year (equivalent to approx. 1/70 of the annual radiation dose by natural radiation (annual average in Japan: approx. 2.1 mSv/year)) at the site boundaries.

*2 The radiation exposure dose due to the current release of radioactive materials from the Reactor Buildings peaked at 0.03 mSv/year at the site boundaries. This is approx. 1/70 of the annual radiation dose by natural radiation (annual average in Japan: approx. 2.1 mSv/year).

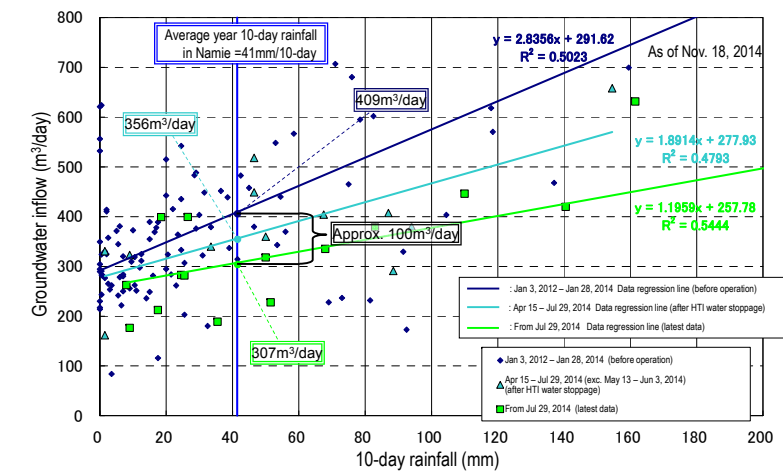
Figure 1: Analytical results of inflow into buildings

- It was confirmed that the groundwater inflow into the buildings had decreased by 100 m³/day based on the evaluation data obtained to date through measures such as the groundwater bypass and water stoppage of the High Temperature Incinerator Building (HTI) (see Figure 1).

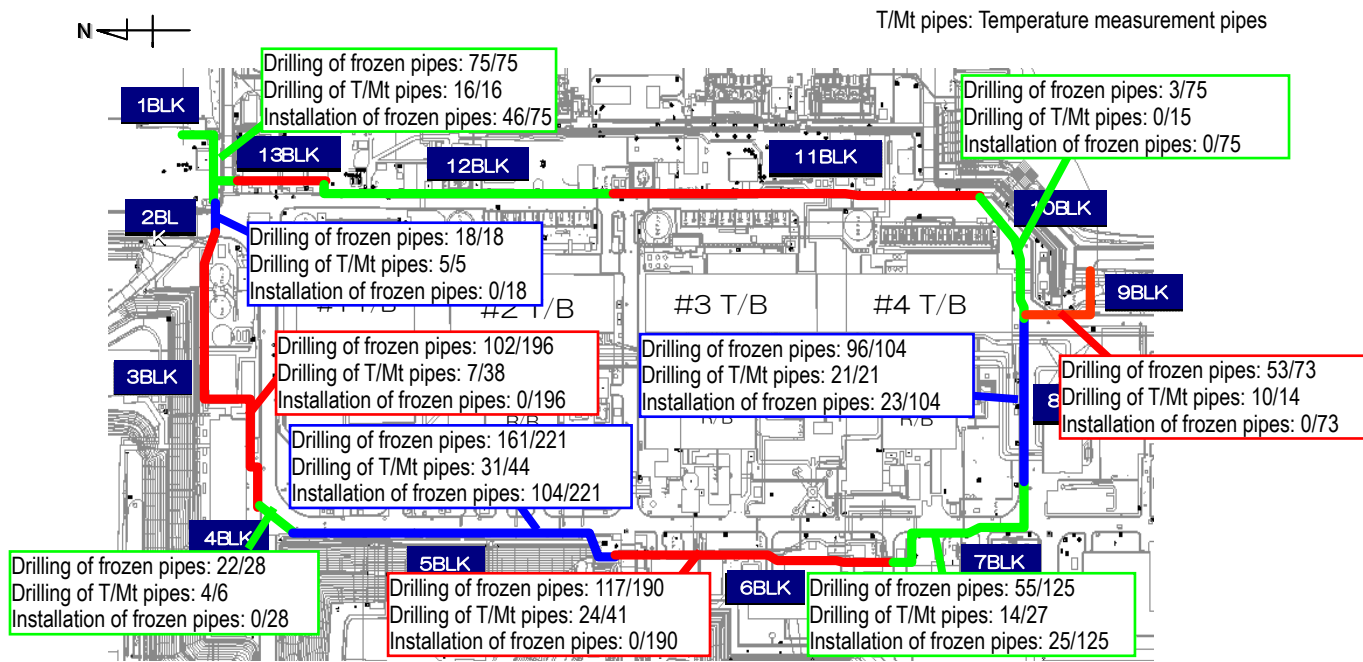
Figure 3: Drilling status for frozen-soil impermeable walls and installation of frozen pipes

- To facilitate the installation of frozen-soil impermeable walls surrounding Units 1-4 (a subsidy project of the Ministry of Economy, Trade and Industry), drilling to place frozen pipes commenced (from June 2). As of November 25, drilling at 834 points (for frozen pipes: 702 of 1,545 points, for temperature-measurement pipes: 132 of 317 points) and installation of frozen pipes at 268 of 1,545 points had been completed (see Figure 3).
- Installation of 30 chillers for freezing was completed (from August 26 to November 26).

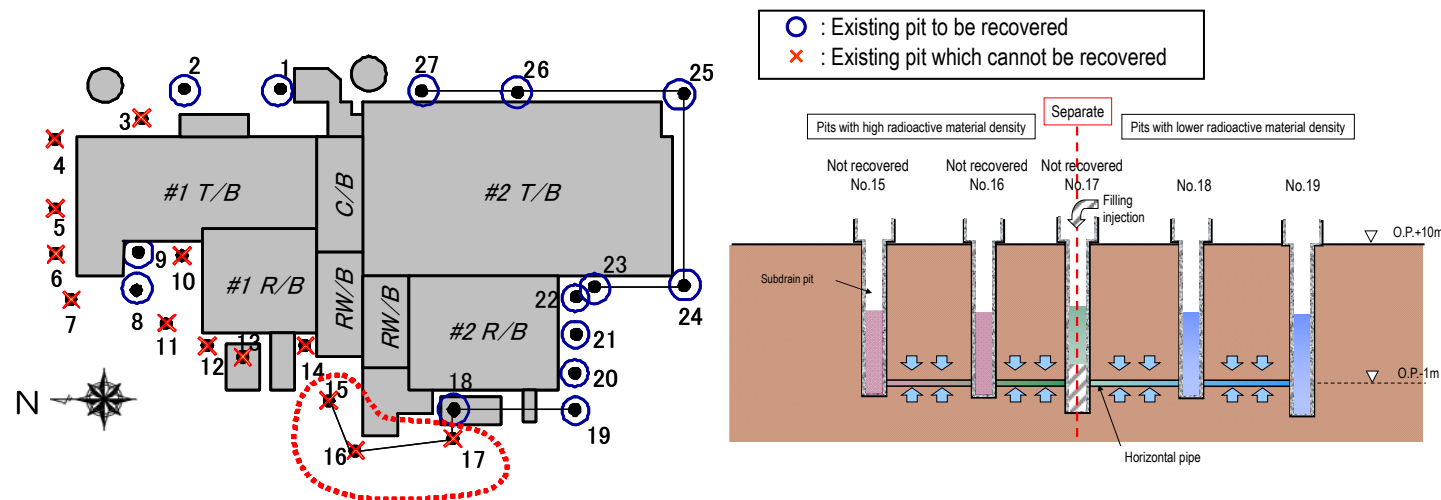
Figure 4: Existing subdrain pits around Units 1 and 2

- Though an increase in the radioactive material density was detected at pit Nos. 18 and 19 (October 22), the density drastically declined in the water quality measurement two days later. It was estimated that as those pits connect with Nos. 15-17, which could not be recovered due to the high radiation dose, via horizontal pipes, the fallout components were gradually drawn into pit Nos. 18 and 19 by pump operation. From November 14-21, pit No. 17 was blocked with crushed stone and mortar (see Figure 4).

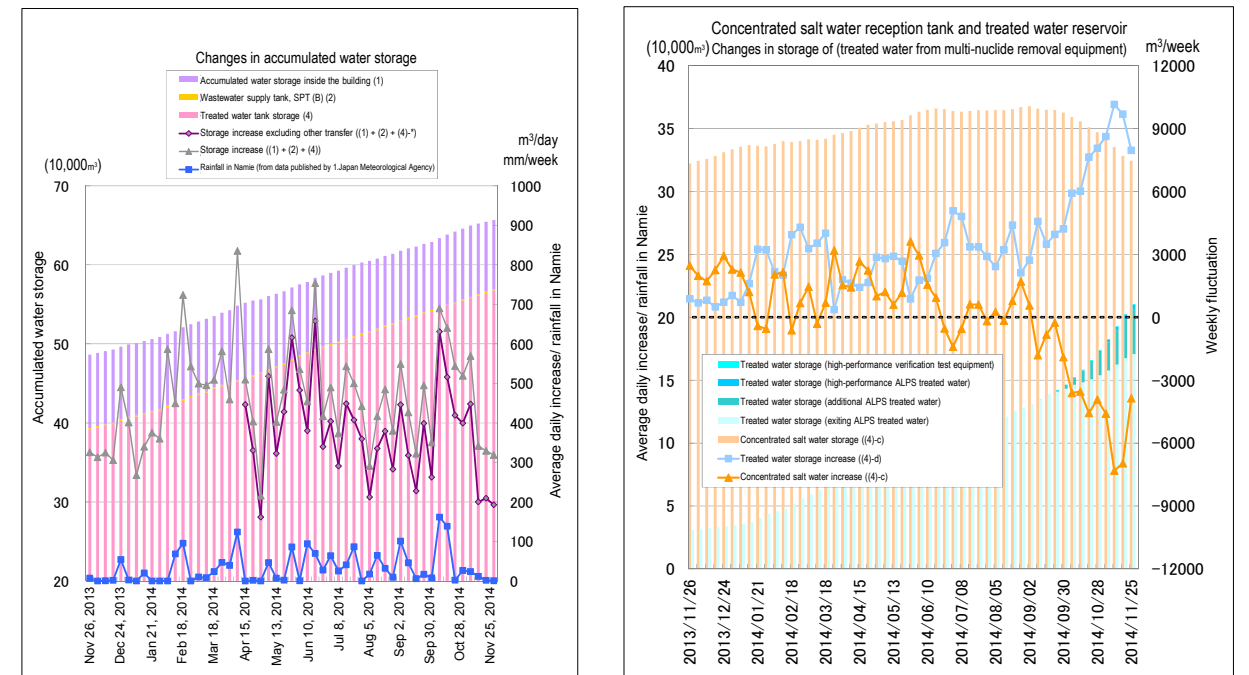
Figure 5: Status of accumulated water storage

- To purify RO concentrated salt water stored in tanks, mobile strontium-removal equipment commenced operation in the G4 south area (from October 2). The number of mobile strontium-removal units will be increased to purify RO concentrated salt water stored in tanks in the H5 north area (scheduled to commence in mid-January). The second mobile strontium-removal equipment will also be installed to purify RO concentrated salt water in tanks of C and G6 areas (scheduled to commence in late January).
- In addition to multi-nuclide removal equipment (existing, additional and high-performance) and mobile strontium-removal equipment, measures including removal of strontium by cesium absorption apparatus (KURION), secondary cesium absorption apparatus (SARRY), and RO concentrated water treatment equipment are installed to reduce risks of contaminated water via multiple approaches.

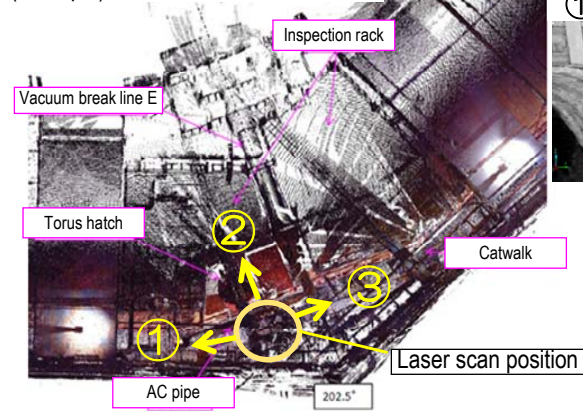
Figure 10: Results of laser scan inside torus room

Torus room laser scan points data

(Example) Around vacuum break line E

Points data processed photos

①-③ are images viewed from laser scan position

Combining it with 3D data on the R/B 1st floor allows obstacles on both 1st and underground floors to be checked simultaneously. This allows efficient examination of positions to install repair equipment for PCVs and vacuum break lines.

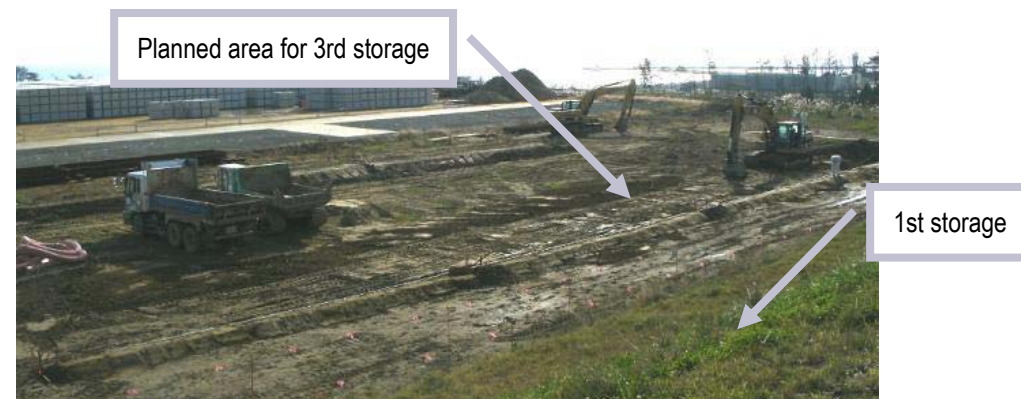
Figure 11: Temporary soil cover-type storage – Drilling status of 3rd installation area

- To store waste appropriately, construction of the 3rd temporary soil cover-type storage for rubble commenced on November 10. Reception of rubble will commence in around March 2015.

To store waste appropriately, construction of the 3rd temporary soil cover-type storage for rubble commenced on November 10. Reception of rubble will commence in around March 2015.

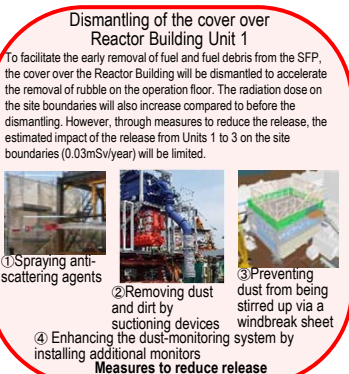
Image of the cover for fuel removal

- Regarding Unit 1, there are plans to dismantle the cover over the Reactor Building to remove rubble from the top of the operating floor. Two roof panels of the Unit 1 Reactor Building (R/B) were removed to facilitate investigation of the rubble status on the R/B top floor. When the building cover is dismantled and the rubble removed, sufficient measures to prevent scattering of radioactive materials will be taken and monitoring conducted.
- Regarding Unit 2, to prevent risks of reworking due to change in the fuel debris removal plan, the plan continues to be examined within a scope not affecting the scheduled commencement of removal.

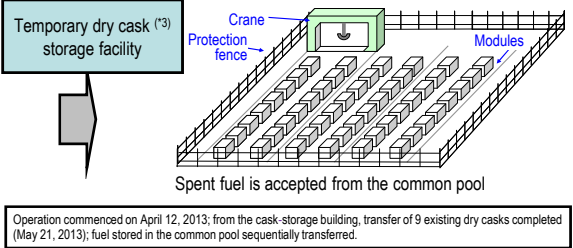
- Progress to date
- The common pool has been restored to a condition allowing it to re-accommodate fuel to be handled (November 2012)
 - Loading of spent fuel stored in the common pool to dry casks commenced (June 2013)
 - Fuel removed from the Unit 4 spent fuel pool began to be received (November 2013)

Operation commenced on April 12, 2013; from the cask-storage building, transfer of 9 existing dry casks completed (May 21, 2013); fuel stored in the common pool sequentially transferred.

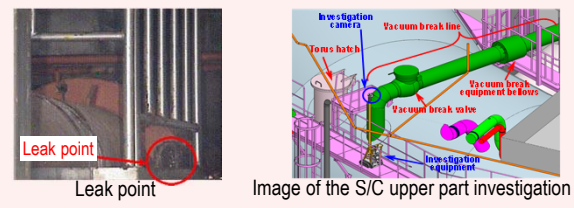
Investigation in the leak point detected in the upper part of Unit 1 Suppression Chamber (S/C^(*))

Investigation in the leak point detected in the upper part of Unit 1 S/C from May 27 from one expansion joint cover among the lines installed there. As no leakage was identified from other parts, specific methods will be examined to halt the flow of water and repair the PCV.

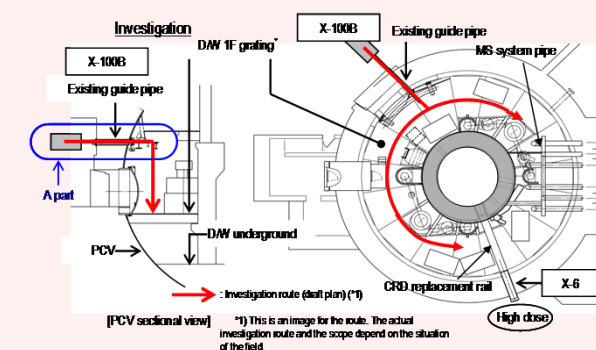
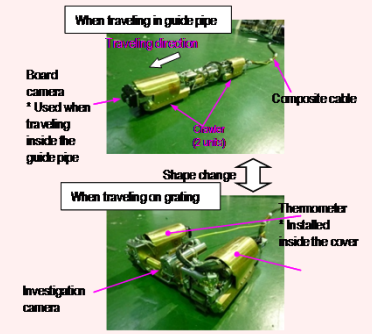
Status of equipment development toward investigating inside the PCV

- Inserting equipment from Unit 1 X-100B penetration⁽⁵⁾ to investigate in clockwise and counter-clockwise directions.

- Crawler-type equipment with a shape-changing structure which allows it to enter the PCV from the narrow access entrance (bore: φ100mm) and stably move on the grating is currently under development. A field demonstration is scheduled for the 2nd half of FY2014.

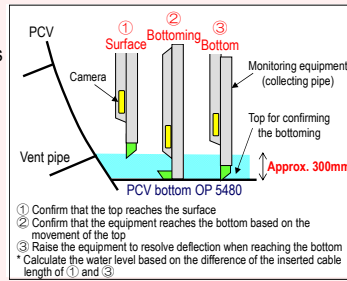
Method to measure water levels when re-installing monitoring instrumentation for Unit 2 PCV

- (2) Reinstallation of the PCV thermometer and water-level gauge
 - Some of the permanent supervisory instrumentation for PCV could not be installed in the planned locations due to interference with existing grating (August 13, 2013).

- The instrumentation was removed on May 27, 2014 and new instruments were reinstalled on June 5 and 6. The trend of added instrumentation will be monitored for approx. one month to evaluate its validity.

- The measurement during the installation confirmed that the water level inside the PCV was approx. 300mm from the bottom.

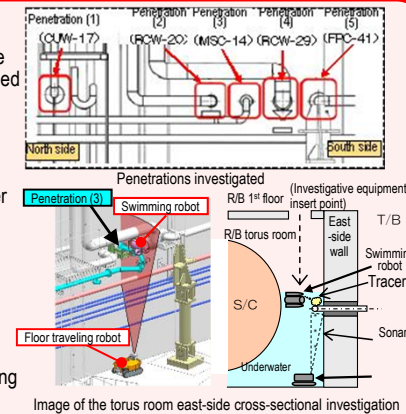
Investigative results on torus room walls

- The torus room walls were investigated (on the north side of the east-side walls) using equipment specially developed for that purpose (a swimming robot and a floor traveling robot).
- At the east-side wall pipe penetrations (five points), "the status" and "existence of flow" were checked.
- A demonstration using the above two types of underwater wall investigative equipment showed how the equipment could check the status of penetration.
- Regarding Penetrations 1 - 5, the results of checking the sprayed tracer (*) by camera showed no flow around the penetrations. (investigation by the swimming robot)
- Regarding Penetration 3, a sonar check showed no flow around the penetrations. (investigation by the floor traveling robot)

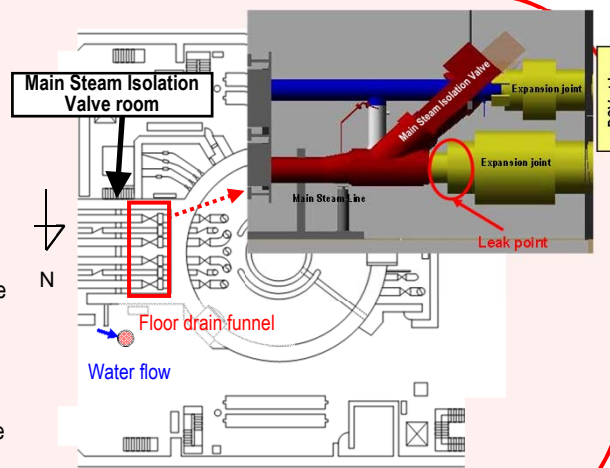
Outline of the water-flow status

From April 23, image data has been acquired by camera and the radiation dose measured via pipes for measurement instrumentation, which connect the air-conditioning room on the Reactor Building 2nd floor with the Main Steam Isolation Valve Room on the 1st floor. On May 15, water flow from the expansion joint of one Main Steam Line was detected.

This is the first leak from PCV detected in Unit 3. Based on the images collected in this investigation, the leak volume will be estimated and the need for additional investigations will be examined. The investigative results will also be utilized to examine water stoppage and PCV repair methods.

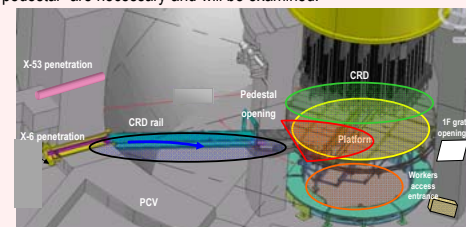
Status of equipment development toward investigating inside the PCV

- (1) Investigation from X-53 penetration
 - From October 22-24, the status of X-53 penetration, which may be under the water and which is scheduled for use to investigate the inside of the PCV, was investigated using remote-controlled ultrasonic test equipment. Results showed that the penetration is not under the water.

- (2) Investigation plan following the investigation of X-53 penetration
 - Based on the measurement values of hydraulic head pressure inside the PCV, X-6 penetration may decline. It is estimated that access to X-6 penetration is difficult.

- For access from another penetration, approaches such as "further downsizing the equipment" or "moving in water to access the pedestal" are necessary and will be examined.

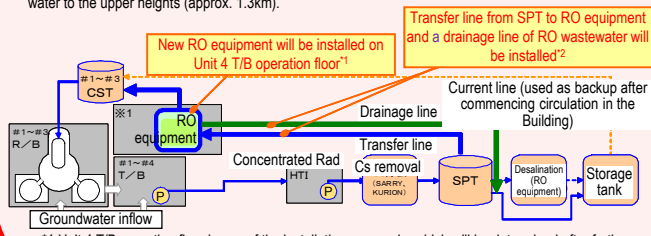
Work to improve the reliability of the circulation water injection cooling system and pipes to transfer accumulated water.

- Operation of the reactor water injection system using Unit 3 CST as a water source commenced (from July 5, 2013). Compared to the previous systems, in addition to the shortened outdoor line, the reliability of the reactor water injection system was enhanced, e.g. by increasing the amount of water-source storage and enhancing durability.
- By newly installing RO equipment inside the Reactor Building by the end of FY2014, the reactor water injection loop (circulation loop) will be shortened from approx. 3km to approx. 0.8km*.
- * The entire length of contaminated water transfer pipes is approx. 2.1km, including the transfer line of surplus water to the upper heights (approx. 1.3km).

*1 Unit 4 T/B operation floor is one of the installation proposals, which will be determined after further examination based on the work environment
 *2 A detailed line configuration will be determined after further examination

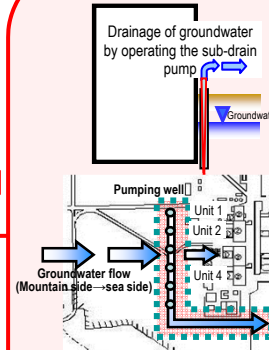
Reducing groundwater inflow by pumping sub-drain water

Aiming to reduce the level of groundwater by pumping subdrain water, tests were conducted to verify the stable operation of water treatment facilities, including subdrain. The results showed that through purification by the system, the density of radioactive materials declined to below the operational target and no other γ nuclides were detected.

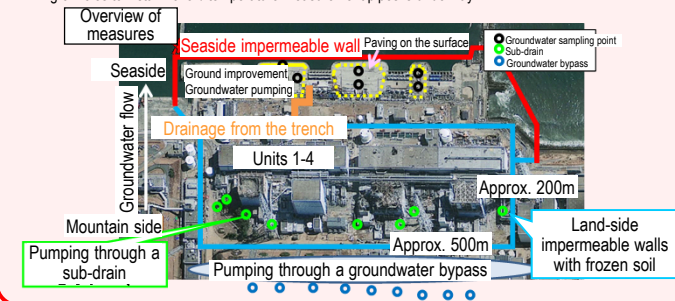
- Removing contaminated water in branch trenches and closing them (completed on September 19, 2013)
 - Treatment and removal of contaminated water in the seawater pipe trench Unit 2: November 14, 2013 – April 25, 2014, treatment of cesium and strontium. From November 25, work to remove contaminated water and fill trenches with cement-based materials has got underway.

- Unit 3: November 15, 2013 – July 28, 2014, treatment of cesium. Drilling of holes to install frozen/ temperature-measurement pipes is underway.
