Main works and steps for decommissioning

Fuel removal from Unit 4 SFP has been completed. Preparatory works to remove fuel from Unit 1-3 SFP and fuel debris (Note 1) removal are ongoing.

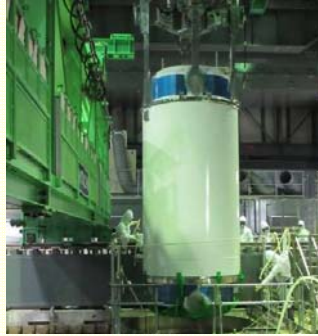
<Work conditions for transfer of the final fuel transportation container>

The transfer of non-irradiated fuel assemblies to the Unit 6 SFP was also completed on December 22.

This marks the completion of all fuel removal from the Unit 4. Based on this experience, fuel assemblies will be removed from the Unit 1-3 pools.

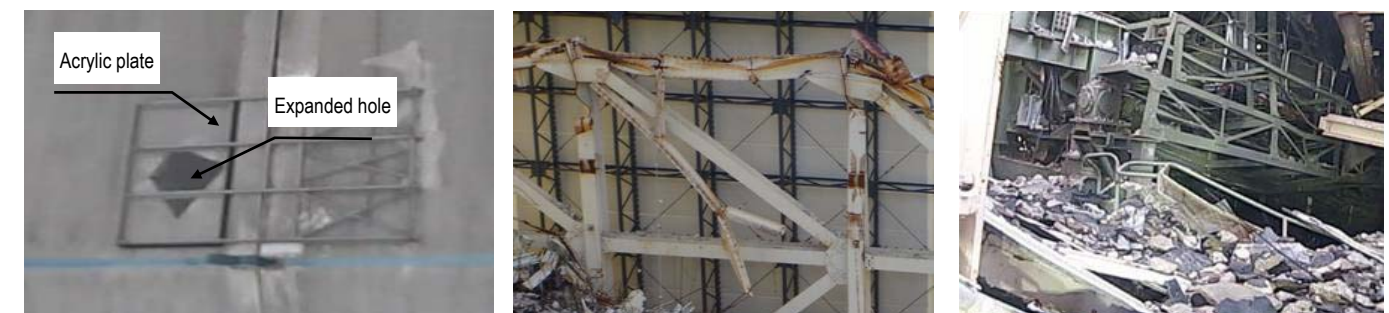
Figure 9: Upper part of Unit 1 Reactor Building – Covering status of hole in roof panel and status of rubble investigations

Covering status of expanded hole in roof panel of building cover Existing steel frame at upper part of Reactor Building Underside of collapsed roof

- After removing the two roof panels, the trends of the dust conditions were monitored with regard to the density of radioactive materials in the air, and the results confirmed that due to the effects of the wind, there were no elevations in the concentration of dust.

- In the rubble investigation, confirmation in greater detail was achieved than it could be achieved with balloon investigations and other types of investigations performed in the past. Since it was possible to confirm the status of the rubble to be removed in advance at the upper part of the Reactor Building, the plans for rubble removal will be reviewed. On the underside of the collapsed roof, no conditions such as fallen fuel-handling machines or steel frame materials protruding from the water surface that would cause damage to the spent fuel pool or to the fuel assemblies inside the pool were detected. Further investigations will be conducted after the roof cover has been dismantled.

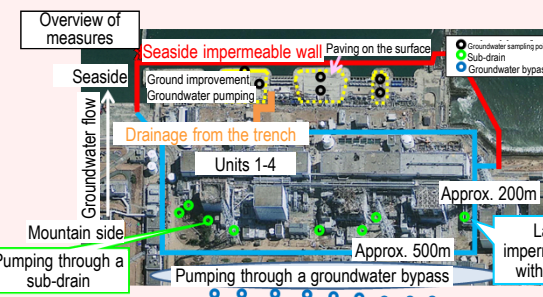
- (3) Eliminate contamination sources
 - Removing contaminated water in branch trenches and closing them (completed on September 19, 2013)
 - Removal of contaminated water in the seawater pipe trench

- Unit 2: November 25, 2014 to December 18, 2014 - filling of tunnel sections with cement-based materials.
 - Unit 3: Drilling of holes to install frozen/ temperature-measurement pipes is completed.
