Main works and steps for decommissioning

Progress status

TEPCO Fukushima Daiichi Nuclear Power Station Site Layout

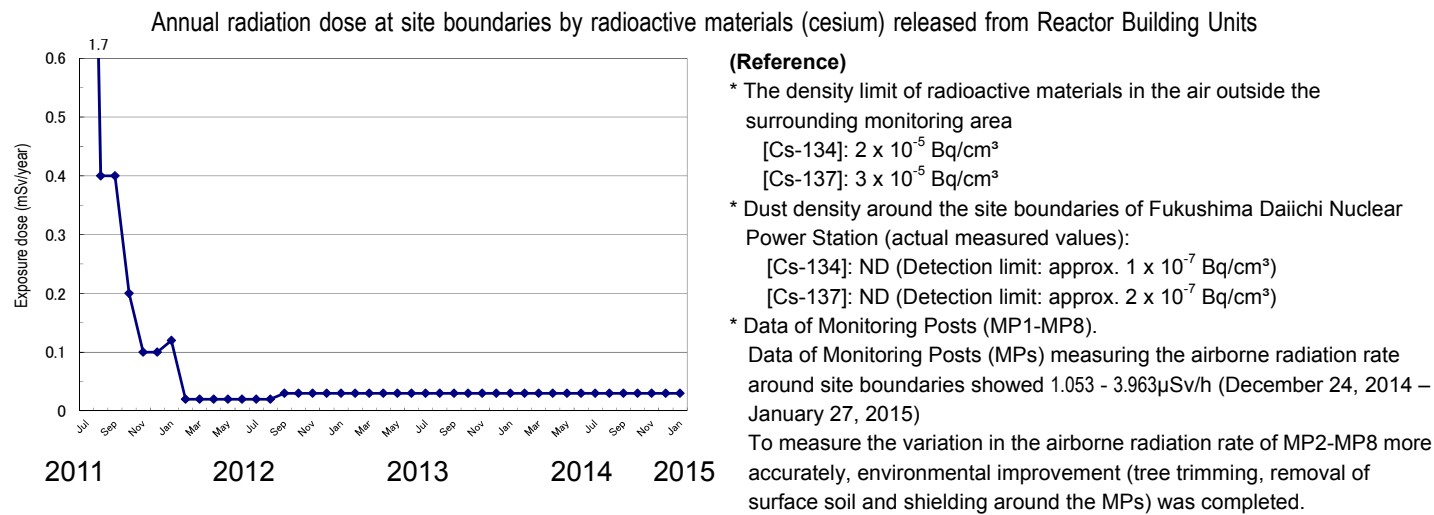
The density of radioactive materials newly released from Reactor Building Units 1-4 in the air measured at site boundaries was evaluated at approx. 1.4×10^{-9} Bq/cm³ for both Cs-134 and -137. The radiation exposure dose due to the release of radioactive materials was 0.03 mSv/year (equivalent to approx. 1/70 of the annual radiation dose by natural radiation (annual average in Japan: approx. 2.1 mSv/year)) at the site boundaries.

Note: Different formulas and coefficients were used to evaluate the radiation dose in the facility operation plan and monthly report. The evaluation methods were integrated in September 2012. As the fuel removal from the spent fuel pool (SFP) commenced for Unit 4, the radiation exposure dose from Unit 4 was added to the items subject to evaluation since November 2013.

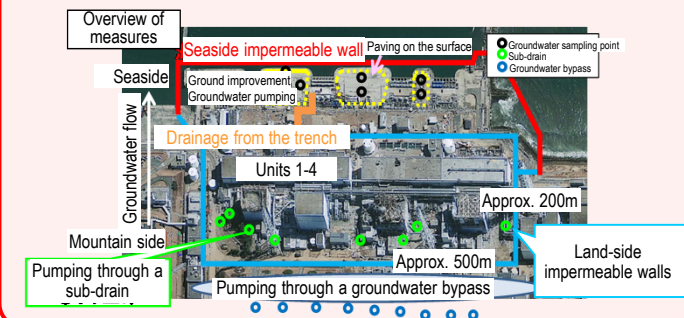
- Unit 2: November 25 to December 18, 2014 - filling of tunnel sections with cement-based materials
 - Unit 3: Filling of tunnel sections will commence.

- Drilling of holes to install frozen/ temperature-measurement pipes is underway.
