## Main works and steps for decommissioning

Fuel removal from Unit 4 SFP had been completed. Preparatory works to remove fuel from Unit 1-3 SFP and fuel debris (Note 1) removal are ongoing.

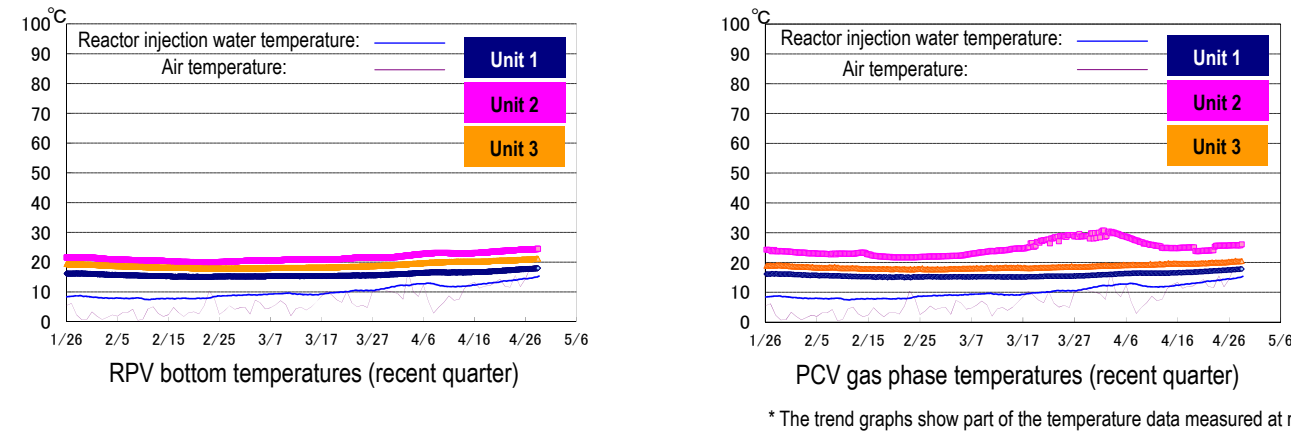
Through continuous reactor cooling by water injection, the temperatures of the Reactor Pressure Vessel (RPV) bottom and the Primary Containment Vessel (PCV) gas phase have been maintained within the range of approx. 10 to 40°C for the past month, though they vary depending on the unit and location of the thermometer.

◆ The temperatures of the Reactor Pressure Vessel (RPV) and the Primary Containment Vessel (PCV) of Units 1-3 have been maintained within the range of approx. 10-40°C<sup>\*1</sup> for the past month. There was no significant change in the density of radioactive materials newly released from Reactor Buildings in the air<sup>\*2</sup>. It was evaluated that the comprehensive cold shutdown condition had been maintained.

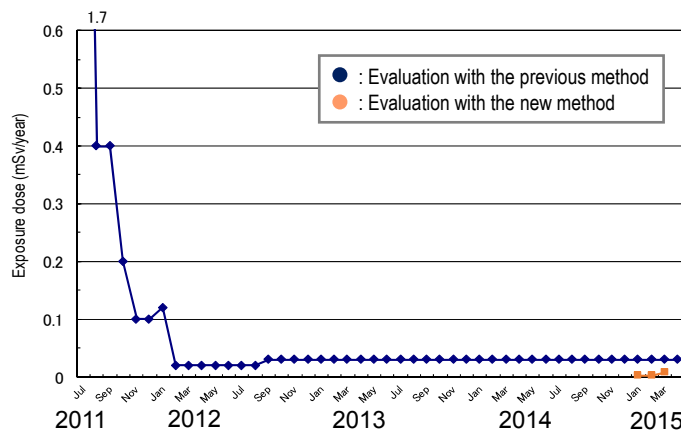
Annual radiation dose at site boundaries by radioactive materials (cesium) released from Reactor Building Units 1-4

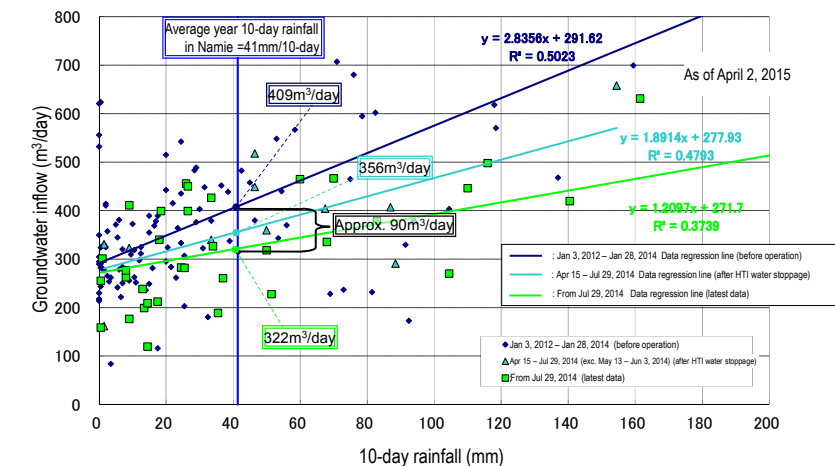
Figure 1: Analytical results of inflow into buildings

- It was confirmed that the groundwater inflow into the buildings had decreased by approx. 90 m<sup>3</sup>/day, based on the evaluation data to date, through measures such as groundwater bypass and water stoppage of the High Temperature Incinerator Building (HTI) (see Figure 1).

- It was confirmed that the groundwater level at the observation holes had decreased by approx. 10-15 cm compared to the level before pumping at the groundwater bypass started.

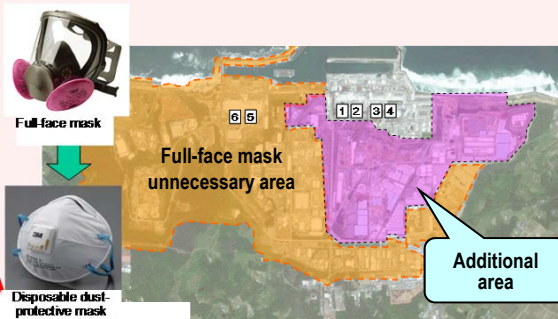
Full-face mask unnecessary area

Operation based on the rules for mask wearing according to radioactive material density in air and decontamination/ ionization rules was defined, and the area is being expanded.

Continuous dust monitors will be installed in the planned additional area and after confirming the dust density, the area will be specified as the full-face mask unnecessary area. In tank areas, wearing disposable dust-protective masks will be allowed outside the fences and within the fences of the tank areas for treated water from multi-nuclide removal equipment (scheduled end of May, 2015).

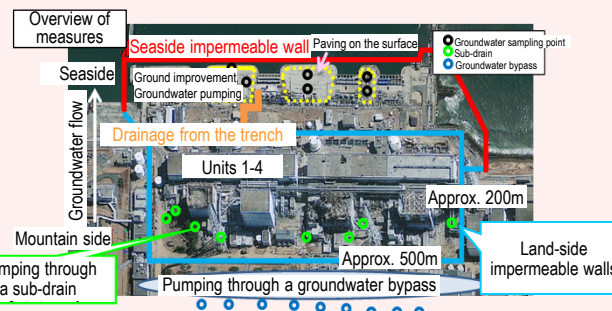
- Unit 2: November 25 to December 18, 2014 - tunnel sections were filled. February 24, 2015 - filling of the Vertical Shafts commenced.
    - Unit 3: February 5 to April 8, 2015 - tunnel sections were filled.

- Unit 4: February 14 - March 21, 2015 - tunnel sections were filled. April 15, 2015 - filling of opening apertures commenced.
