Main works and steps for decommissioning

Fuel removal from Unit 4 SFP had been completed. Preparatory works to remove fuel from Unit 1-3 SFP and fuel debris (Note 1) removal are ongoing.

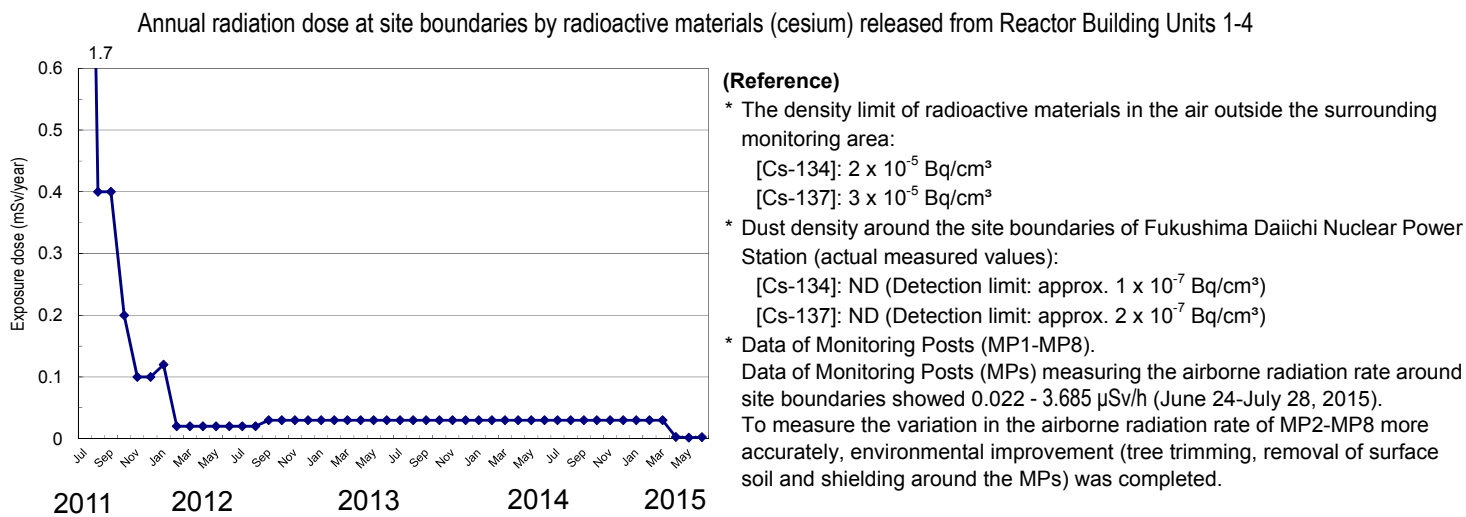
As of June 2015, the density of radioactive materials newly released from Reactor Building Units 1-4 in the air and measured at the site boundaries was evaluated at approx. 8.8×10^{-11} Bq/cm³ for Cs-134 and 1.6×10^{-10} Bq/cm³ for Cs-137 respectively. The radiation exposure dose due to the release of radioactive materials was less than 0.0025 mSv/year at the site boundaries.

Note: Different formulas and coefficients were used to evaluate the radiation dose in the facility operation plan and monthly report. The evaluation methods were integrated in September 2012. As the fuel removal from the spent fuel pool (SFP) commenced for Unit 4, the radiation exposure dose from Unit 4 was added to the items subject to evaluation since November 2013. The evaluation has been changed to a method considering the values of continuous dust monitors since FY2015, with data to be evaluated monthly and announced the following month.

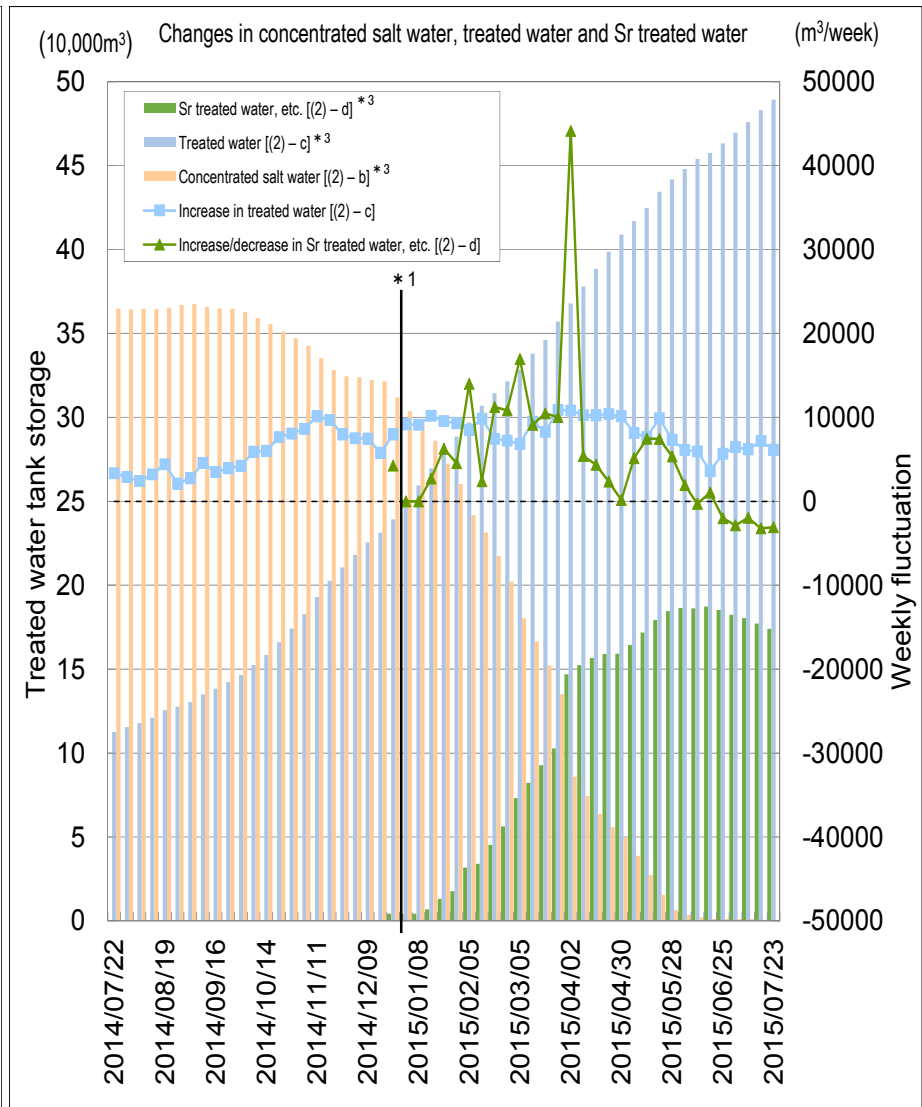
Figure 4: Status of accumulated water storage

As of July 23, 2015

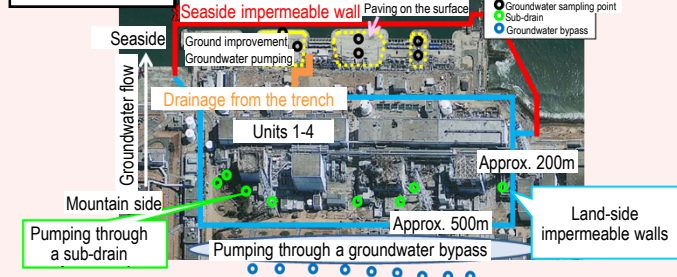
Overview of measures

- Unit 4: February 14 - March 21, 2015 - tunnel sections were filled. April 15 to 28, 2015 - opening apertures II and III were filled.
