Main works and steps for decommissioning

Progress toward decommissioning: Fuel removal from the spent fuel pool (SFP)

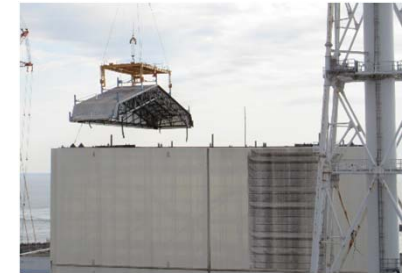
(Dismantling of the Unit 1 building cover)

Toward fuel removal from Unit 1 SFP, the building cover is being dismantled.

Dismantling of the building cover started in July 2015. The dismantling is being conducted steadily with anti-scattering measures fully implemented and radioactive materials monitored.

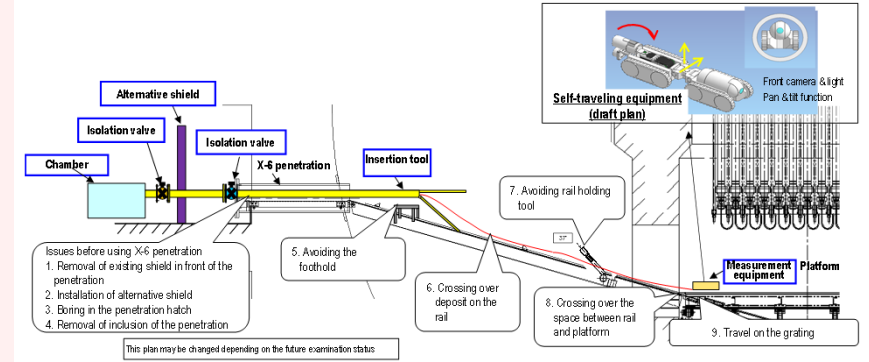
Investigative issues inside the PCV and equipment configuration (draft plan)

Prior to removing the fuel debris, to check the conditions inside the Primary Containment Vessel (PCV), investigations inside the PCV are scheduled.

- [Investigative outline]
- Inserting the equipment from Unit 2 X-6 penetration⁽¹⁾ and accessing inside the pedestal using the CRD rail to conduct investigation.
- [Status of investigative equipment development]
- Based on issues confirmed by the CRD rail status investigation conducted in August 2013, the investigation method and equipment design are currently being examined.
 - As a portion of shielding blocks installed in front of X-6 penetration could not be moved, a removal method using small heavy machines was planned. The work for removing these blocks resumed on September 28 and removal of interfering blocks for future investigations was also completed on October 1.

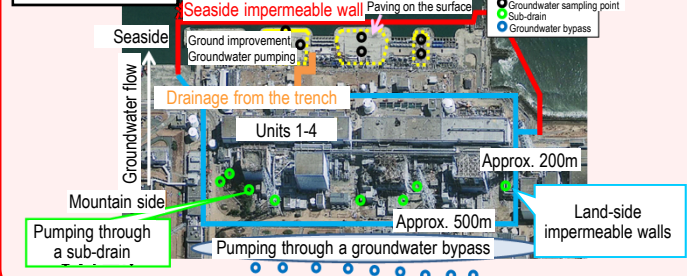
Overview of measures

- To prevent contamination expansion into the sea, the following measures are being implemented:
 - Prevent leakage of contaminated water
 - Ground improvement behind the bank to prevent the expansion of radioactive materials. (Between Units 1 and 2: completed on August 9, 2013; between Units 2 and 3: from August 29 and completed on December 12, 2013; between Units 3 and 4: from August 23, 2013 and completed on January 23, 2014)

- Unit 4: February 14 - March 21, 2015 - tunnel sections were filled. April 15 to 28, 2015 - opening apertures II and III were filled.
