## Main decommissioning works and steps

All fuel has been removed from Unit 4 SFP and preparatory work to remove fuel from Unit 1-3 SFP and fuel debris (Note 1) removal is ongoing.

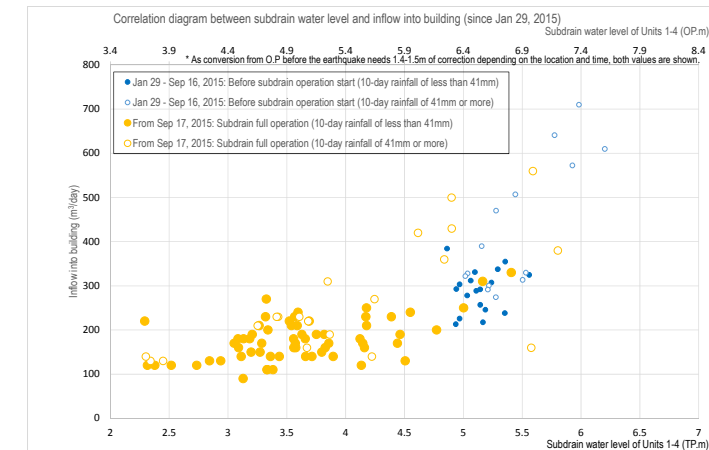
Figure 1: Correlation between inflow such as groundwater and rainwater into buildings and the water level of Unit 1-4 subdrains

- “Inflow of groundwater/rainwater into buildings” correlates highly with the average water level of subdrains around the Unit 1-4 buildings.
- Since January 2017 in particular, the average subdrain water level has declined as measures for subdrains, closure of unfrozen sections of the land-side impermeable walls (on the mountain side) and other construction have progressed as well as the low-rainfall climate. “Inflow of groundwater/rainwater into buildings” has also declined correspondingly.
