Main decommissioning works and steps

Progress Status and Future Challenges of the Mid- and Long-Term Roadmap toward Decommissioning of TEPCO Holdings' Fukushima Daiichi Nuclear Power Station Units 1-4 (Outline)

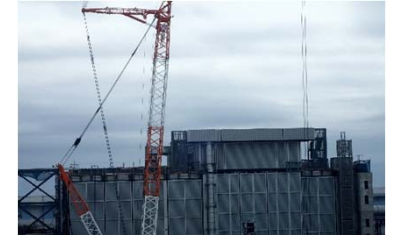
As measures to reduce the dose on the Reactor Building operating floor, the decontamination and installation of shields were completed in June and December 2016 respectively. Installation of a cover for fuel removal started from January 2017.

Installation of a cover for fuel removal at Unit 3 (June 27, 2017)

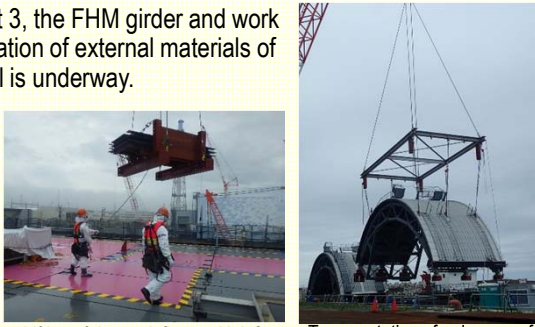
Toward fuel removal from Unit 3, the FHM girder and work floors were installed and installation of external materials of the FHM girder the traveling rail is underway.

Prior to starting installation of a dome roof around August 2017, a dome roof unit (one of eight) was transported by ship from the Onahama Port to the site on June 27.

<Lifting of the work floor at Unit 3> <Transportation of a dome roof to the site>
