Main decommissioning works and steps

All fuel has been removed from Unit 4 SFP and preparatory work to remove fuel from Unit 1-3 SFP and fuel debris (Note 1) removal is ongoing.

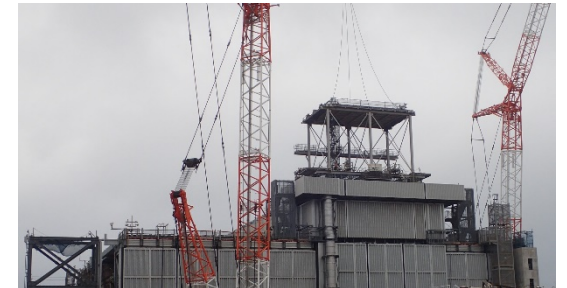
Toward fuel removal from Unit 3 SFP, works to install the cover are underway.

As measures to reduce the dose on the Reactor Building operating floor, the decontamination and installation of shields were completed in June and December 2016 respectively. Installation of a cover for fuel removal started from January 2017.

Installation of a cover for fuel removal at Unit 3 (July 26, 2017)

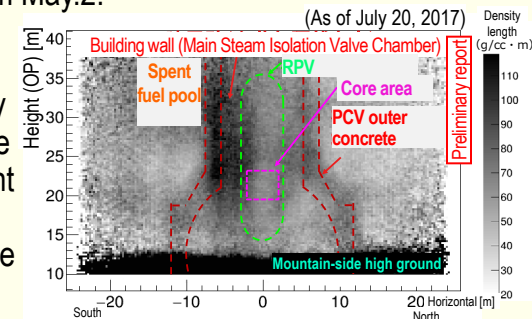
Investigation into fuel debris inside the Unit 3 reactor using muon

To identify the status of fuel debris inside the Unit 3 reactor, measurement using muons (a type of elementary particle) derived from cosmic radiation will start from May.2.

To date, the evaluation has yet to confirm any large fuel though there was a possibility of fuel debris remaining inside part of the RPV. Measurement will continue until around the end of August to help advance the data analysis.

<Muon measurement>

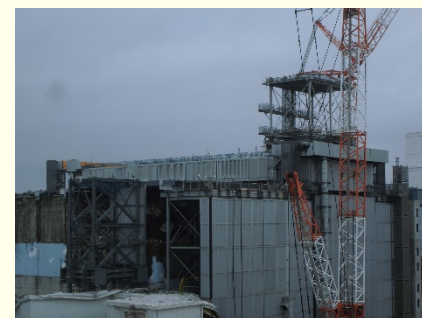
Toward fuel removal from Unit 3, installation and adjustment of a rail on which the fuel handling machine (FHM) and the crane would travel were completed on July 21.

As preparation for the fuel removal in around mid-FY2018, installation of the fuel removal cover dome roof will start from July 22.

< Installation of the dome roof (installation of slide trestle) >

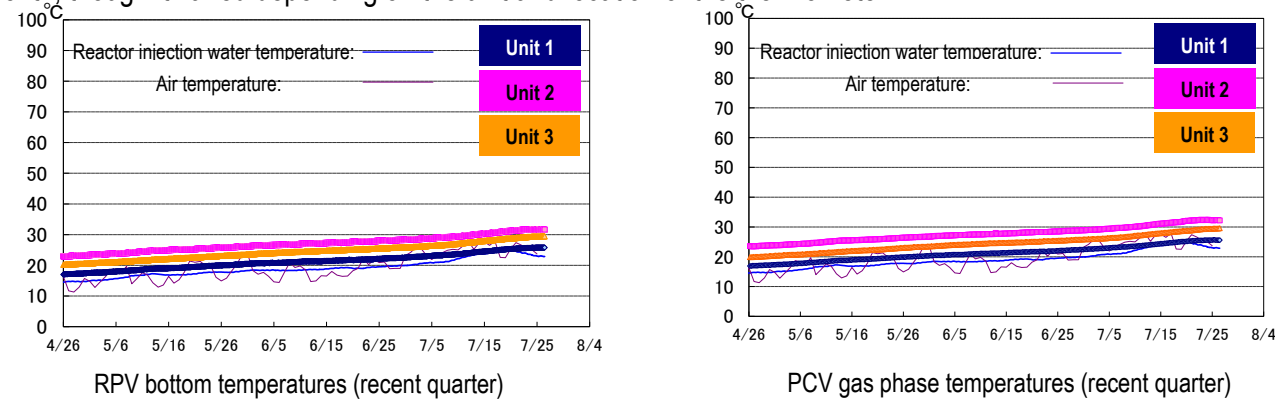
Through continuous reactor cooling by water injection, the temperatures of the Reactor Pressure Vessel (RPV) bottom and the Primary Containment Vessel (PCV) gas phase were maintained within the range of approx. 20 to 35°C for the past month, though it varied depending on the unit and location of the thermometer.

* The trend graphs show part of the temperature data measured at multiple points.
