## Main decommissioning works and steps

All fuel has been removed from Unit 4 SFP and preparatory work to remove fuel from Unit 1-3 SFP and fuel debris (Note 1) retrieval is ongoing.

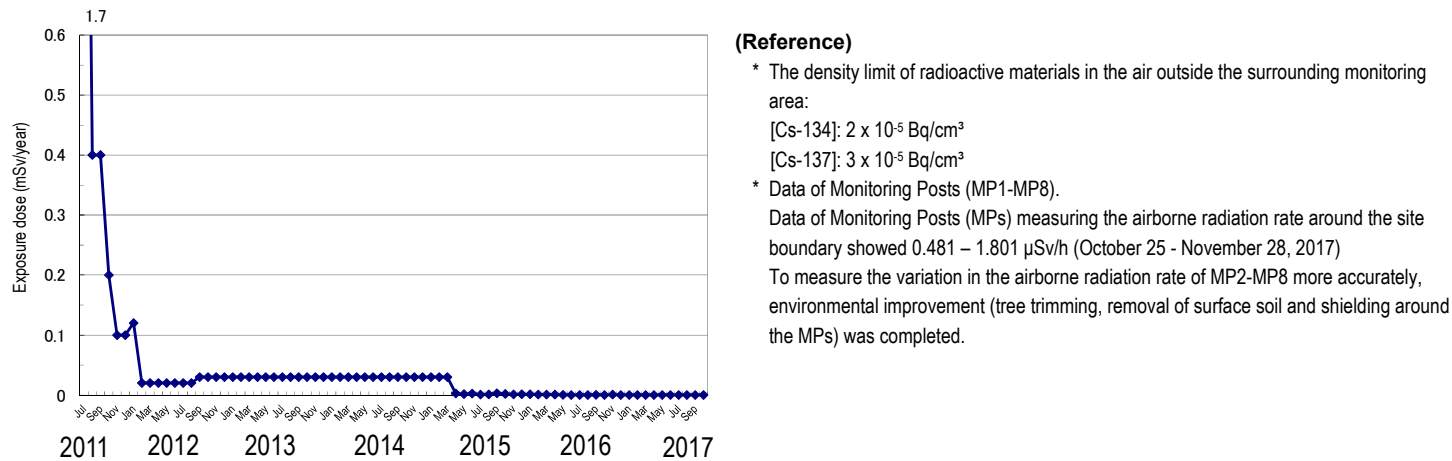
Annual radiation dose at site boundaries by radioactive materials (cesium) released from Reactor Building Units 1-4

As of October 2017, the density of radioactive materials newly released from Reactor Building Units 1-4 in the air and measured at the site boundary was evaluated at approx.  $2.0 \times 10^{-12}$  Bq/cm<sup>3</sup> for Cs-134 and  $8.5 \times 10^{-12}$  Bq/cm<sup>3</sup> for Cs-137, while the radiation exposure dose due to the release of radioactive materials there was less than 0.00025 mSv/year.

Note: Different formulas and coefficients were used to evaluate the radiation dose in the facility operation plan and monthly report. The evaluation methods were integrated in September 2012. As the fuel removal from the spent fuel pool (SFP) commenced for Unit 4, the radiation exposure dose from Unit 4 was added to the items subject to evaluation since November 2013. The evaluation has been changed to a method considering the values of continuous dust monitors since FY2015, with data to be evaluated monthly and announced the following month.

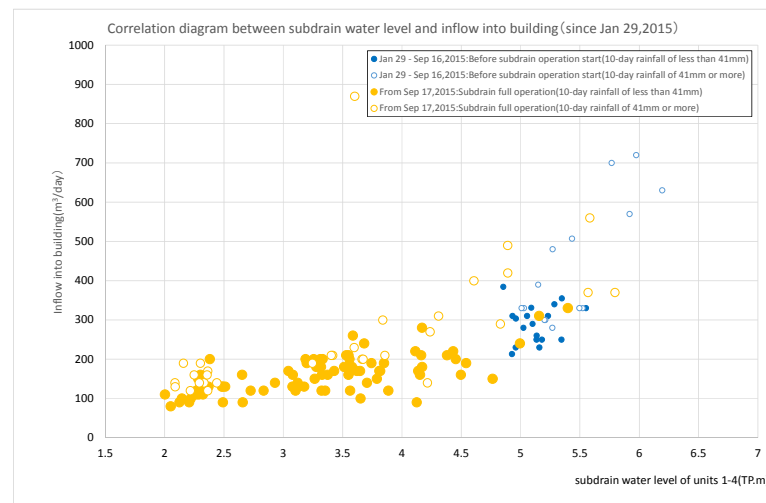
Figure 1: Correlation between inflow such as groundwater and rainwater into buildings and the water level of Unit 1-4 subdrains

- Since the subdrains went into operation, the inflow into buildings tended to decline to less than 150 m<sup>3</sup>/day when the subdrain water level declined below T.P. 3.0 m, while the inflow increased during rainfall.

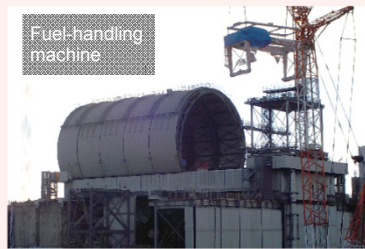
Installation of dome roof (November 12)

Measures to reduce dose on the Reactor Building top floor (decontamination, shields) were completed in December 2016. Installation of a cover for fuel removal and a fuel-handling machine is underway from January 2017.
