Main decommissioning works and steps

Summary of TEPCO data as of April 25, 2018

TEPCO Holdings Fukushima Daiichi Nuclear Power Station Site Layout

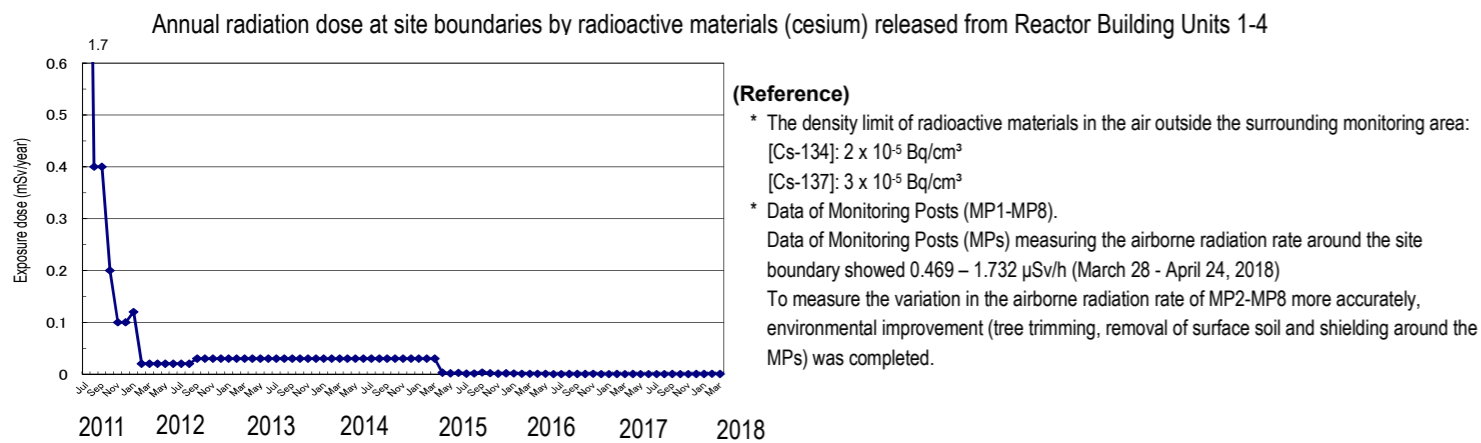
As of March 2018, the density of radioactive materials newly released from Reactor Building Units 1-4 in the air and measured at the site boundary was evaluated at approx. 3.7×10^{-12} Bq/cm³ for Cs-134 and 2.1×10^{-11} Bq/cm³ for Cs-137, while the radiation exposure dose due to the release of radioactive materials there was less than 0.00036 mSv/year.

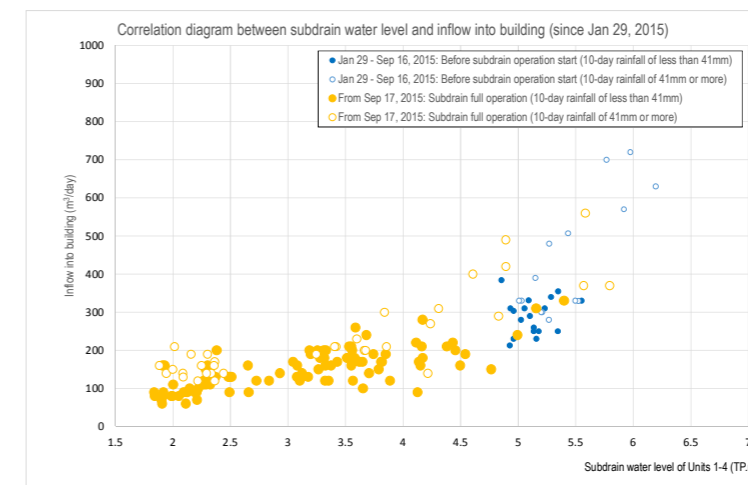
Figure 1: Correlation between inflow such as groundwater and rainwater into buildings and the water level of Unit 1-4 subdrains

- Since the subdrains went into operation, the inflow into buildings tended to decline to less than 150 m³/day when the subdrain water level declined below T.P. 3.0 m but increased during rainfall.

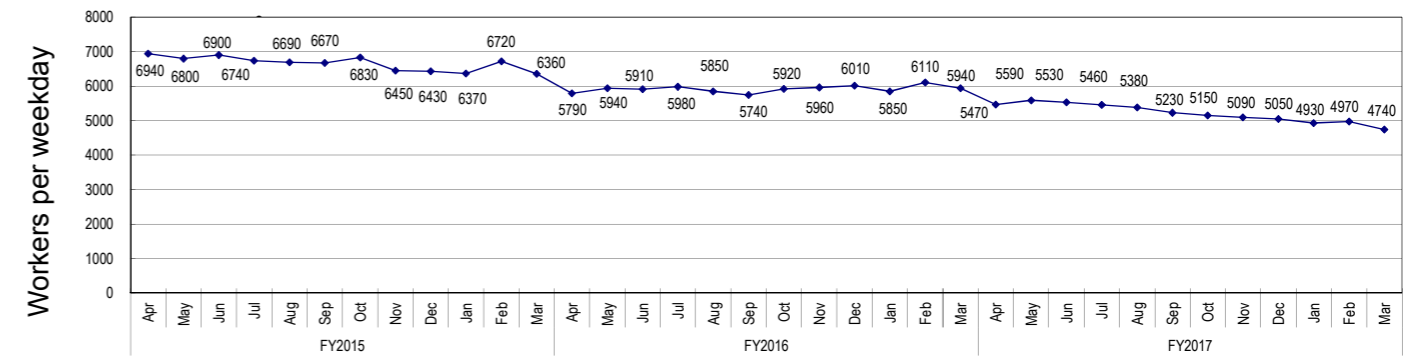
Figure 6: Changes in the average number of workers per weekday for each month since FY2015 (actual values)

* Calculated based on the number of workers from August 3-7, 24-28 and 31 (due to overhaul of heavy machines)

- It was confirmed with the prime contractors that the estimated manpower necessary for the work in May 2018 (approx. 4,550 per day: TEPCO and partner company workers) would be secured at present. The average numbers of workers per day per month (actual values) were maintained, with approx. 4,700 to 7,000 since FY2015 (see Figure 6).

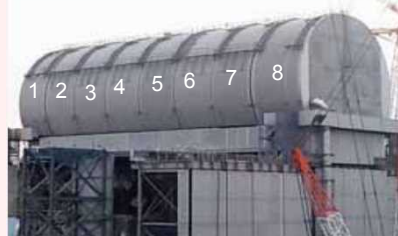
Installation of dome roof (February 21)

Installation of the fuel removal cover was completed on February 23, 2018. Work will continue with safety first toward fuel removal around mid-FY2018.
