Main decommissioning works and steps

All fuel had been removed from Unit 4 SFP by December 22, 2014. Work continues toward fuel removal and debris (Note 1) retrieval from Unit 1-3.

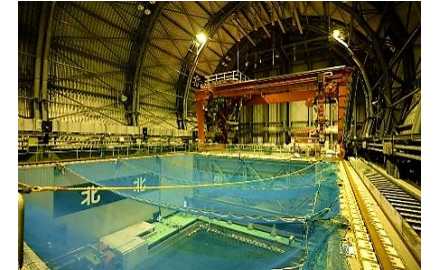
Status inside the cover for fuel removal (March 15, 2018)

As measures to reduce the dose on the Reactor Building operating floor, the decontamination and installation of shields were completed in June and December 2016 respectively. Installation of a fuel removal cover started from January 2017 and installation of all dome roofs was completed in February 2018.

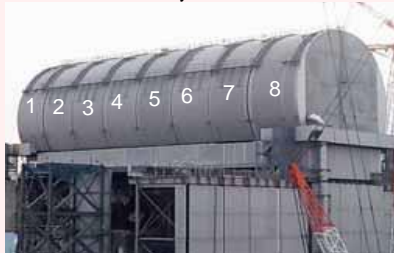
Installation of dome roof (February 21)

Installation of the fuel removal cover was completed on February 23, 2018. Work will continue with safety first toward fuel removal around mid-FY2018.
