Main decommissioning works and steps

All fuel had been removed from Unit 4 SFP by December 22, 2014. Work continues toward fuel removal and debris (Note 1) retrieval from Unit 1-3.

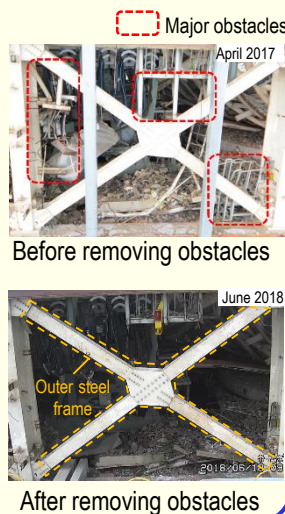
Status toward fuel removal at Unit 1

Toward fuel removal from the Unit 1 spent fuel pool, preparatory work to protect the pool is underway. Prior to the protection, obstacles are being removed and facilities for remote-controlled equipment, etc. are being installed as a part of steel frame removal to assure the work performance. Removal of the outer steel frames will start when the preparation is completed. To formulate a work plan to steadily implement the pool protection work, the dose around the pool will be measured from July. Work will continue carefully after reflecting the investigative results in the measures for safety.

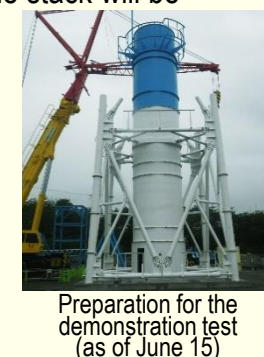
Progress toward dismantling of the Unit 1/2 exhaust stack

Damage and cracks were detected at the Unit 1/2 exhaust stack. From the perspective of further reducing risks, the upper half of the stack will be dismantled to assure seismic margin. The dismantling will proceed without human intervention to reduce exposure of workers. Manufacturing of dismantling equipment is underway. In conjunction with the manufacturing, preparation to facilitate onsite work is also underway. A demonstration test will start around August and consideration and preparation for safe operation will continue.

- Damage and cracks were detected at the Unit 1/2 exhaust stack. From the perspective of further reducing risks, the upper half of the stack will be dismantled to assure a seismic margin.

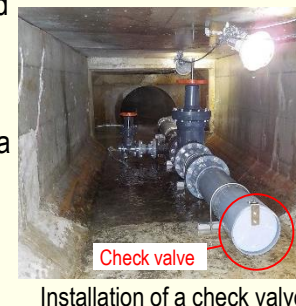
Measures to prevent rainwater inflow to buildings during heavy rain

Measures are being implemented to prepare for an increase in contaminated water generated during heavy rain such as typhoon. Onsite investigations identified a route as one of the factors behind such increase, in which rainwater flowed backward in the drain pipe, installed to channel rainwater in the site to the collection tank, and subsequently went into buildings. To prevent the backward flow in the drain pipe, a check valve was installed on June 22. Countermeasures for other inflow routes will also be implemented to further reduce the contaminated water generated.

- Progress status of measures to prevent rainwater inflow to buildings during heavy rain
 - Measures are being implemented to prepare for an increase in contaminated water generated during heavy rain such as typhoon.

- To prevent the backward flow in the drain pipe, a check valve was installed on June 22.
 - Countermeasures for other inflow routes will also be implemented to further reduce the contaminated water generated.

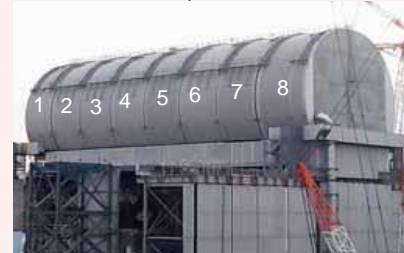
Installation of dome roof (February 21)

Prior to the installation of a cover for fuel removal, removal of large rubble from the spent fuel pool was completed in November 2015. To ensure safe and steady fuel removal, training of remote control was conducted at the factory using the actual fuel-handling machine which will be installed on site (February – December 2015). Measures to reduce dose on the Reactor Building top floor (decontamination, shields) were completed in December 2016. Installation of a cover for fuel removal and a fuel-handling machine is underway from January 2017. Installation of the fuel removal cover was completed on February 23, 2018. Work will continue with safety first toward fuel removal around mid-FY2018.

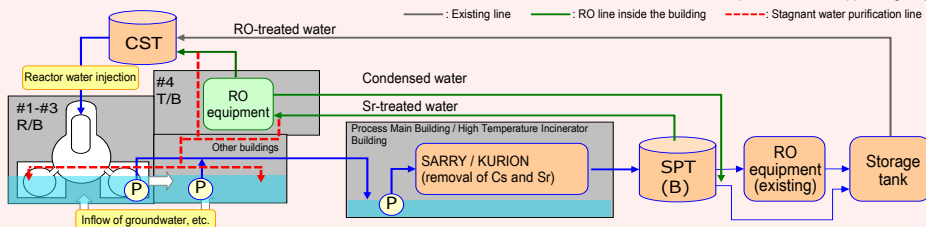
- To reduce the risk of contaminated-water leakage, the circulation loop was shortened by installing a reverse osmosis (RO) device in the Unit 4 Turbine Building within the circulation loop, comprising the transfer of contaminated water, water treatment and injection into the reactors. Operation of the installed RO device started from October 7 and 24-hour operation started from October 20. Installation of the new RO device inside the building shortened the circulation loop from approx. 3 to 0.8 km.

- The risks of stagnant water inside the buildings will continue to be reduced in addition to reduction of its storage.

* The entire length of contaminated water transfer pipes is approx. 2.1km, including the transfer line of surplus water to the upper heights (approx. 1.3km).
