## Main decommissioning works and steps

All fuel had been removed from Unit 4 SFP by December 22, 2014. Work continues toward fuel removal and debris (Note 1) retrieval from Unit 1-3.

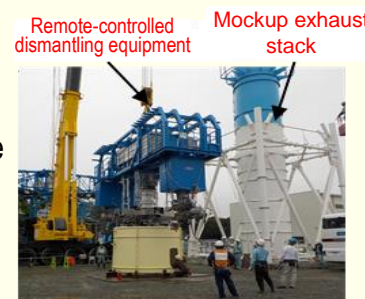
Mockup test

For the Unit 1/2 exhaust stack, in which damage and breakage were detected, the upper half will be dismantled from the perspective of further reducing risks. (information in the previous report).

To facilitate the onsite work, a mockup test of the dismantling equipment started at a simulated facility from August 28.

Knowledge acquired in the test will be reflected in the implementation plan, such as work procedures. Toward the preparatory work for dismantling from December, efforts will continue with safety first.

- **Progress status toward dismantling the Unit 1/2 exhaust stack**
  - For the Unit 1/2 exhaust stack, in which damage and breakage were detected, the upper half of the stack will be dismantled from the perspective of further reducing risks.

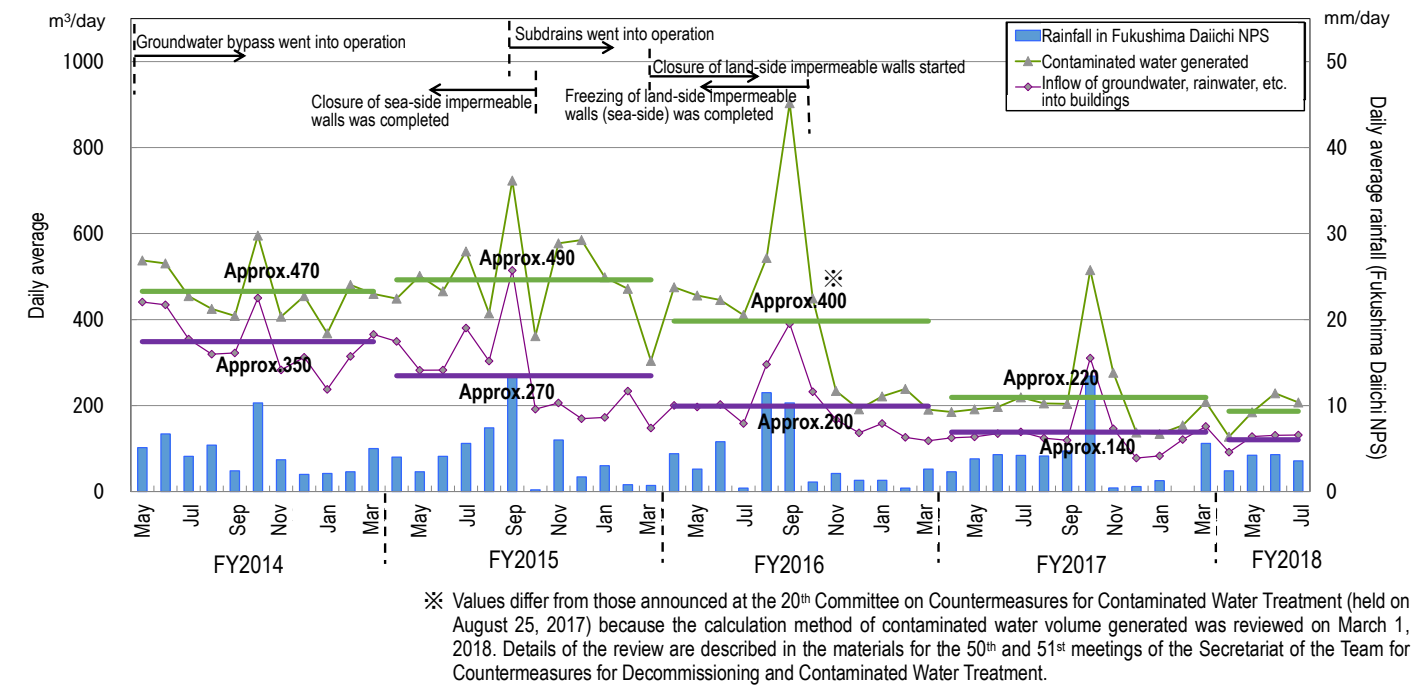
Figure 1: Changes in contaminated water generated and inflow of groundwater, rainwater, etc. into buildings

- As a result of steady implementation of “isolation” measures (groundwater bypass subdrains, frozen walls, etc.), the inflow reduced from approx. 470 m<sup>3</sup>/day (the FY2014 average) when the measures were first launched to approx. 220 m<sup>3</sup>/day (the FY2017 average), though the figure varied depending on rainfall, etc.
- Measures will continue to further reduce the volume of contaminated water generated.

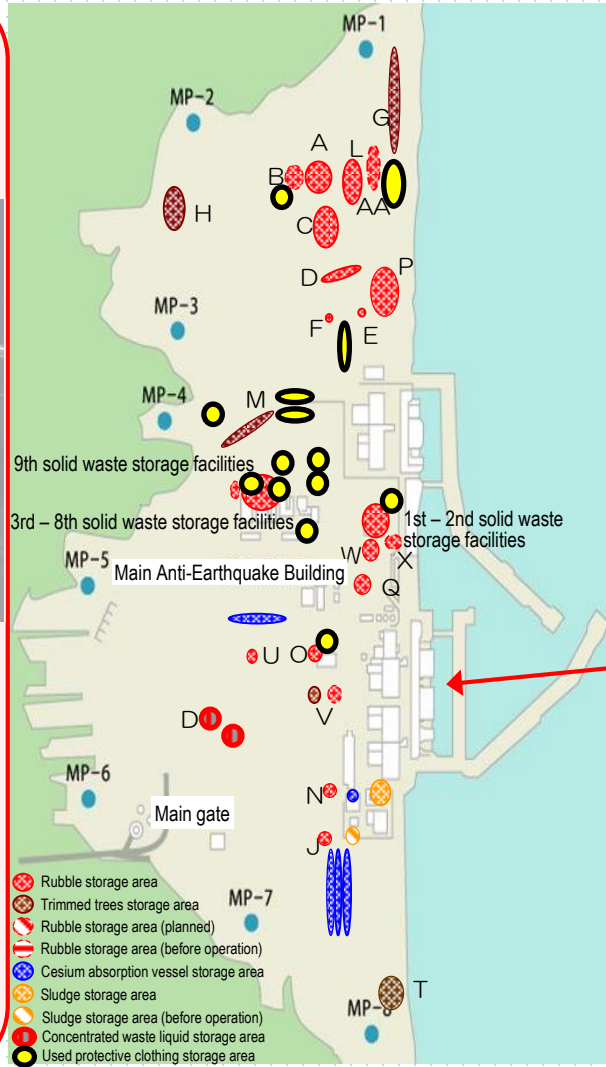
- Rubble storage area
- Trimmed trees storage area
- Rubble storage area (planned)
- Rubble storage area (before operation)
- Cesium absorption vessel storage area
- Sludge storage area
- Sludge storage area (before operation)
- Concentrated waste liquid storage area
- Used protective clothing storage area
